2011 Continuing Surveillance Annual Report

Gas System Integrity Department
May 2012

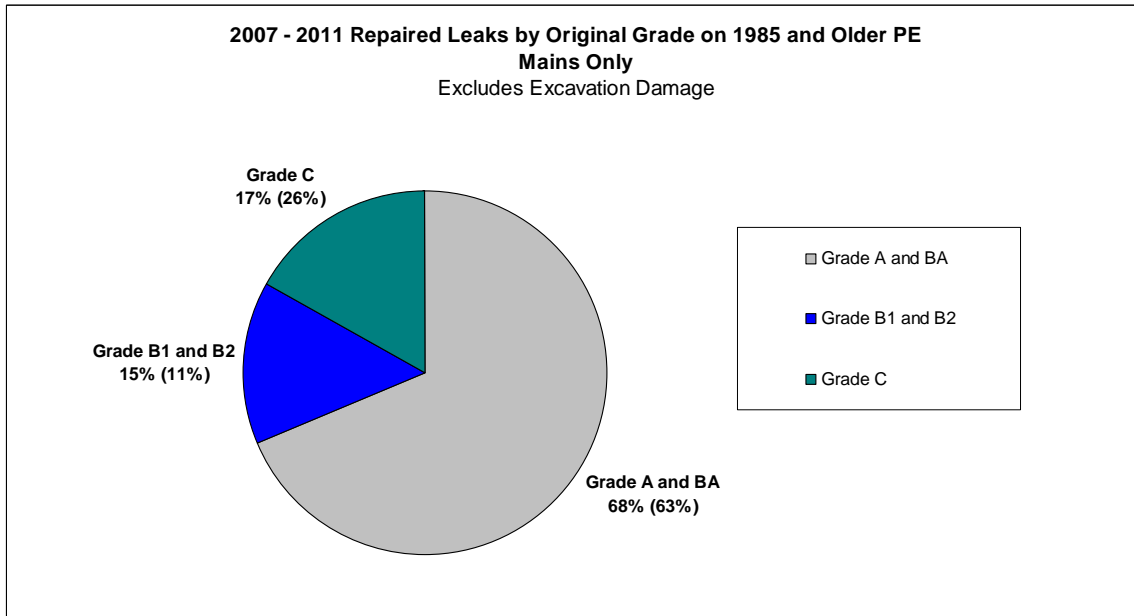
Figure 18. 2007-2011 Repaired leaks by Original Grade on 1985 and Older PE Mains

Additional analysis of leak repairs by grade and material type show leaks repaired on older vintage PE main are more than twice as likely to be hazardous than leaks repaired on older STW main or bare steel main. The following graph shows the original leak grade of leaks repaired on older PE main both as a 5 year average and for 2011.

As shown in this graph, the original grade of repaired leaks on older PE main are hazardous approximately 65% of the time compared to 30% and 20% on older STW main and bare steel main respectively. This trend provides insight into the consequence of leaks especially on older vintage PE mains. Both the likelihood and consequence of a leak are part of PSE’s risk analysis and are incorporated into risk ranking methodologies.

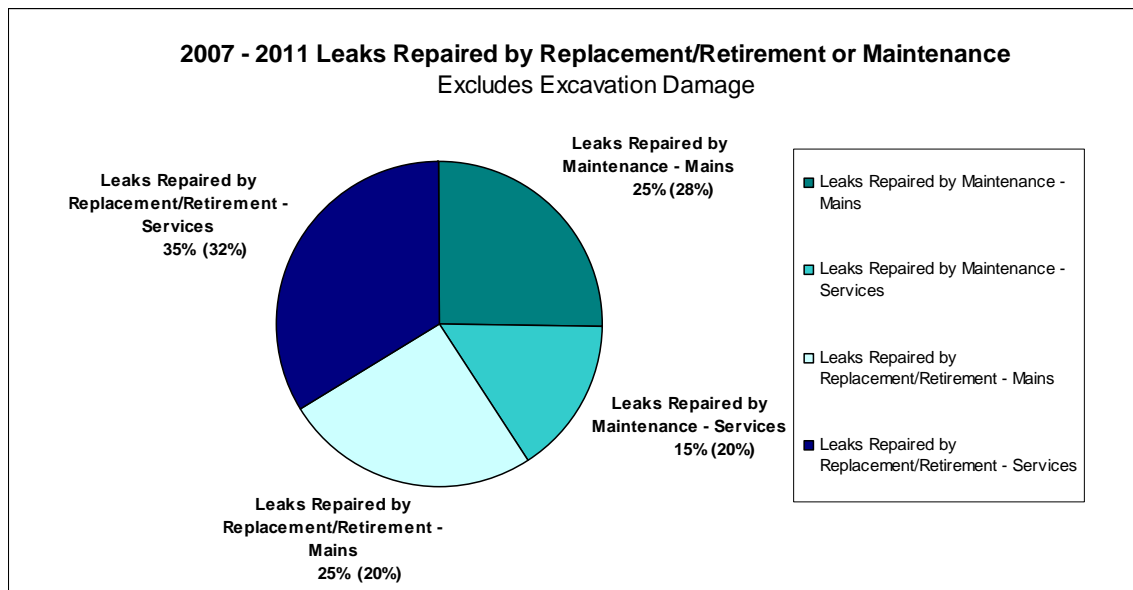
Figure 19. 2007-2011 Leaks Repaired by Replacement/Retirement or Maintenance

For the remainder of the leaks, Figure 19 illustrates the mix of leak repairs performed by replacing or retiring facilities versus maintenance activities (i.e. installing leak clamps, greasing valves, tightening fittings, etc.).

As shown in this graph, more than half of the leaks over the past 5 years have been repaired by replacement. The following graph shows the repair versus replacement trend for each of the past 5 years.

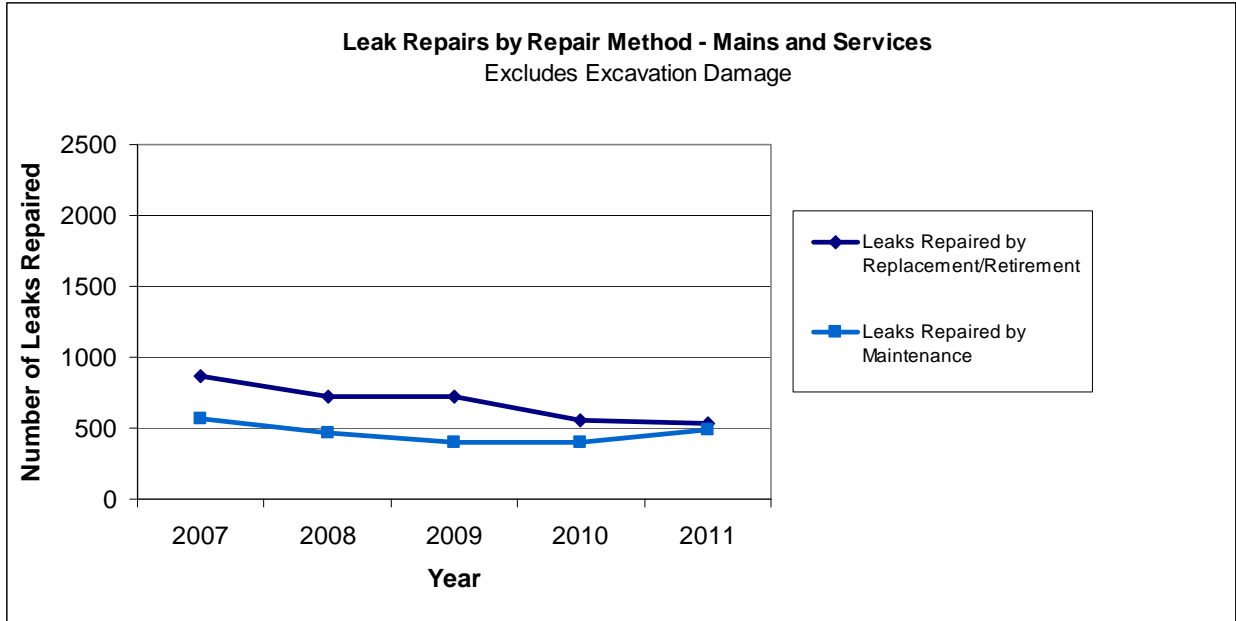
Figure 20. Leak Repairs by Repair Method – Mains and Services

This graph shows that repairs due to replacement are declining. This is likely due to the fact that replacements in prior years had a higher concentration of active leaks. As more facilities continue to be replaced, this trend is expected to continue as replacements will focus not only on active and historical leaks but also on more proactive replacement prior to leaks occurring that require repair.

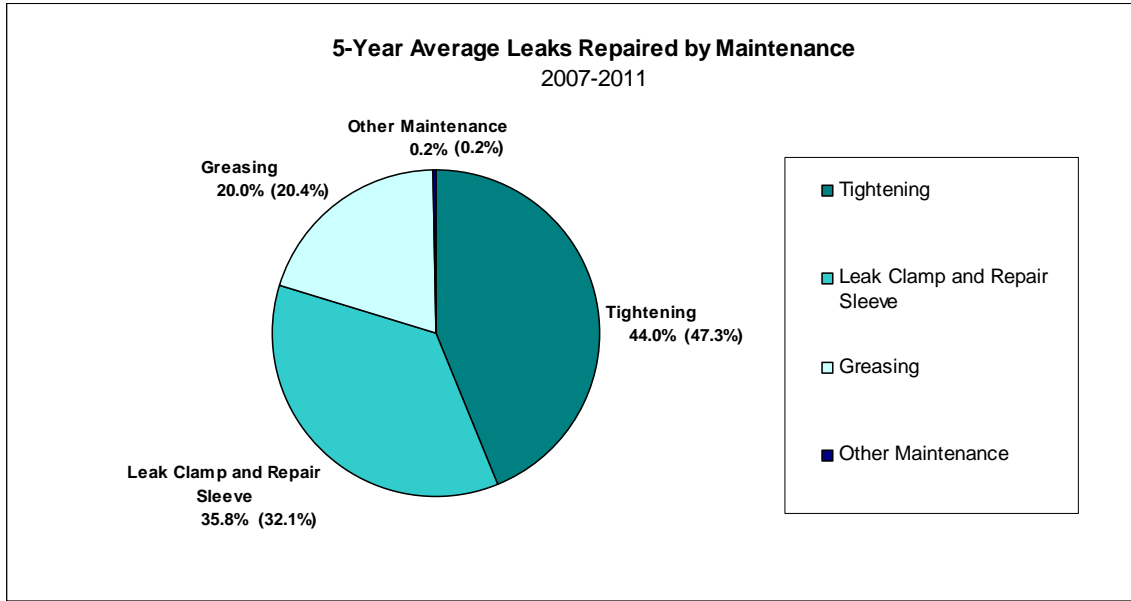
Figure 21. 5-Year Average Leaks Repaired by Maintenance

As shown in this graph, the majority of leaks repaired through maintenance are repaired by tightening or installing a leak clamp. The 2011 data shows a similar trend as the 5 year average data. These trends will continue to be evaluated to determine if there are any emerging threats that require additional mitigative measures.

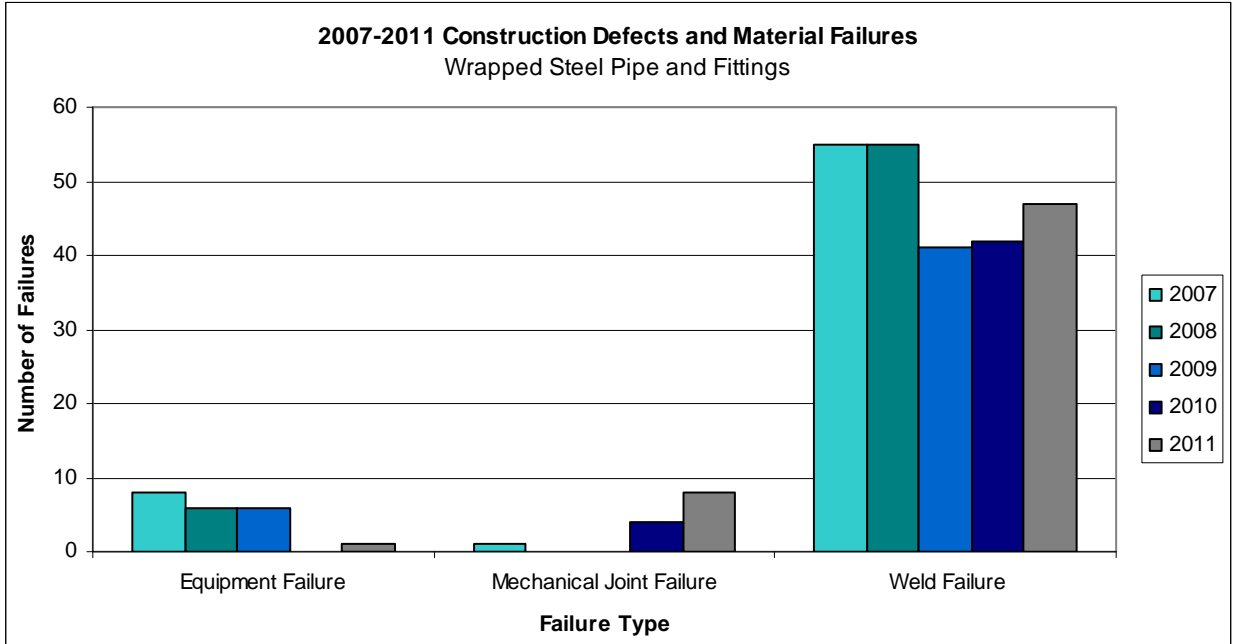
Figure 22. 2007-2011 Construction Defects and Material Failures – Wrapped Steel Pipe and Fittings

Since joining procedures and mechanical fitting designs are dramatically different for steel and plastic systems, each material type will be reviewed separately, beginning with steel pipe. Figure 22 illustrates the construction defect and material failure data from the failure analysis findings for wrapped steel pipe and fittings.

This graph shows weld failure as the leading cause of construction defect and material failure on wrapped steel pipe. The majority of these failures occur on older vintage STW pipe where the service tee is welded to the main. This graph also shows an increase in mechanical joint failures in recent years. Most of these failures were due to leaking service tee caps or leaking flanges on valves. The Wrapped Steel Pipe Mitigation Program discussed in *Part 4. Mitigative Measures and Additional and Accelerated Actions* assigns risk weightings to these failures, and segments are prioritized for mitigation based on the risk score. These trends will continue to be monitored and analyzed to determine if new or revised mitigative measures are necessary beyond the Wrapped Steel Pipe Mitigation Program.

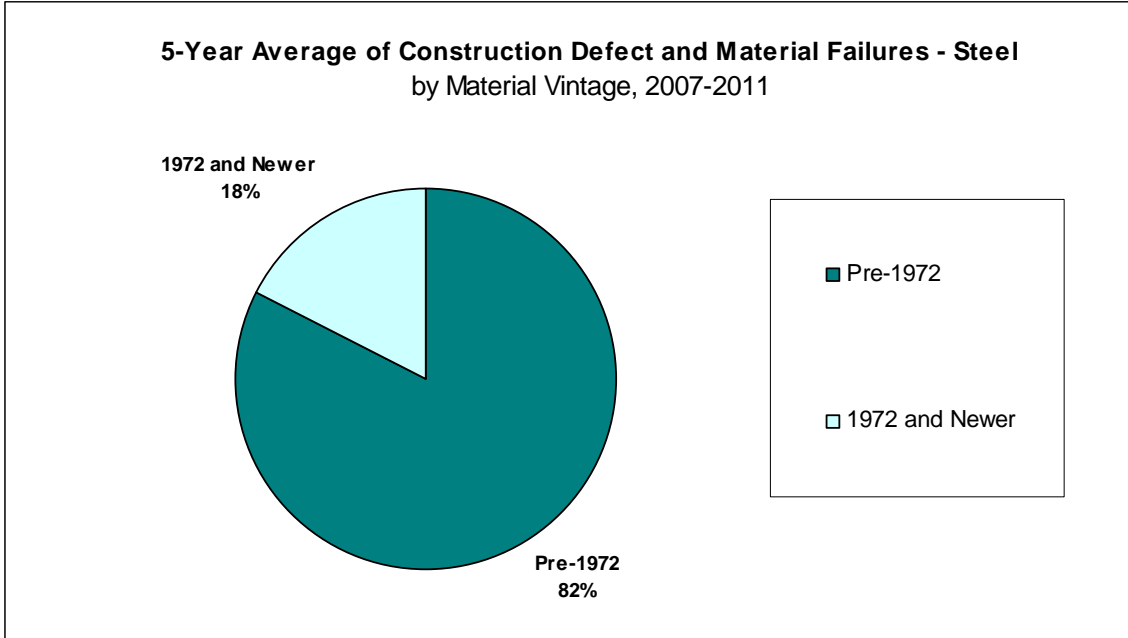
Figure 23. 5-Year Average of Construction Defect and Material Failures - Steel

Figure 23 shows the construction defect and material failure data on steel pipe by year the pipe was installed. As shown in this graph, steel pipe installed prior to 1972 has experienced the majority of failures within these two failure categories.

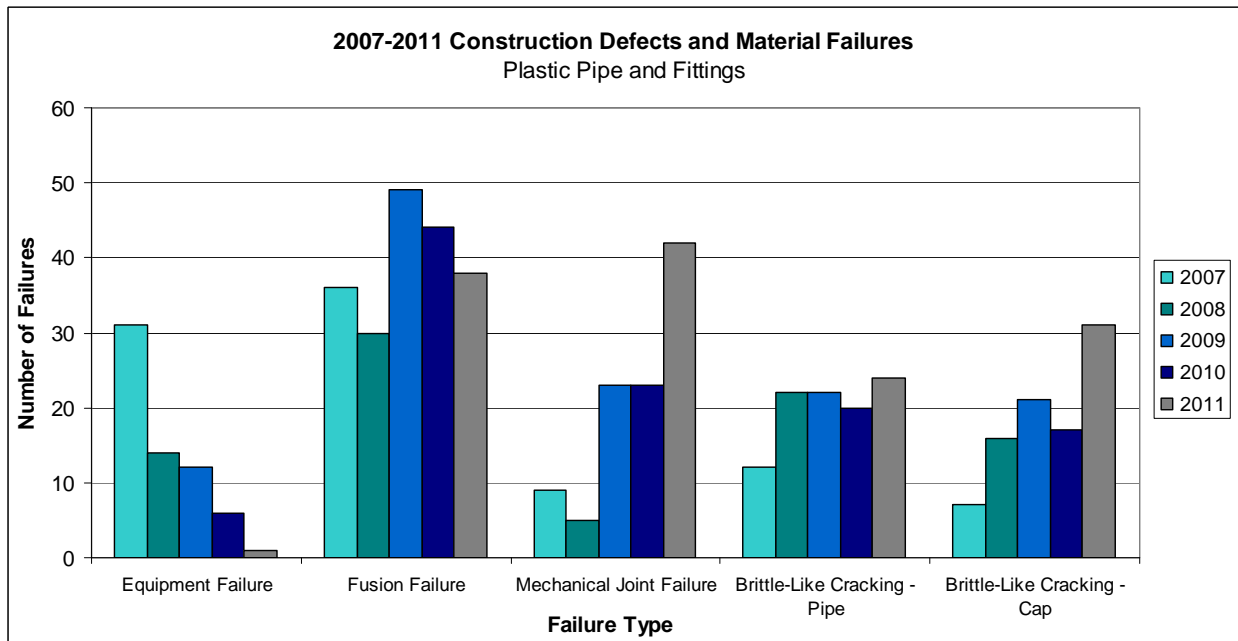
Figure 24. 2007-2011 Construction Defects and Material Failures - Plastic

A similar review of construction defect and material failures was also analyzed for plastic pipe. This data is presented in Figure 24.

Note: In previous years, this graph had brittle-like cracking on PE service tee caps categorized as Equipment Failure or Brittle-like Cracking (general). To more accurately analyze these failures, additional analysis was performed on all years of data to categorize these failures more accurately.

As shown in this graph, there has been a notable increase in the number of leaks due to brittle-like cracking of service tee caps as well as mechanical joint failures. This may be indicative of a trend or it may be due to continuous improvement in the Failure Analysis process that has resulted in more failures being categorized as Construction Defect or Material Failure and fewer failures categorized as Undetermined, Other, and Unknown.

Most of these PE service tee caps that failed due to cracking occurred on Plexco Celcon caps installed between 1990 and 1997. This is consistent with industry trends as Celcon has been identified as a material known to be susceptible to brittle-like cracking. Service tees installed after 1997 are unlikely to experience this failure as Plexco began using PE for their service tee caps in 1996.

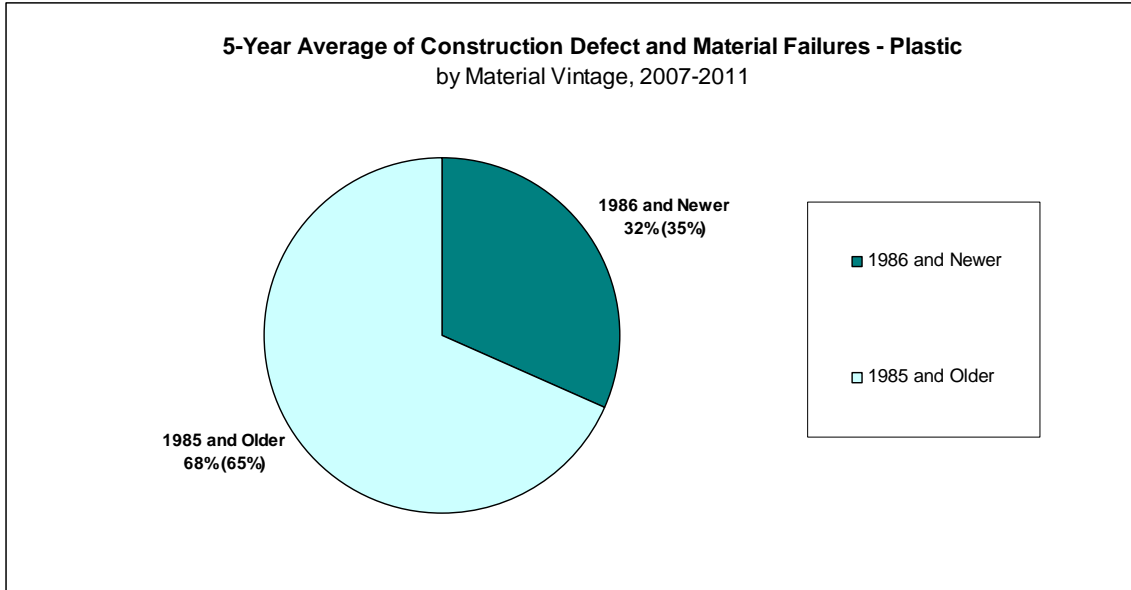
Figure 25. 5-Year Average of Construction Defect and Material Failures – Plastic

Figure 25 shows the 5-year average of plastic construction defects and material failures by when the facility was installed. As shown in the graph, majority of failures occur on plastic pipe installed prior to 1986.

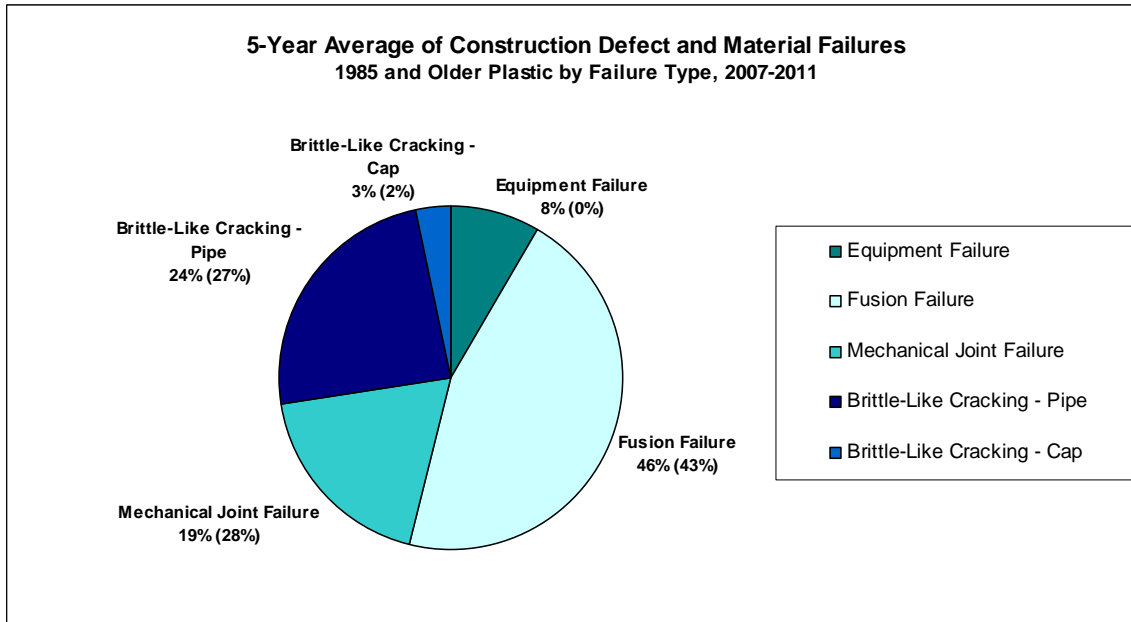
Figure 26. 5-Year Average of Construction Defect and Material Failures – 1985 and Older PE

Additional analysis of construction defect and material failures on plastic pipe installed prior 1986 indicates that 70% of these failures are due to fusion failures or brittle-like cracking. This data is shown in Figure 26 and shows the trends in 2011 are consistent with the 5-year average.

Brittle-like cracking is primarily due to rock impingement but also occurs where the pipe has been squeezed or experienced point loading due to external forces. The Older Vintage PE Pipe Mitigation Program assigns risk weightings to fusion failures, brittle-like cracking, and reports of rock in the vicinity of PE pipe. Segments are prioritized for mitigation based on this risk score.

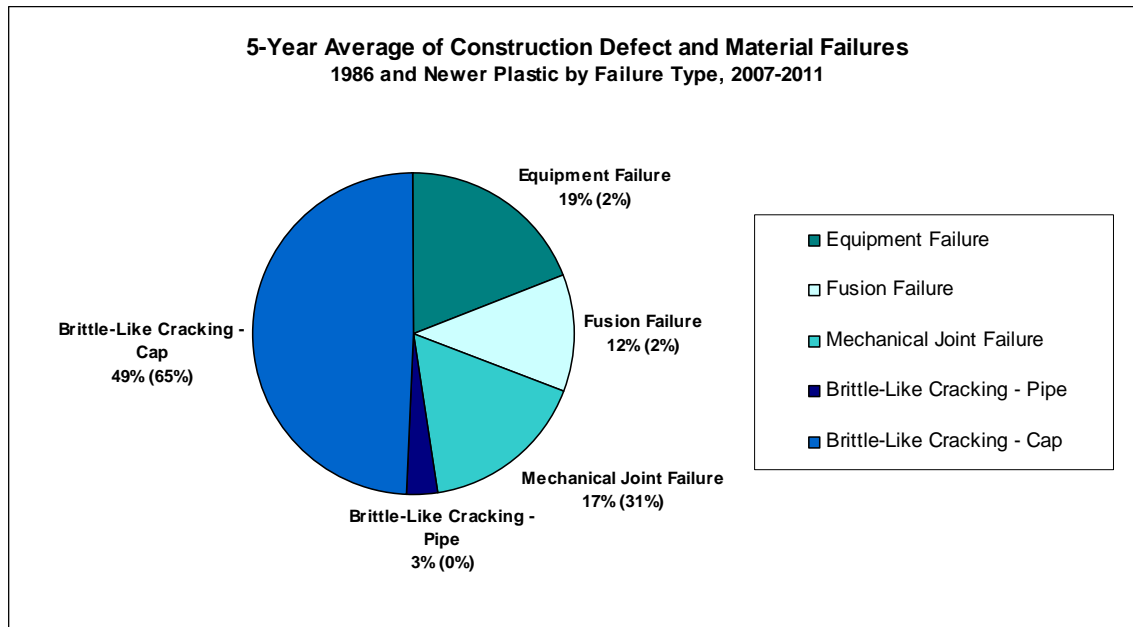
Figure 27. 5-Year Average of Construction Defect and Material Failures – 1986 and Newer PE

Analysis of construction defect and material failures on plastic pipe installed after 1986 indicates the majority of these failures are due to brittle-like cracking on PE service tee caps. As previously discussed, the brittle-like cracking cap failures occur mostly on the Celcon caps installed between 1990 and 1997. Figure 27 shows the root cause of these failures for both the 5-year average and for 2011.

This graph shows an increase in the percent of construction defects and material failures due to mechanical joint failures in 2011. This increase may be indicative of a trend or it may be due to continuous improvement in the Failure Analysis process that has resulted in more failures being categorized; i.e. fewer failures are categorized as Undetermined, Other, and Unknown. It may also be due to increased attention on accurately categorizing mechanical fitting failures due to the requirement to report these to PHMSA. PSE will continue to monitor these trends as additional years of data are obtained to determine if there are any trends that indicate additional mitigative measures should be implemented.

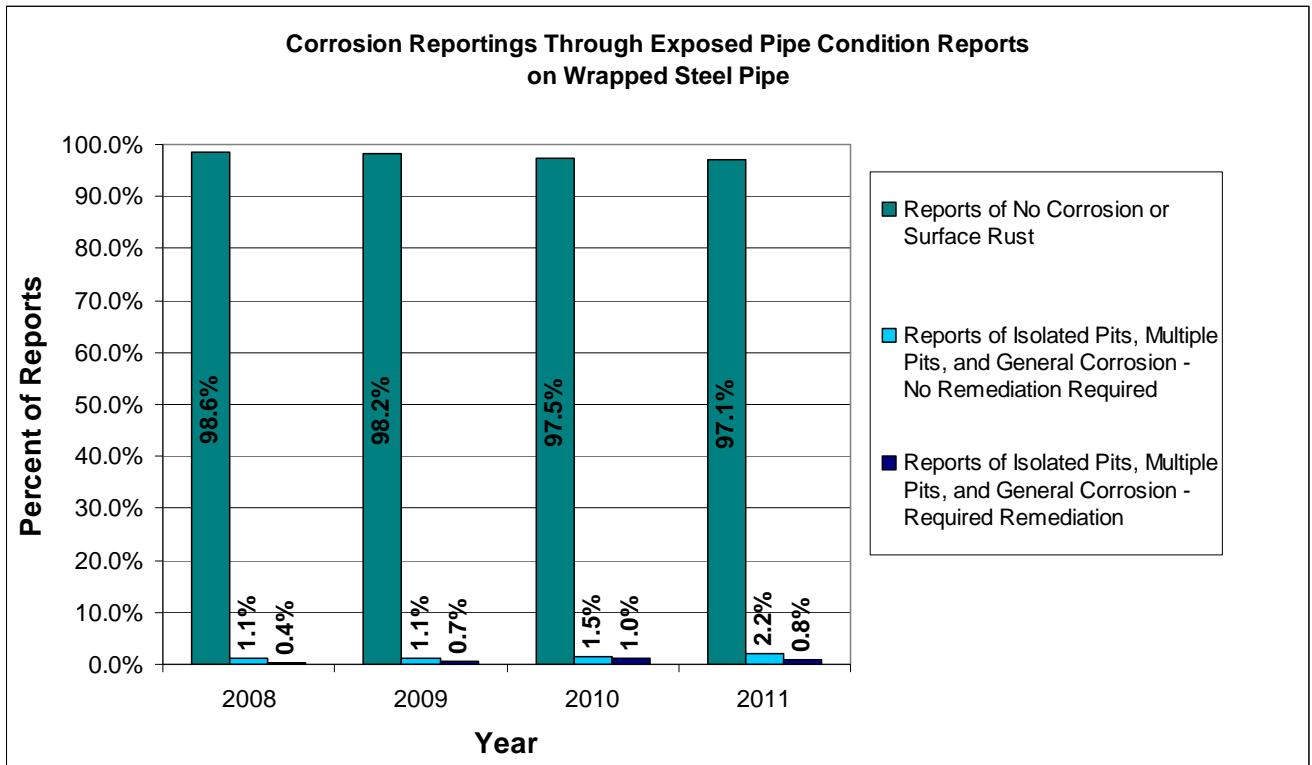
Figure 28. Corrosion Reportings through Exposed Pipe Condition Reports

Based on a 4-year average from 2008 through 2011, wrapped steel pipe is exposed at nearly 5,000 locations each year due to routine maintenance, system expansion, and new customer hook-ups. Each of these exposures provides an opportunity to examine and report on the condition of the pipe. Figure 28 presents data obtained each time a section of wrapped steel pipe is exposed.

This data shows that on average 98% of the time wrapped steel pipe is exposed there is no corrosion or only minor surface rust. It also shows that for the 2% of the time when corrosion is found, less than half require remediation.

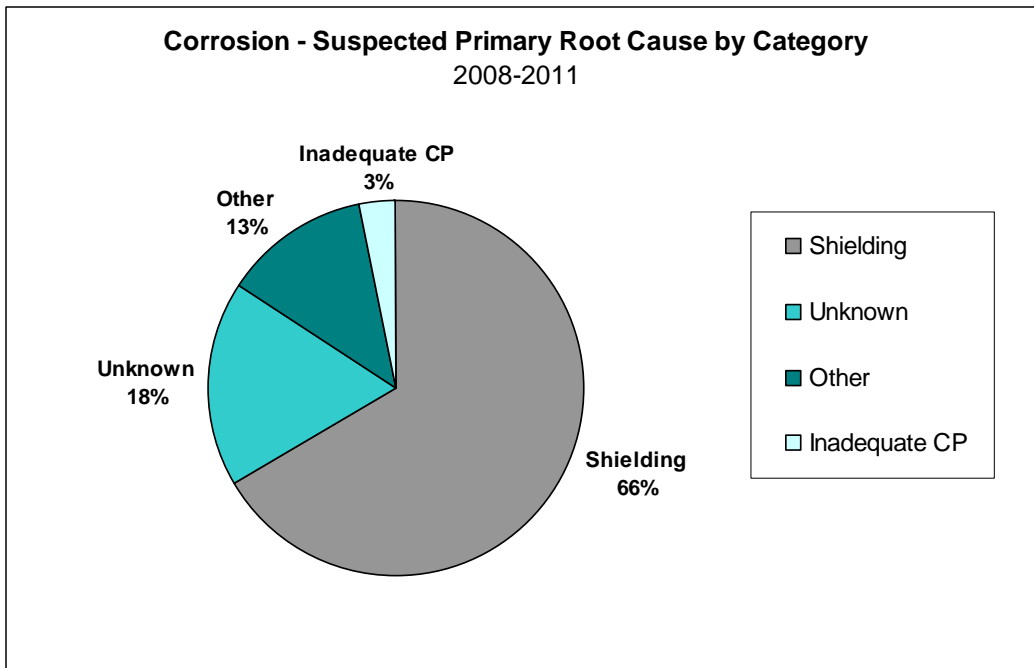
Figure 29. Corrosion Suspected Root Cause by Category

When Gas System Integrity department is notified that corrosion is found on wrapped steel pipe, additional data is collected. This data includes more specific information on coating conditions, corrosion characteristics, soil and environment conditions, and any other information that may assist in understanding what caused the corrosion. PSE analyzes this information to try to determine the primary root cause of the corrosion and the secondary cause. This data is further analyzed to determine if there are any trends that warrant attention. The results of this analysis are presented in the following section.

As shown in this graph, the most common cause of corrosion is due to the pipe being shielded from cathodic protection (CP). Shielding occurs when the CP current is not able to reach the pipe due to either disbonded coating or a foreign object near or in contact with the pipeline. Additional suspected root causes are categorized as either Unknown, Inadequate CP, or Other, The root cause is categorized as Inadequate CP when the cathodic protection is low at the time

the pipe was exposed. Other includes where there are multiple contributors and it is difficult to determine which ultimately caused the corrosion.

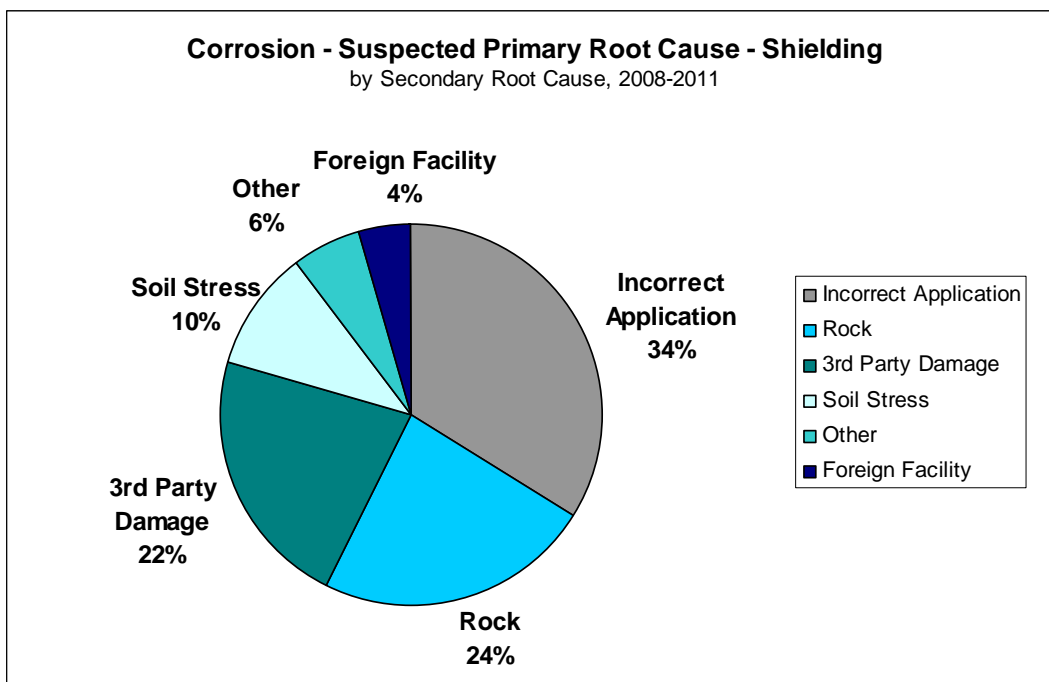
Figure 30. Corrosion Due to Shielding by Secondary Root Cause

As shielding is the most significant root cause of corrosion, Figure 30 provides additional information on the secondary root cause; i.e. what caused to the pipe to be shielded. Shielding of cathodic protection could be caused by either disbanded coating or an object in contact with the pipe. As shown in this graph, the most common causes are incorrect application of the coating, rocks in the backfill, and third party damage. Corrosion can also occur when the pipe is shielded by to foreign facilities and coating failures due to soil stress. Examples of shielding due to “Other” include material near the pipe such as wood timbers or asphalt that shields the pipe from CP.

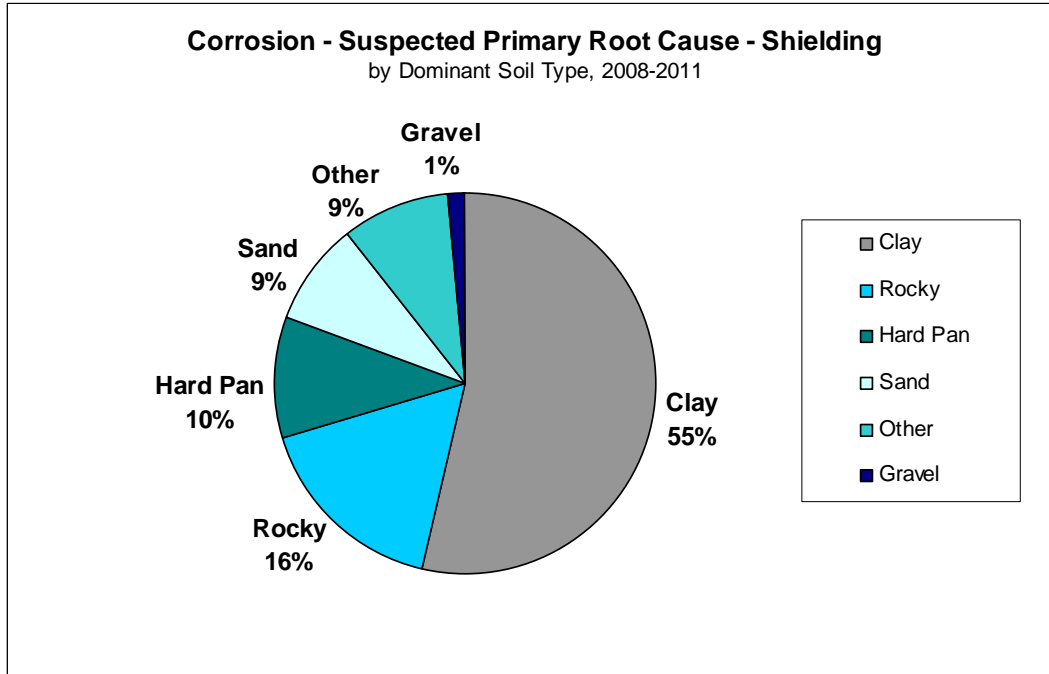
Figure 31. Corrosion Due to Shielding by Soil Type

Since shielding is the largest contributor to corrosion failures, the soil types and pipe vintages are further analyzed to understand what combinations of factors may lead to shielding. This data will continue to be monitored and may be incorporated into PSE’s risk models if the data indicates this is appropriate. Figure 31 shows the different soil types that have been found in the backfill of where shielding has occurred.

Clay is the most dominant soil type found near corrosion failures due to shielding. Clay can contribute to coating becoming disbonded as it binds to the coating and expands and contracts with changes in moisture placing stress on the coating.

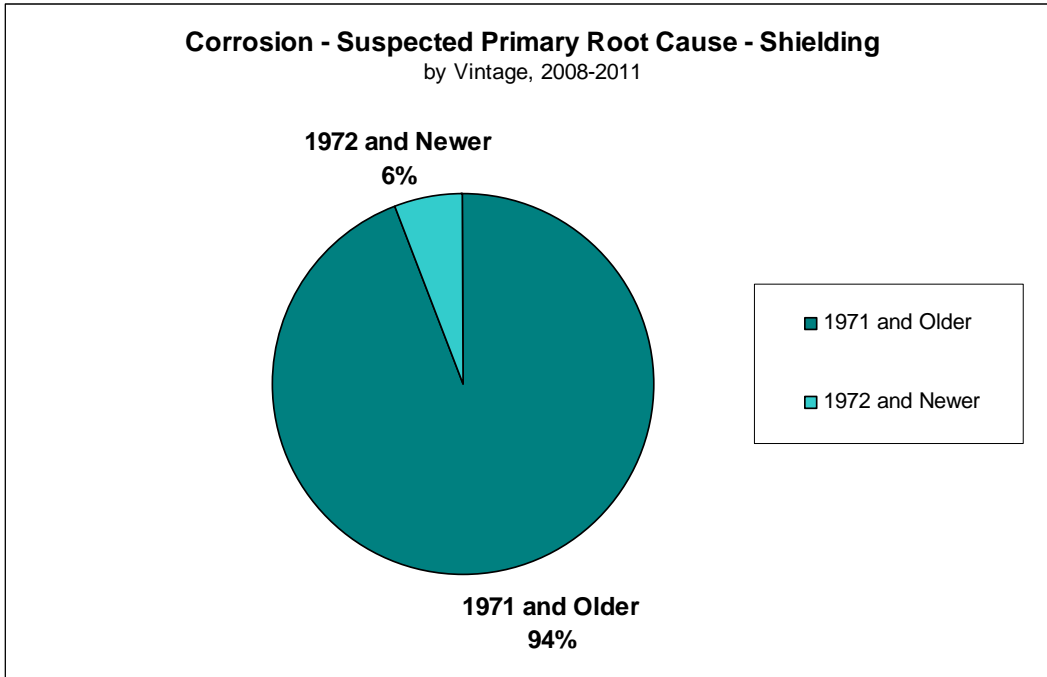
Figure 32. Corrosion Due to Shielding by Vintage

As seen in Figure 32, shielding occurs mostly on older vintage wrapped steel.

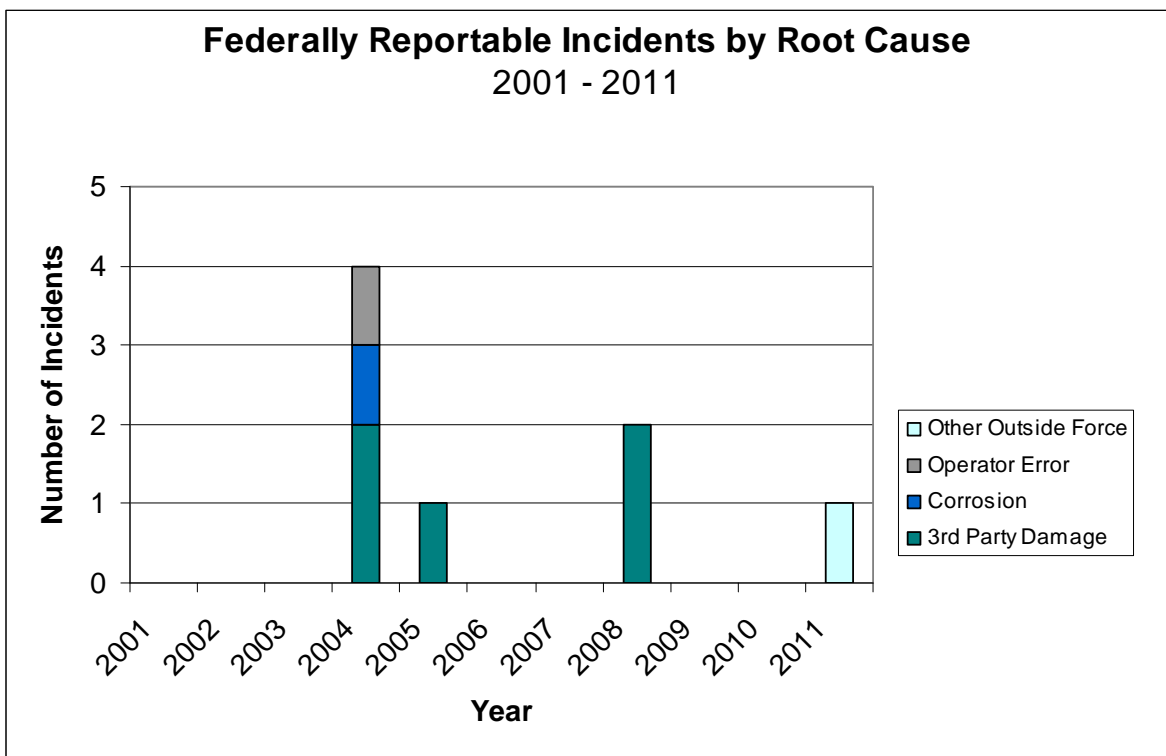
Figure 33. Federally Reportable Incidents by Root Cause

Note: In 2011 there were three incidents that were federally reported. Two of them would have been retracted if there was a process to withdraw reports based on additional information that indicated these incidents did not meet the requirements for federally reporting. Therefore, these two are not included in the analysis and trending.

This data illustrates that third party damage is not only the leading cause of leaks on PSE’s system but is also the leading cause of reportable incidents. The Third Party Damage Prevention Trends section discusses PSE’s Damage Prevention Program and the efforts to continue to reduce third party damage.

There were three incidents that were not caused by third party damage in the period from 2001 to 2011 and three due to third party damage. The corrosion incident resulted in the Wrapped Steel Service Assessment Program (WSSAP) that is discussed in the Gas Maintenance Programs

There are very few federally reportable incidents over time and as a result, there is not a significant trend shown in this data. The data shows that third party damage remains the leading cause of reportable incidents.

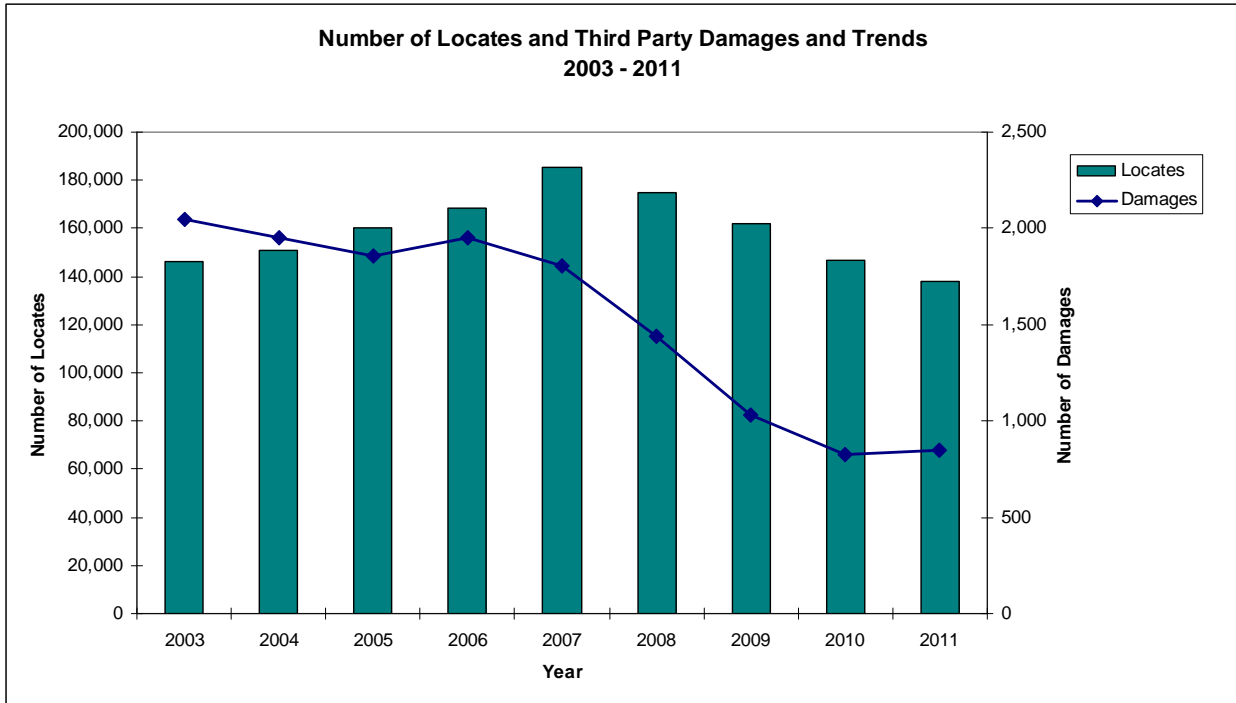
Figure 34. Number of Locates and Third Party Damages and Trends

Figure 34 shows both the number of locate requests per year as well as the number of damages per year. Through 2007, locate requests had been surging as a result of the region's active growth and focused "call-before-you-dig" awareness programs. Since 2008, the number of locate requests has steadily decreased, most likely due to the significant reduction in construction activity attributed to the economic slowdown.

Figure 34 also shows the number of excavation damages per year which have steadily declined over this period of time. While locate requests have continued to decline since 2007, damages have also declined. In 2011, the number of third party damages increased slightly from 2010. However, 2010 and 2011 remain the two lowest years reported in the prior 9 years.

Further reductions in the number of locate requests have occurred due to improvements PSE made to its locating processes and procedures. These improvements include refining the maps that the One Call Center uses to identify where PSE has natural gas facilities and revising codes used by the locate contractors to more accurately reflect when PSE natural gas facilities were located versus PSE electric facilities. These improvements had an impact on the number of locate requests counted for 2011 and are expected to have an even larger impact in 2012 when the improvements will be in place for the entire year.

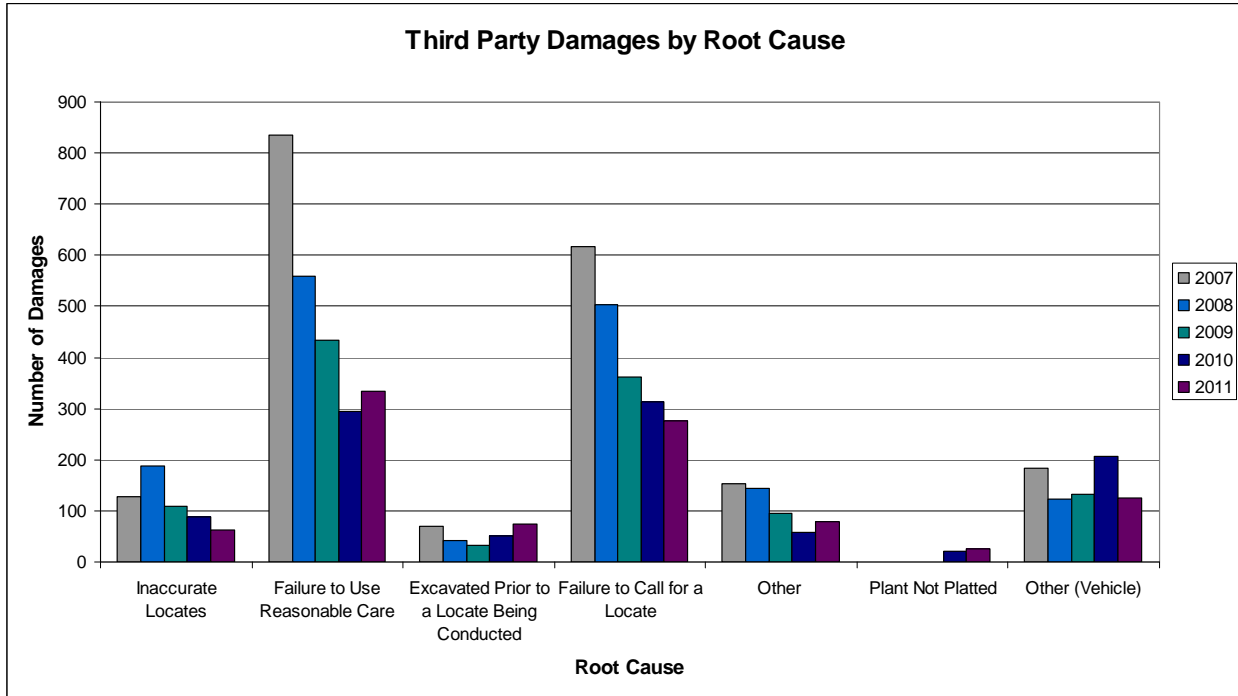
Figure 36. Third Party Damages by Root Cause

While there have been significant reductions in the number of damages due to “Failure to Use Reasonable Care” and “Failure to Call for a Locate”, these two categories are still the leading cause of third party damages. PSE recognizes that a key element required to further reduce these damages will require an enhanced approach to enforcing the requirements of RCW 19.122 relative to both calling before excavation and careful excavation practices. This is supported by research AGA has done to benchmark damage prevention programs across the country. Based on this research, distribution companies operating in states that have mechanisms to enforce damage prevention legislation are able to achieve the lowest number of damages per 1,000 locates.

This graph illustrates the success PSE has had in reducing damages per locate request. The slight increase in 2011 in the number of damages per 1,000 locate request is due in part to the improvements in the locating process described above that resulted in fewer locate requests being counted. Even with this change, 2010 and 2011 remain the two lowest years reported in the prior 9 years. This positive trend has been achieved through a combination of efforts. The most significant reductions have been achieved by excavators using more careful excavation practices and increased public awareness of and adherence to the regulations that require excavators to call for locates prior to excavating as illustrated in Figure 36.
