**BEFORE THE**  
**WASHINGTON UTILITIES AND TRANSPORTATION COMMISSION**

**CASCADE KRAFT SUBSTATION OUTAGE AND POWER QUALITY STUDY**

**February 16, 2007**

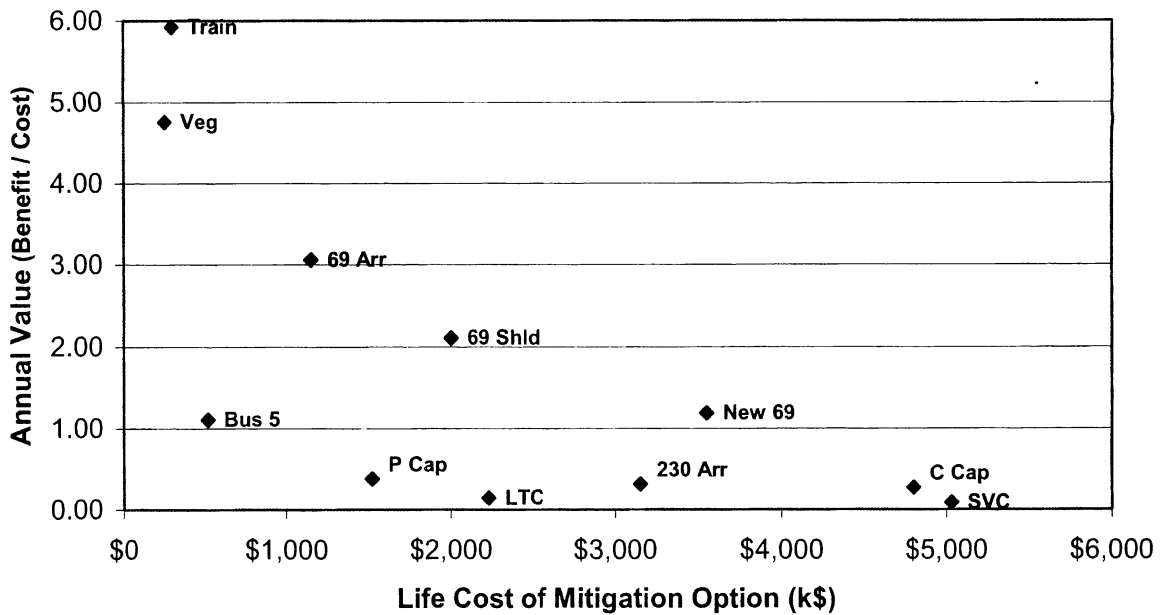
**Figure 3.1**

**Bang / Buck vs. Total Cost  
Boise-Cascade Wallula Plant Mitigation  
Without 2 Highest-cost Options\*\*DVR & New 230 kV Line**

These mitigations are the top 12 options chosen on 9/20/04 by a team meeting comprised of Boise-Cascade and PacifiCorp team members. Some of these options are extremely costly, but they made it on the list because they were seen as effective.
