**Docket Nos. UG-110723
Puget Sound Energy, Inc.'s
Tariff Filing for Pipeline Integrity Program**

2010 Continuing Surveillance Annual Report

May 2011

Gas System Integrity Department

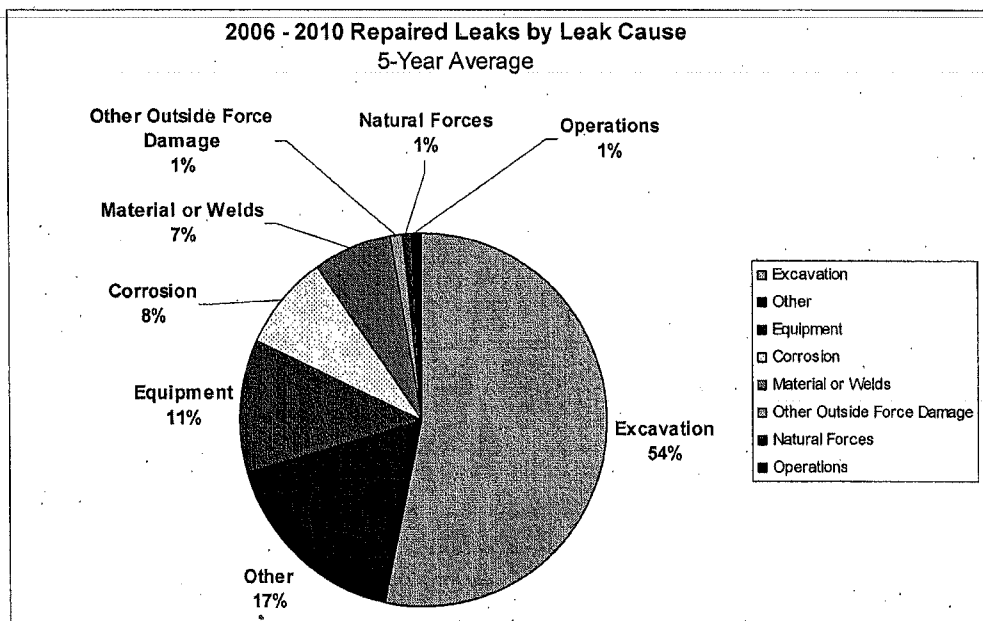
Leak repair data also indicates that excavation damage remains the leading threat to the system. As shown in the following graph, 3rd party damage was the cause of more than 1/2 of the leaks repaired during the last 5 years. In addition, 3rd party damage is the leading cause of federally reportable incidents. These trends are consistent throughout the industry.

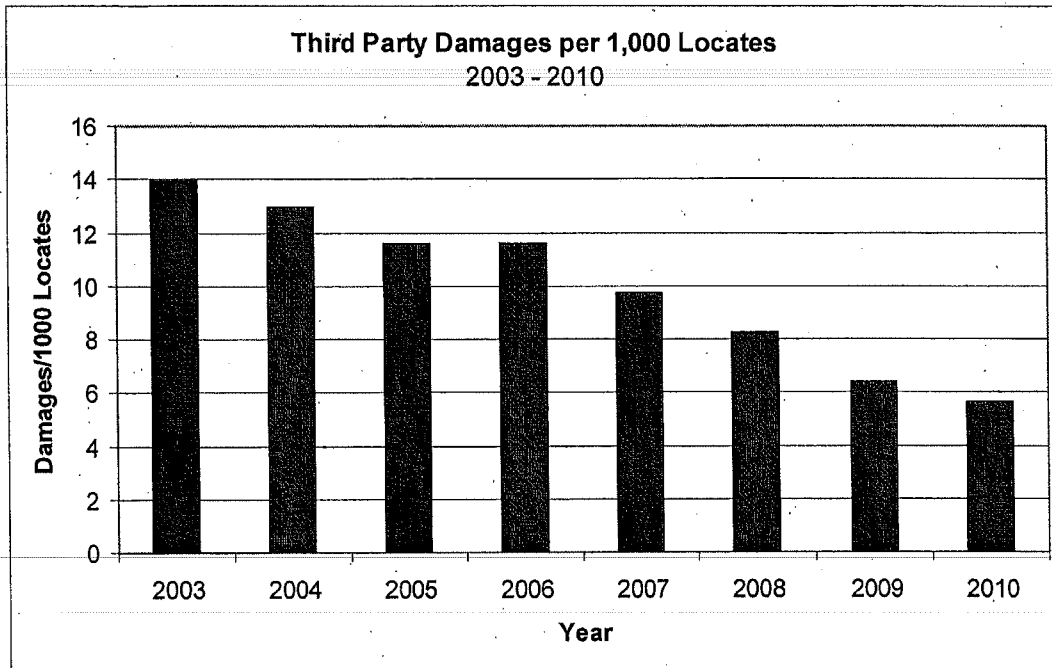
Even though 3rd party damage remains the leading cause of leaks on our system, PSE has achieved a significant reduction in 3rd party damage since 2003. The Common Ground Alliance and industry in general has accepted representing the ratio of damages per 1,000 locates to better normalize the impact of increasing and decreasing excavation activity. As shown in the graph below, PSE has been very successful in reducing damages per 1,000 locate requests. This positive trend has been achieved through a combination of efforts. The most significant reductions have been achieved by excavators using more careful excavation practices and increased public awareness of and adherence to the regulations that require excavators to call for locates prior to excavating.

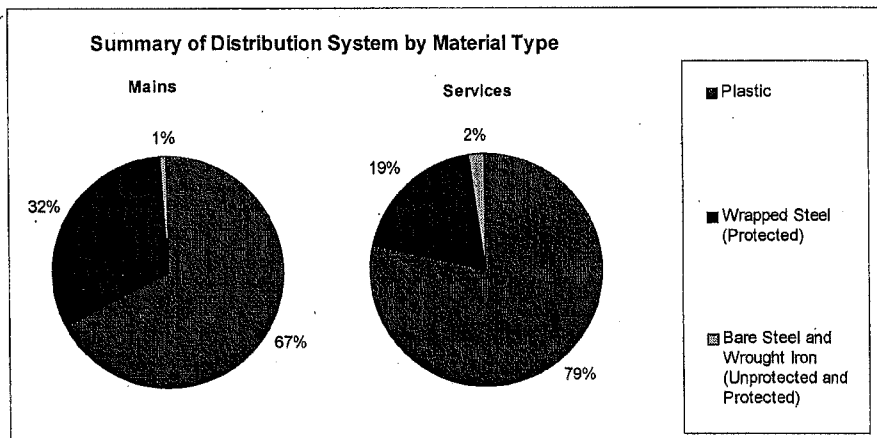
Figure 1. Summary of Distribution System by Material Type

Additional information on PSE's Gas System Description can be found in the *System Data* section of this report as well as Gas Operating Standard (GOS) 2400.0500 Gas System Description. The following table and graph, Table 1 and Figure 1, summarizes the mains and services in PSE's system by material type as of the beginning of 2011.

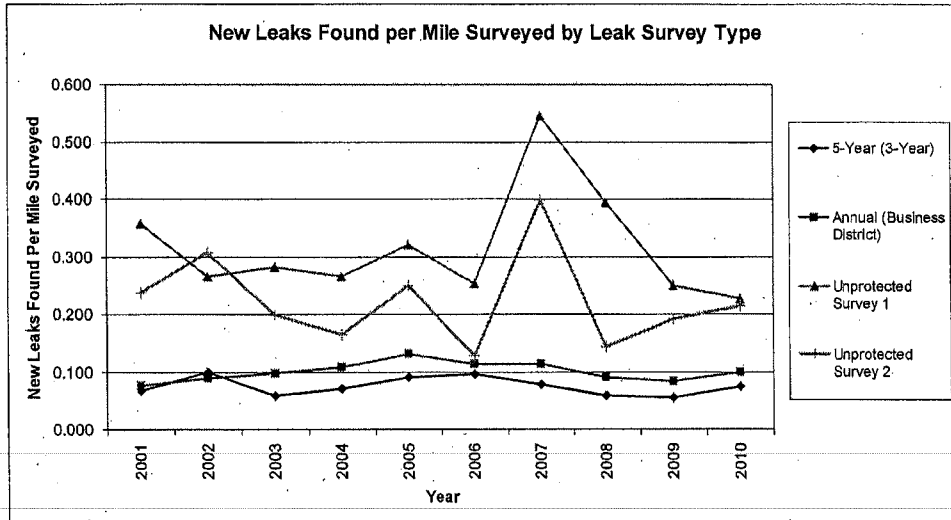
Figure 3. New Leaks Found Per Mile Surveyed by Leak Survey Type

PSE has an extensive Leakage Survey Program which is documented in GOS 2625.1100. This standard specifies the frequency of leak survey for each type of facility. Unprotected steel pipe and copper pipe is leak surveyed twice annually and the results of these surveys are depicted in Figure 3 as “Unprotected Survey 1” and “Unprotected Survey 2”, representing the first and second survey each year, respectively. Pipe within areas that are designated as business districts, high occupancy structure or area, and supply mains operating above 250 psig are leak surveyed annually. The results of these surveys are depicted in the same graph as “Annual (Business District)”. With the exception of a few specialized leak surveys, all other surveys are required by pipeline safety regulations to be performed at least once every 5 years. In 2006, PSE began performing these surveys every 3 years and has continued to maintain this schedule due to efficiencies of combining leak survey activities with atmospheric corrosion monitoring. These surveys are depicted as “5-year (3-year)” on the graph.

As shown in this graph, the highest concentration of new leaks is found on the facilities that are leak surveyed the most frequently and the lowest concentration of new leaks is found on those facilities that are surveyed the least frequently. This chart demonstrates that the different survey frequencies are appropriately distributed for the different types of facilities.

In addition to demonstrating that the different survey frequencies are appropriately assigned to the different types of facilities, this graph shows a significant increase in new leaks found in 2007 on the unprotected pipe leak surveys. PSE noticed this increase in new leaks being found and took steps to ensure personnel were trained to properly identify and grade leaks as well as trained in PSE's phantom leak procedure. Subsequently, the number of new leaks found returned to more typical values.

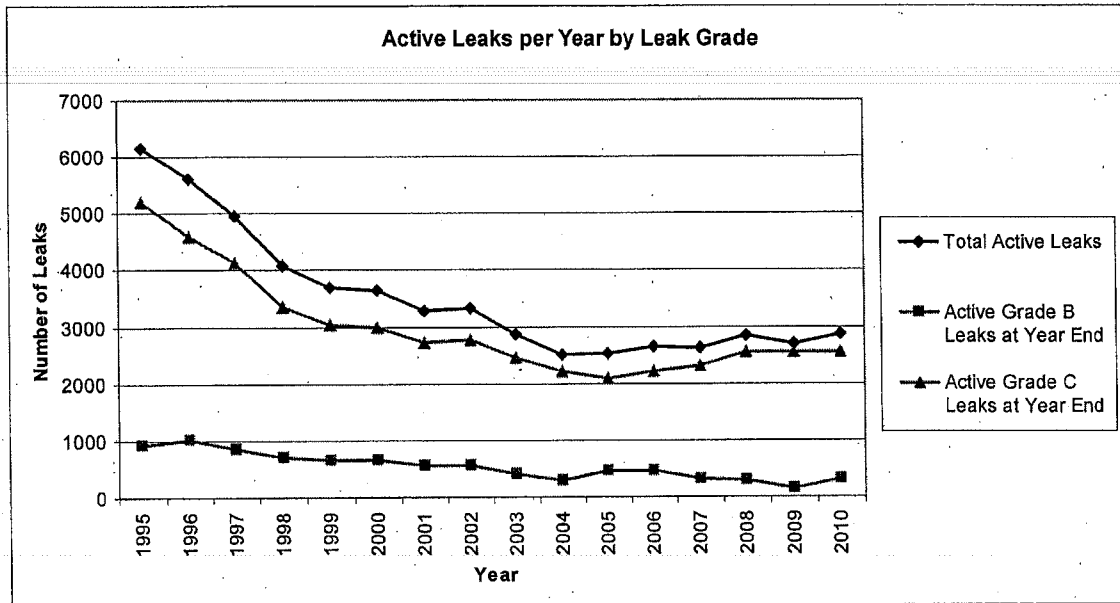
Figure 6. Active Leaks per Year by Leak Grade

Figure 6 illustrates the active leak trends over the past 16 years. Active leaks are leaks that are being monitored but have not yet been repaired. This graph shows the total number of active leaks at the end of each calendar year as well as the number of "C" and "B" leaks that make up this total.

Since 1995, PSE has reduced the total number of active leaks by over 50 percent and the number of “B” leaks by over 65 percent. One of the primary reasons for this reduction in total active leaks can be accredited to the cast iron replacement program which was completed in 2007. As seen in the graph, there was a significant reduction in active leaks each year until it leveled off just prior to the completion of the cast iron replacement program.

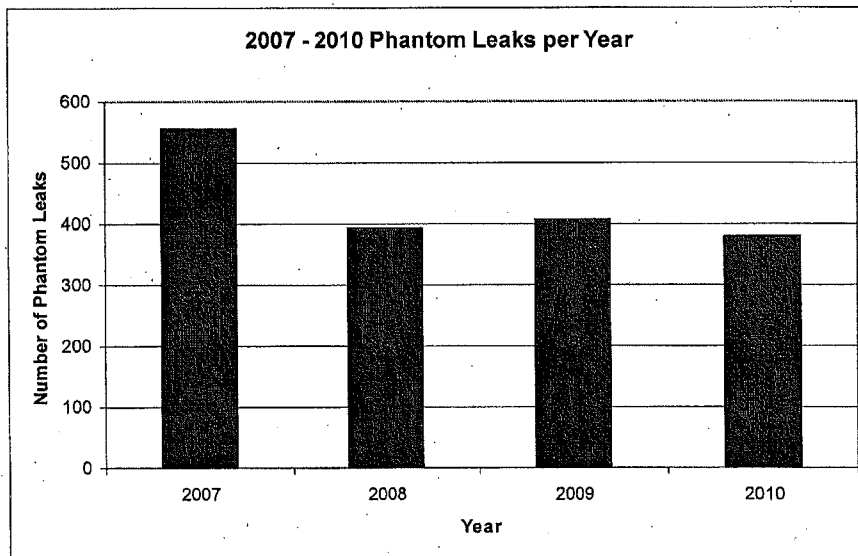
Figure 17. 2007-2010 Phantom Leaks per Year

While most leaks are eliminated by replacement, retirement or maintenance, leaks can also be eliminated when it is determined that there was not actually a leak present. These leaks are classified as phantom leaks. The Figure 17 shows there has been a decrease in the number of phantom leaks since 2007. This decrease is attributed to improvements in the leak repair documentation process that more accurately tracks leaks that are repaired through replacement and reduces those that may have been classified as a phantom leak.

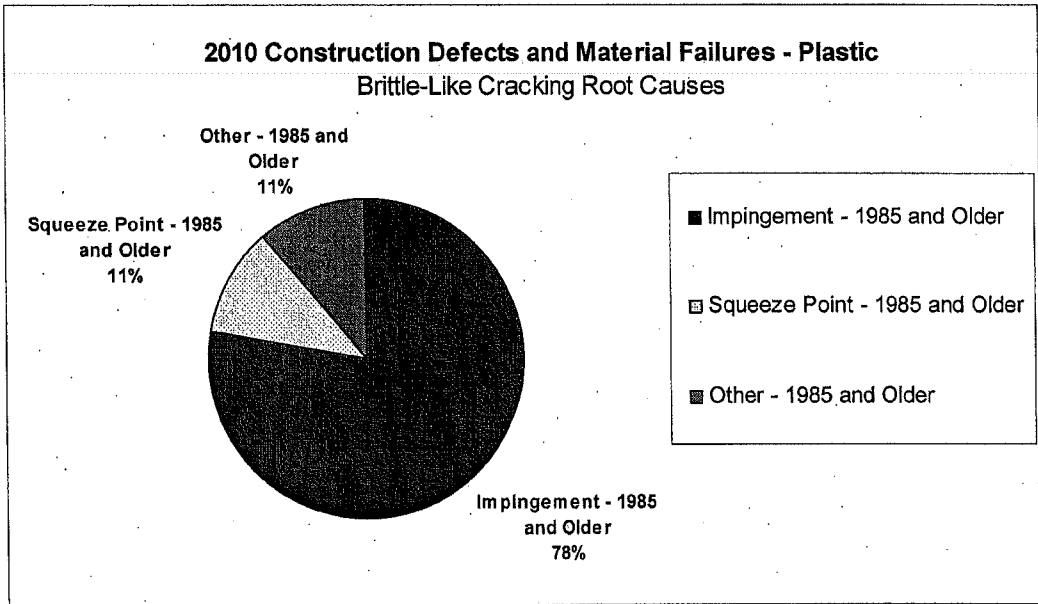
Figure 21. 2010 Construction Defects and Material Failures - Plastic

A more detailed look at 2010 failures due to brittle-like cracking on pipe, as shown in Figure 21, indicates that all brittle-like cracking failures occurred on older vintage plastic pipe. Beginning in mid-2010, PSE began collecting additional data on the root cause of brittle like cracking. This includes identifying whether there was a rock or a foreign facility adding external point loads to the pipe or whether the crack occurred in a location that had previously been squeezed. Based on the data collected in 2010, rock impingement is the leading cause of brittle-like cracking on plastic pipe. These root causes will continue to be monitored for trends as more years of data are collected.

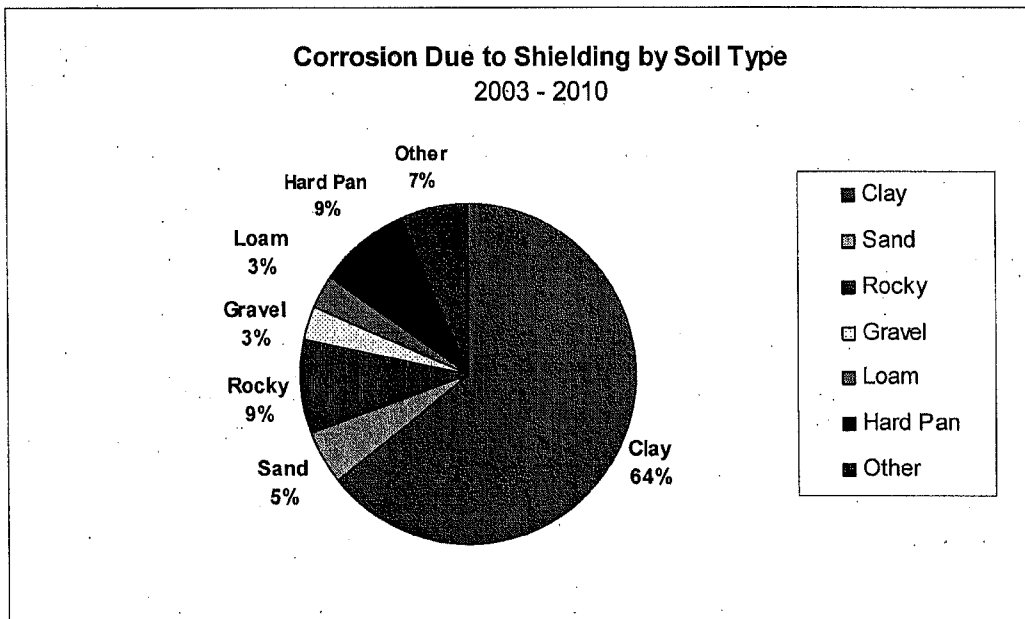
Figure 26. Corrosion Due to Shielding by Soil Type

Since shielding is a large contributor to corrosion failures, the soil types and pipe vintages are further analyzed to understand what combinations of factors may lead to shielding. This data will continue to be monitored and may be incorporated into PSE's risk models if the data indicates this is appropriate. Figure 26 shows the different soil types that have been found in the backfill of where shielding has occurred.

Clay is the most dominant soil type found near corrosion failures due to shielding. Clay is suspected to worsen the condition of the disbonded coating as it binds to the coating and expands and contracts with changes in moisture. Rocky and hard pan soils also coincide with the next largest percentage of corrosion due to shielding. As seen in Figure 27, shielding occurred mostly on older vintage wrapped steel.

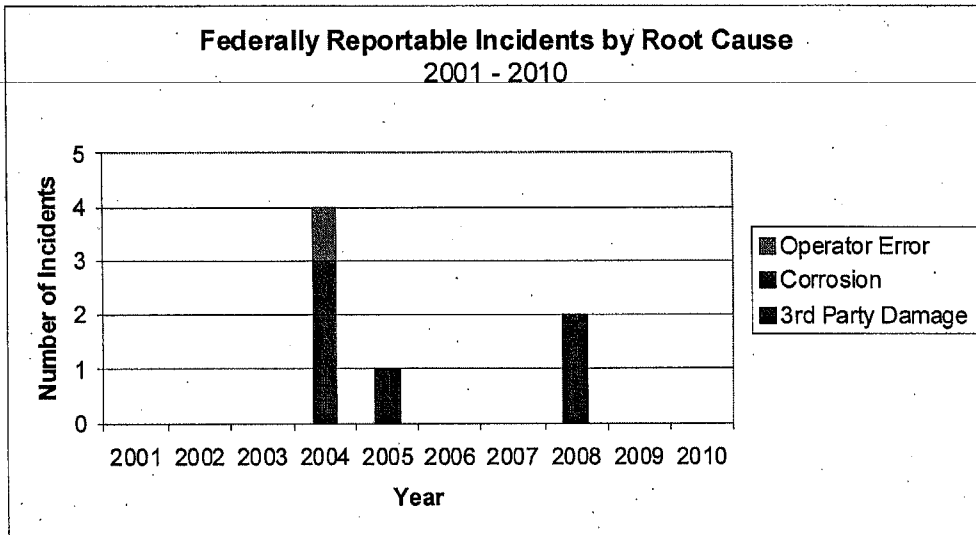
Figure 28. Federally Reportable Incidents by Root Cause

There are very few federally reportable incidents over the past 10 years, thus no trends have been identified. However, these incidents are still worth examining as they represent specific situations where the consequence of a risk is significant. In each of these instances, PSE has examined the root cause and where appropriate PSE has implemented additional measures as described below to reduce future risks.

This data illustrates that 3rd party damage is not only the leading cause of leaks on PSE’s system but is also the leading cause of reportable incidents. The *Third Party Damage Prevention Trends* section discusses PSE’s Damage Prevention Program and the efforts to continue to reduce 3rd party damage.

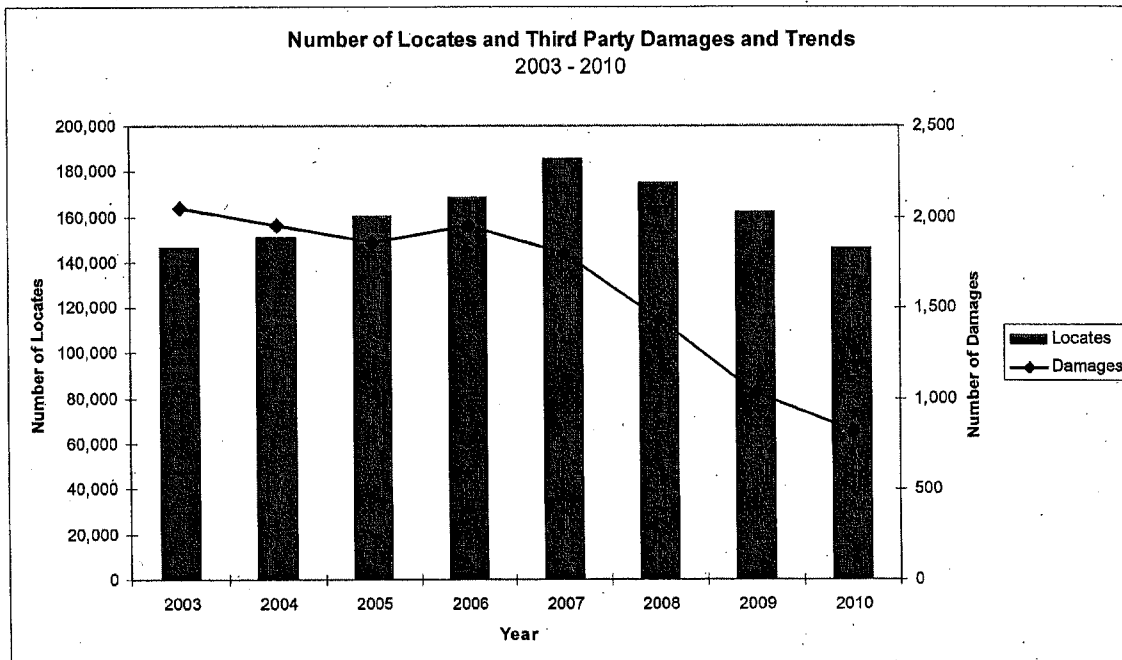
Figure 29. Number of Locates and Third Party Damages and Trends

As shown by Figure 29, through 2007, locate requests had been surging as a result of the region’s active growth and focused “call-before-you-dig” awareness programs. Since 2008, the number of locate requests has steadily decreased, most likely due to the significant reduction in construction activity attributed to the economic slowdown.

The number of excavation damages is also presented on the graph to compare trends. This comparison reveals that excavation damage has generally made a steady decline over this same period of time, continuing a trend that began during the “boom” cycle prior to 2008. In addition, the number of third party damages in 2010 was the lowest reported in the prior 8 years.
