Two-Year Plan for Managing Select Pipe  
Replacement in Avista Utilities' Natural Gas System

Docket No. UG-120715

May 31, 2013

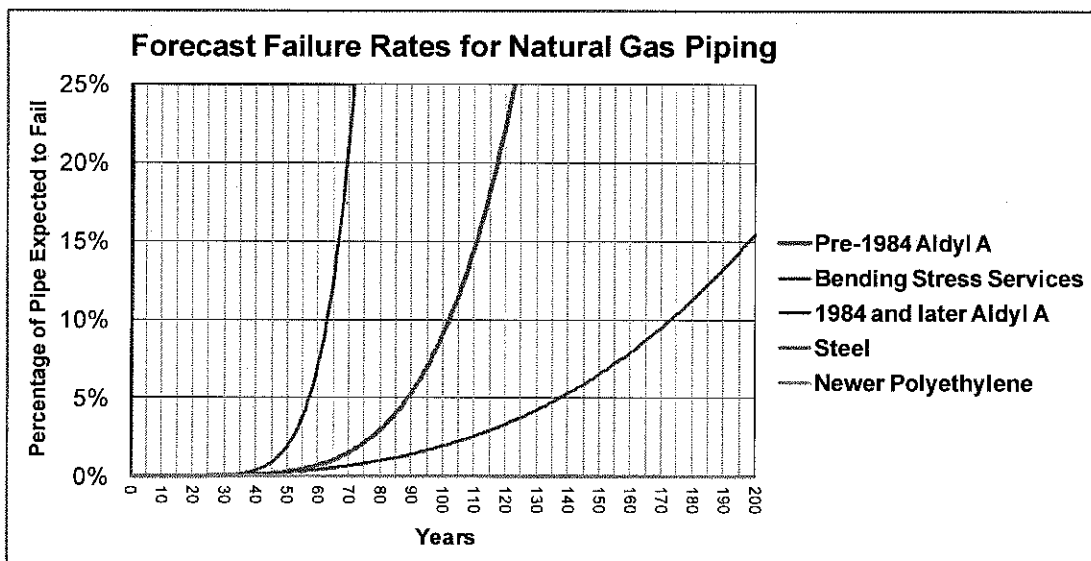
*Figure 5. The expected failure rates for several classes of pipe in Avista's system, as forecast by Availability Workbench Modeling. The "Steel" curve is obscured by the "Newer Polyethylene" curve, both of which are essentially flat lines.*

Results of the forecast modeling, for the pipe classes evaluated, are represented as 'curves' showing the percentage of the amount of each pipe class that is projected to fail in each year of the forecast time period. The resulting reliability curves are shown in the graph below in Figure 5.

The failure curves show dramatic differences in the expected life for the pipe classes evaluated. The difference in expected life between the Aldyl A products as a group, compared with that of steel and newer-generation plastic pipe, is particularly evident. Striking also, are the expected performance differences among the classes of Aldyl A pipe evaluated, providing some clear trends useful in designing remediation strategies.

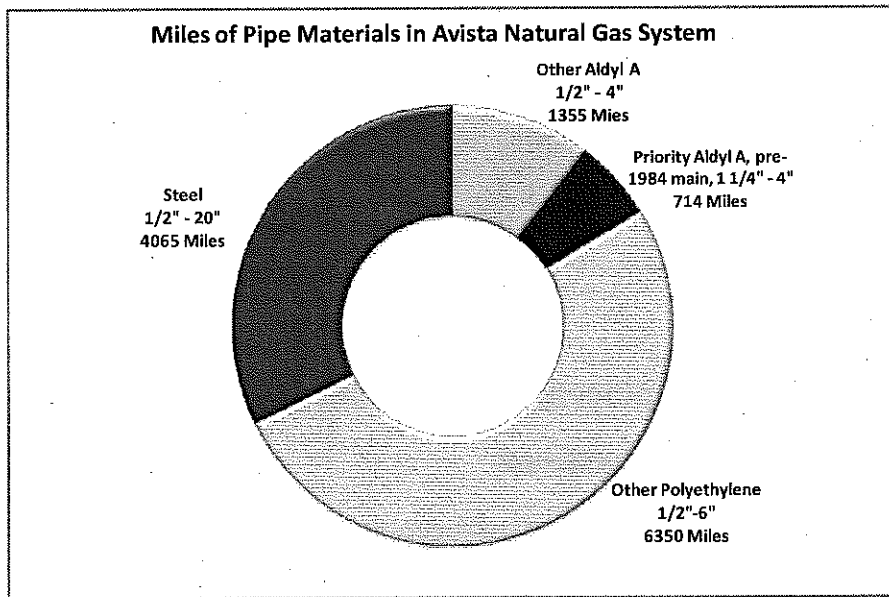
Figure 6. Avista's priority Aldyl A pipe, shown as a proportion of the different pipe classes in Avista's natural gas system (items 2 and 3 from the list above).

**Main Pipe** - Avista has approximately 12,500 miles of natural gas main pipe in its service territories in the States of Washington, Oregon and Idaho. Approximately seventeen percent of this total, or 2,000 miles, is Aldyl A pipe of all classes and sizes. Proportions of various classes of piping in Avista's system, including priority Aldyl A pipe (pre-1973 and pre-1984 mains) is shown below in Figure 6.
