Avista Utilities

Two-Year Plan for Managing Replacement of Select Pipe in Avista Utilities' Natural Gas System in its Washington Service Area

May 24, 2019

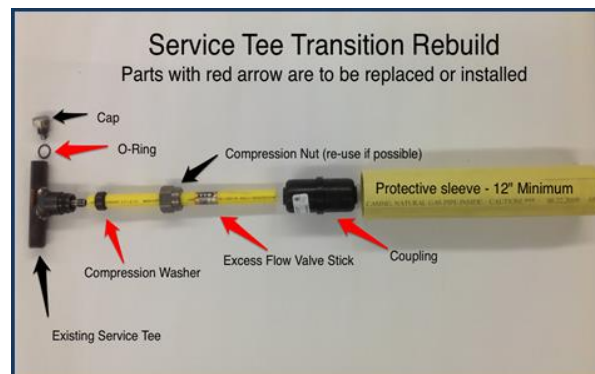
Avista is continuing its planned twenty-year program to systematically remove and replace select portions of the DuPont Aldyl-A medium density polyethylene pipe in its natural gas distribution system. The Company’s Master Plan for this program, titled “Protocol for Managing Select Aldyl-A Pipe in Avista’s Natural Gas System,” provides the background on this pipe, the vintages and types of pipe slated for replacement, as well as the rationale for the proposed twenty-year replacement program. None of the subject pipe is “high pressure main pipe,” but rather, consists of distribution mains at maximum operating pressures of 60 psi and pipe diameters ranging from 1¼ to 4 inches. As part of this program, Avista has also completed rebuilding thousands of transition fittings used to connect Aldyl-A service piping (one-half and three-quarter inch diameter) to steel tees that are welded to steel main pipe (“service tee transitions”). This Aldyl-A sub-program is also known as the Service Tee Transition Rebuild (STTR) program. The illustration below shows the replacement components of the new service tee transition.

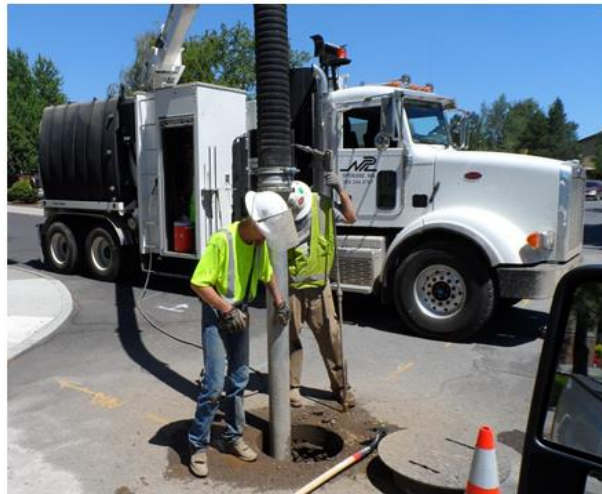
effective. The image above shows the “keyhole” technology used to minimize the pavement impact associated with rebuilding service tee transitions.

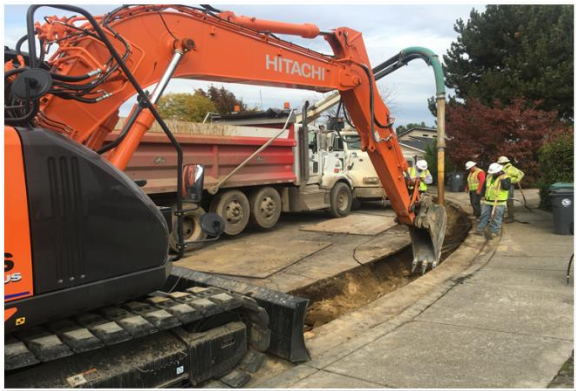
in established municipal areas and neighborhoods with existing paved roadways, sidewalks, landscaping, and other underground facilities. The illustration at left shows the pavement cut required for open trench installation of new main pipe.

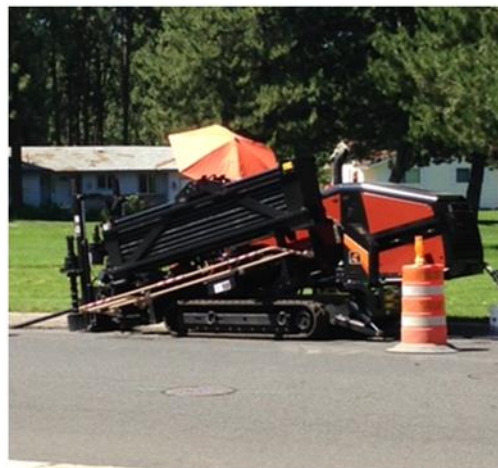
optimize the use of trenchless technologies. The image at right shows the horizontal drilling machine used to replace main pipe. Not all projects, however, are suitable for the use of split and pull or horizontal drilling technologies. There are many instances where split and pull replacement cannot be performed, for example, due to safety issues associated with joint-trench utilities when the existing pipe makes a restrictive
