Avista Utilities Asset Management

Protocol for Managing Select Aldyl A Pipe in Avista Utilities' Natural Gas System

May 2013

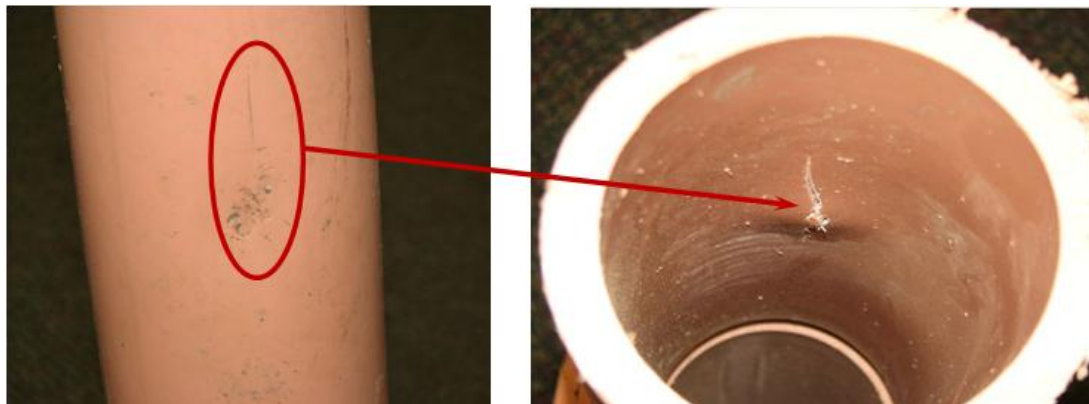
The second-most common material failure observed in Avista's Aldyl A pipe was due to localized, brittle cracking in Aldyl A mains that resulted from rock impingement – rock pressure directly on the pipe, or places where ‘squeeze-off’ was applied over the pipe's service life. These failures are very typical for certain resins of Aldyl A main pipe, having been consistently reported by other utilities since before the time of DuPont's 1986 letter. As described earlier, when these external stresses (rock impingement or squeeze-off) cause the pipe to fail, it always begins with crack initiation on the inside surface of the pipe wall, eventually resulting in slow crack growth that propagates toward the outer wall of the pipe, and finally, through-wall failure. These failures generally appear as short, tight cracks in the outer wall of the pipe that run either parallel, or slightly off-parallel with the length of the pipe. A typical failure in Aldyl A main pipe, showing a crack through the pipe wall as it appears on both the inner and outer surfaces, is shown below in Figure 3.

Figure 3. Typical brittle-like crack through the wall of Aldyl A pipe, resulting from rock contact directly on the pipe.

Although the duration of the stress caused by rock contact with the pipe is very different from that associated with squeeze-off, they both result the same pattern of crack initiation and slow crack growth leading to failure of the pipe. Other sources of external stress that can result in brittle failure of Aldyl A pipe, as mentioned earlier in the report, include bending of the pipe, soil settlement, dents or gouges to the pipe, and improper installation of fittings.

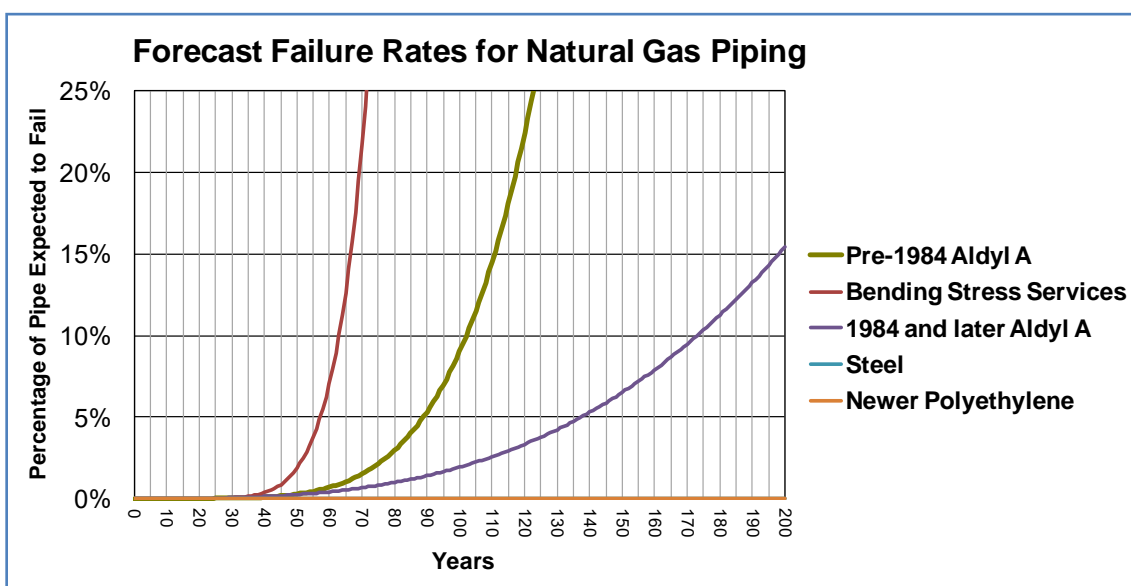
Results of the forecast modeling, for the pipe classes evaluated, are represented as ‘curves’ showing the percentage of the amount of each pipe class that is projected to fail in each year of the forecast time period. The resulting reliability curves are shown in the graph below in Figure 5.

Figure 5. The expected failure rates for several classes of pipe in Avista’s system, as forecast by Availability Workbench Modeling. The “Steel” curve is obscured by the “Newer Polyethylene” curve, both of which are essentially flat lines.

The failure curves show dramatic differences in the expected life for the pipe classes evaluated. The difference in expected life between the Aldyl A products as a group, compared with that of steel and newer-generation plastic pipe, is particularly evident. Striking also, are the expected performance differences among the classes of Aldyl A pipe evaluated, providing some clear trends useful in designing remediation strategies.

The reliability forecast is essentially a mathematical calculation of the ‘chance’ of future failure and decisions of significant risk and financial magnitude are based, at least in part, on that result. Importantly though, the forecast has a ‘real numbers’ foundation in the actual leak data, records of material failure and repair, and the relationship of those events with time. For Aldyl A pipe, the model is using observed endpoints in the life of the pipe resulting from a loss in ductility and slow crack growth, for example, and integrating that with other data to forecast future expected failures. Comparatively, the relatively rare observed failures in steel pipe and newer-generation plastic pipe are

reflected in their nearly-flat cumulative failure curves. The value of using proven reliability forecasting approaches and widely-adopted software is derived from their ubiquitous application across reliability-critical industries, and their continuous testing, evaluation, and support. Finally, as Avista adds new data in coming years for pipe failures of all material classes, including Aldyl A, it serves to increase the statistical power of the forecast results.

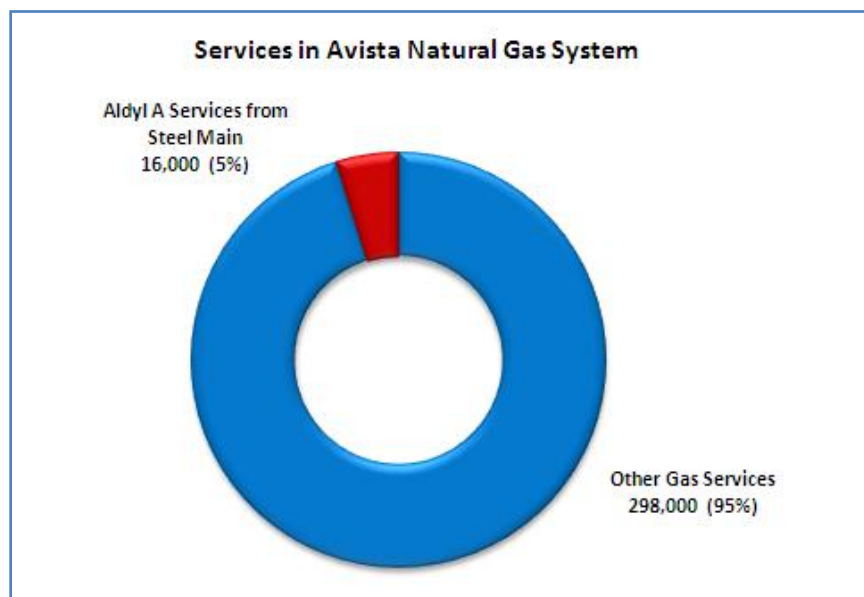
Gas Services - Avista has approximately 314,000 natural gas services, of which approximately 16,000, or five percent, are Aldyl service pipe tapped to steel main pipe, shown below in Figure 7 as priority Aldyl A services.

Figure 7. Avista's priority Aldyl A gas services (tapped from steel mains), shown as a proportion of Avista's total gas services.
