BEFORE THE WASHINGTON UTILITIES AND TRANSPORTATION COMMISSION

REPRESENTING AVISTA CORPORATION

Avista Utilities  
**Facilities Infrastructure Plan**  
2020

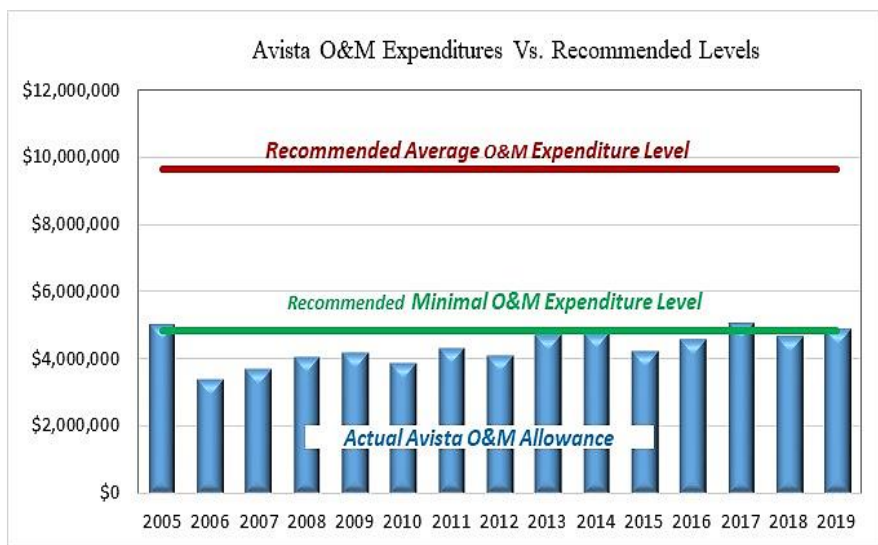
Figure 8. Avista Maintenance Expenditures vs. Industry Recommendation

The estimated replacement value of Avista’s assets when the survey was taken in 2018 was approximately \$242 million, with estimated maintenance and replacement requirements based on the Terracon report of \$8,800,640 *per year*, which equals 3.64% of the current replacement value of Avista’s facility-related assets. Figure 8 clearly demonstrates that the

amount spent by Avista at about \$4 million per year (the blue bars), does not reach the minimum level of O&M expenditures standard in the building industry for basic sustenance of facilities (the green line). At Avista, O&M expenditures have actually decreased with the addition of more square footage. In fact, over the past ten years Facilities has increased its portfolio of square footage by almost 63% with no significant increases in staff or funding levels for maintenance and repair.

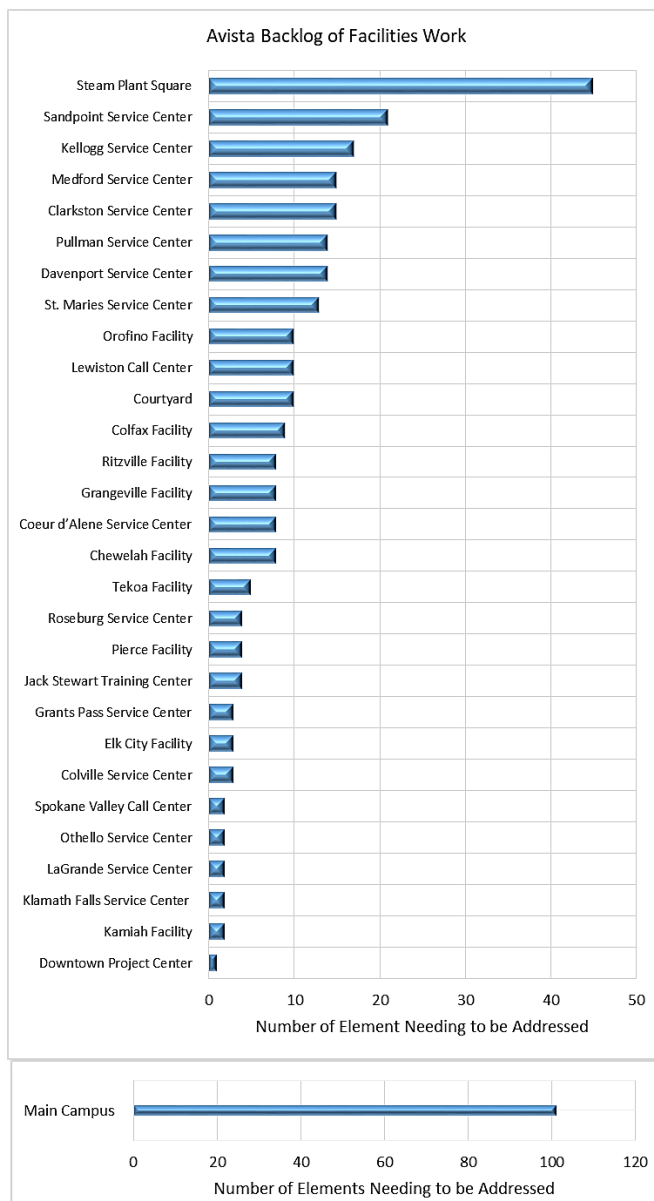
Figure 9. Avista Work Backlog Identified by Terracon Study

The backlog of work required to adequately maintain Avista facilities continues to grow as shown in Figure 9. Nearly every facility requires some kind of corrective work, and this has been especially true at the Mission campus, which houses nearly 60% of the Company's buildings.

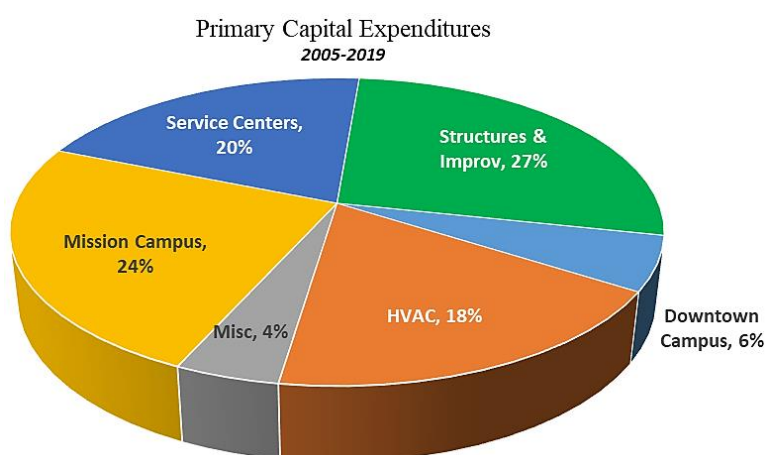
Figure 16. Primary Capital Expenditures for Facilities 2005-2019

Facilities uses their capital funding to tackle a wide variety of required work. The general categories are shown in Figure 16.

The “miscellaneous” category shown on the pie chart includes a broad spectrum of capital projects, including security expenditures like fencing, cameras, and fire suppression systems, parking lot repair or improvements, and storage solutions to name a few. In the recent past, this category included the cost to reroute North Crescent around the Mission Campus as an example.

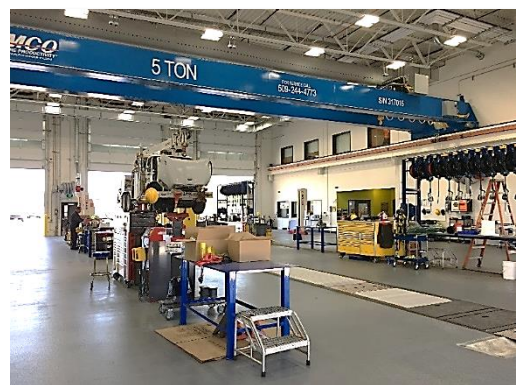
*New Fleet Building wash bay and service areas (above)*

In this new building, personnel have the capability of adding or removing booms, buckets, and accessories as needed, there are pull-through lanes to increase safety,<sup>21</sup> parts and fluids are located directly adjacent to each of the maintenance bays (rather than in the back of the building), safe wash bays were added,<sup>22</sup> doorways are wide enough to fit today’s larger vehicles,<sup>23</sup> and lifts are included that can be quickly adapted to

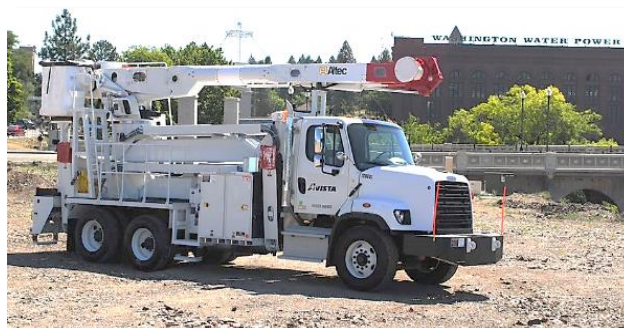
*Our largest vehicles can fit into the Fleet Building for maintenance & repair*

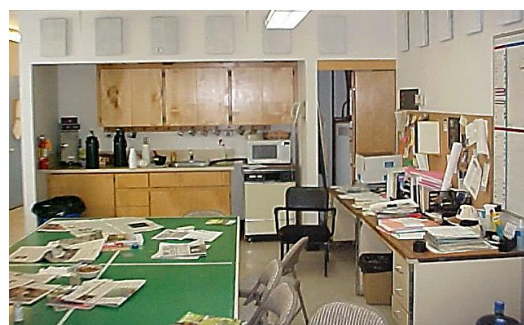
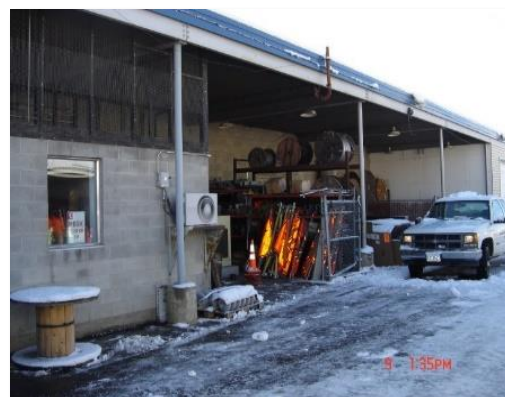
Above: Pullman break room/meeting room/work area  
Below: One of the many Pullman storage areas

The current facility is simply too small to efficiently and effectively support employees in serving customers. Supplies are scattered across a variety of storage areas around the Pullman area, not onsite. Expensive company vehicles have no protected parking areas and today’s large work vehicles

cannot fit into the existing shop for maintenance. There is also insufficient space for employee work areas.

A third-party assessment found that the building suffers from a serious need for repairs to the electric, water, plumbing and septic systems, roof, floors, and ceilings. The shop roll-up doors (original to the building) have become a safety concern for both employees and the vehicles that use them. There is no fire system in place at all. This independent survey identified over \$5 million in repairs needed to continue to utilize the original building.

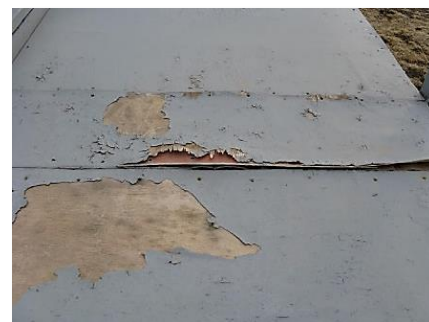
*Above: Roof repairs needed*

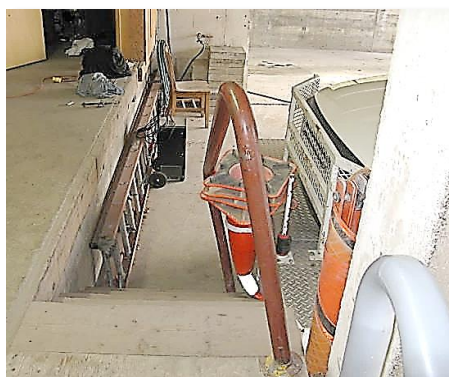
*Left: A line truck impedes a stairway in order to fit inside a service bay*

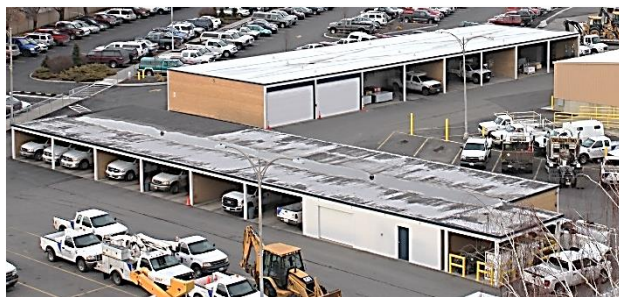
Above: Mission Campus canopy buildings

purchasing emergency generators, or replacing old and inefficient electric or plumbing systems. It can also include work improvement elements such as adding a crane to safely lift heavy equipment, shelves to store maintenance materials closer to work areas, or adding ergonomics to improve productivity. One focus area is for canopies, the covered areas used to shelter trucks and equipment. Many of these have become unstable over time and require replacement.

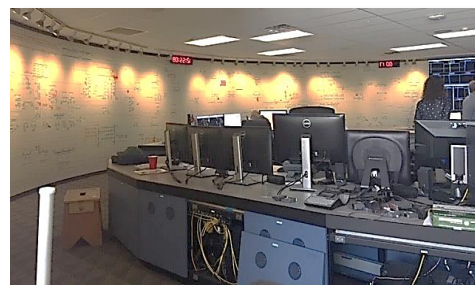
Above: One desk in System Dispatch: note the number of required screens and space needed

The existing Distribution Operations area is congested, in great part due to the large number of computer screens required to monitor distribution system conditions and handle daily distribution operations, as well as deal with outages and emergency situations. This group is also responsible for dispatching crews for maintenance activities or to address issues. Distribution Operators work 12-hour shifts, 24 hours a day, every day. As they hand off their work to the next Operator on shift, there is no room at the desk for the incoming Operator to sit beside the on-shift Operator to be brought up to speed on current conditions. In addition, there is no space in their area for training or to utilize when they bring in additional personnel and expertise during events such as storms.

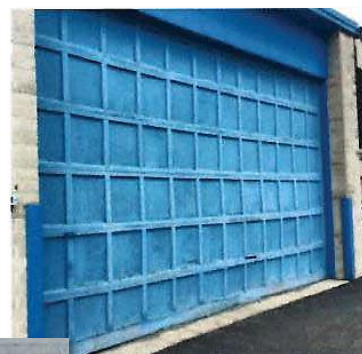
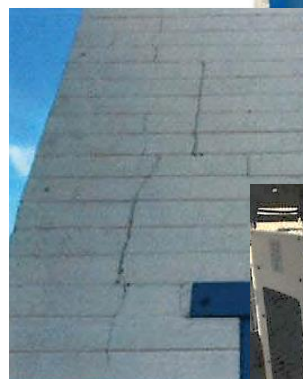
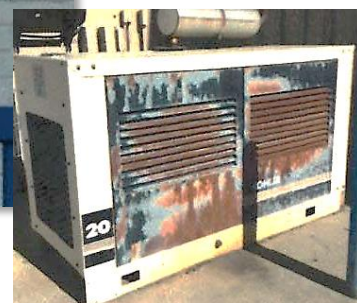
*Sandpoint Office  
cracked walls, end-of-  
life bay doors and  
HVAC equipment*

Safety concerns at this facility are very real. There are no exit lights or smoke detection systems. The yard is so small that there are both vehicle and employee safety issues as vehicles attempt to maneuver into and out of the yard and up to the loading dock. Some of the roll up loading bay doors are damaged beyond repair, the lighting must be upgraded, the roof requires repair, the windows must be replaced, the concrete sidewalks and asphalt parking areas are cracked and pitted, the fences are broken in places, there are security issues, and the list goes on. Many of the building's systems, including electrical and HVAC, are antiquated and inefficient and some violate current code requirements.

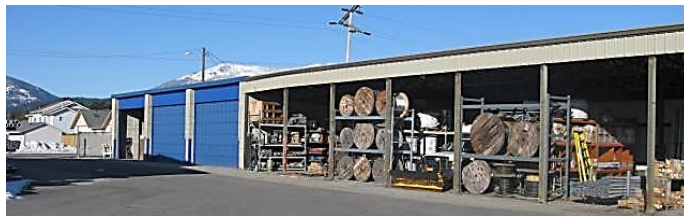
*Overcrowded storage area*

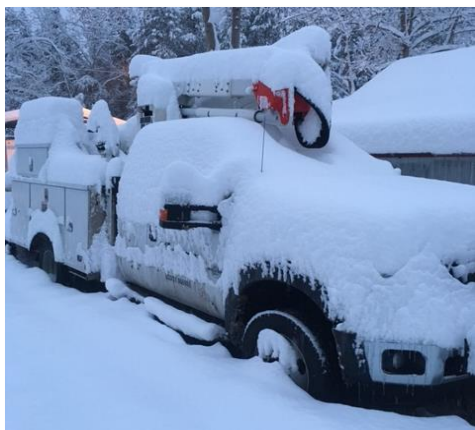
*Covered parking would be great! At times, vehicles must be shoveled out before use*

vehicles before they can go out into the field because there are not adequate places for Company vehicles to be sheltered. In fact, one of the old shelters collapsed in 2017 due to snow loading and poor construction. Recently another vehicle suffered significant damage due to ice unloading from an Avista storage area due to lack of covered vehicle spaces.
