**BEFORE THE WASHINGTON
UTILITIES & TRANSPORTATION COMMISSION**

DOCKET NOS. UE-200900 and UG-200901 (*Consolidated*)

Avista Supplemental Response to Public Counsel Data Request No. 108, Attachment A

SUBJECT: Capital Additions, Test Year (Electric)

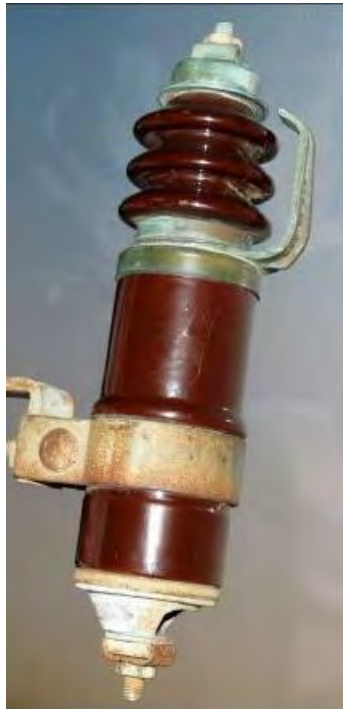
Figure 1: Early Expulsion Arrester by Joslyn Supply Co. 1940 Vintage

- Replace cracked porcelain arresters and butyl rubber arresters with signs of chalking.
 - Only reframe arresters that are currently framed above the cross arm to below the cross arm if the arrester is “Identified For Replacement”.¹⁰
 - Design arrester wildlife protectors on all new overhead transformers.¹¹
 - Add bushing caps as required.
- Compare the cost of the “Identified For Replacement” components versus the cost of replacing the entire pole using the “Component Versus Pole Replacement Analysis Tool” to determine what should be replaced.¹²

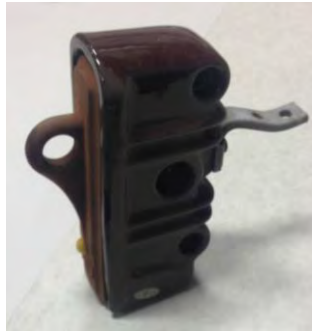
- Porcelain cutouts in operational condition may be changed out at the discretion of the Designer.
 - If the transformer is being replaced, the porcelain cutout shall also be replaced.
- Replace cracked porcelain cutouts and butyl rubber cutouts with signs of chalking.
- Do not replace cutouts based only on age.
- Design Fuse Marking Signs on all poles with a trunk, lateral, riser, or fuse.²⁶
- Replace all of the cutouts on a cross arm if one or more require replacement.
 - If cutout(s) located on an equipment arm are identified for replacement, relocate the cutouts to the primary cross arm.
- If replacing cutouts on an existing pole:
 - Install a fiberglass standoff bracket for a cutout on single phase armless overhead construction.²⁷
- Replace the following types of cutouts:
 - Chance brand porcelain
 - Porcelain Box
 - Grasshopper
 - Open Link
 - Q-Q

Figure 4: Porcelain Box

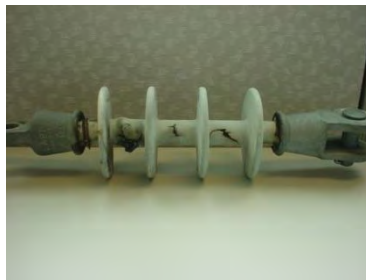
- Replace any insulators that show signs of damage (chips), tracking, or deterioration (chalking).

Figure 10: Damaged Insulator

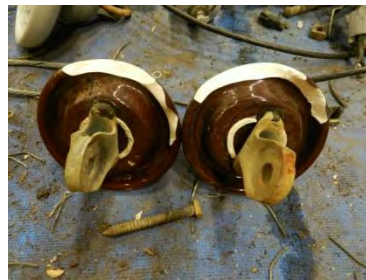
Figure 11: Damaged Insulator

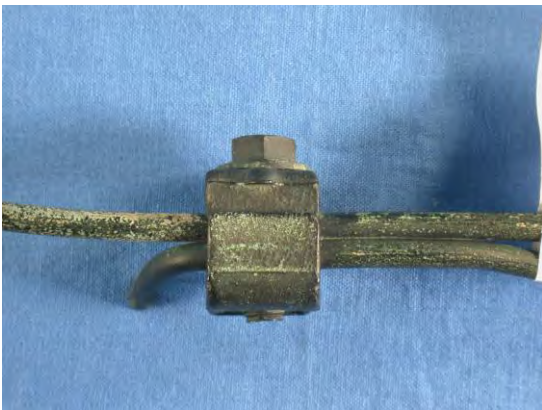
- Copper Conductor
 - Replace primary and neutral overhead conductors if:
 - The wire has the older style small bolt (Fargo connectors). These will be some of the oldest installations (see pictures below).
 - There are physical signs of annealing. Physical signs of annealing include:
 - If a span has obvious kinks and bends caused by previous physical and electrical current damage is observed.
 - If wire sags greater than expected because it has been damaged or a section may have been spliced.
 - If more complete verification is needed, a service man can check various sections of the #6 copper wire by attaching a hot tap to the wire and twisting to determine if the wire has been annealed (softened).⁷²

Figure 14: Older Style Small Bolt

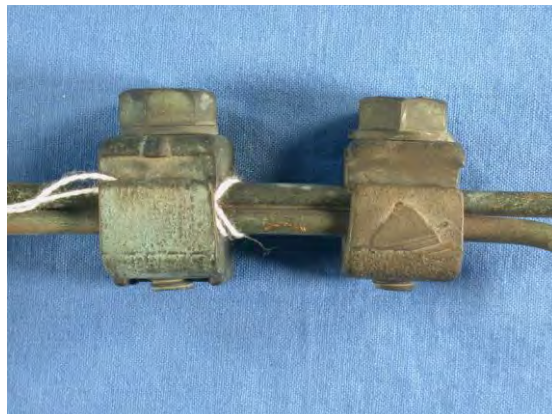
Figure 15: Newer Style Small Bolt

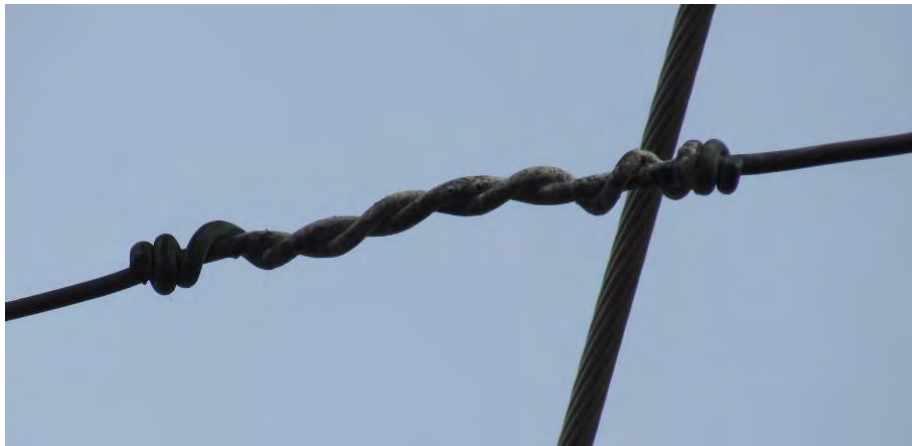
- Western Union Style Splices
 - Remove all linemen (western union) style splices, and replace with appropriate standard splice.

Figure 16: "Western Union" Style Splice

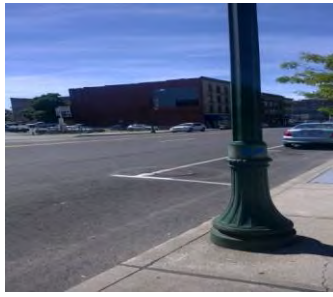
- Address unauthorized attachments on Avista facilities.⁸¹
- Replace or repair steel poles with flaking rust near the base (bottom 5'), rusted or damaged anchor bolts, poles leaning, direction of the overhead secondaries, broken concrete base, pole dings and dents, missing handhole covers, missing pole grounds, and older style green pedestal based poles.
- Consider removing all existing steel service poles depending on condition and replace with appropriate wood equivalent.
- Contact Transmission Engineering when performing work on a transmission pole with distribution underbuild.

Figure 17: Green Pedestal Base Pole

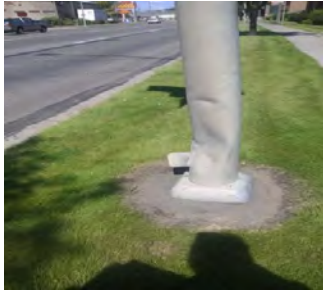
Figure 19: Pole Damage

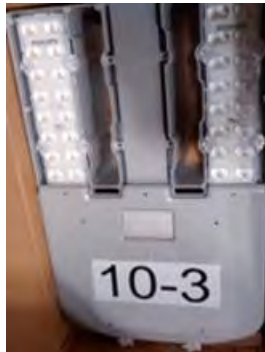
- Install LEDx00Tx in non-residential street and area light applications only, such as major roadway arterials, streets, and intersections. These lights come in both 100 and 200 W equivalents, and in both Types 3 and 5.⁸⁶
- Install the LED fixtures with the correct distribution light type.⁸⁷
 - Type 2 or 3 LED fixtures are for mid-block applications only, and are ideal for residential streets scenarios.

Figure 25: 100W equivalent-
Type 3

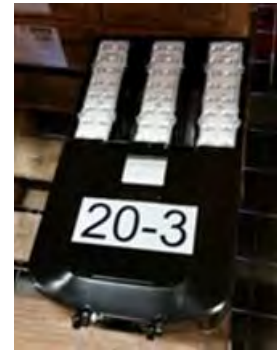
Figure 26: 200W equivalent-
Type 3

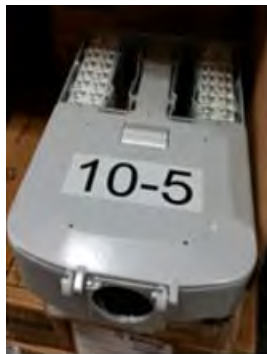
- Type 4 or 5 LED fixtures are for street corner and intersections only.

Figure 27: 100W equivalent-
Type 5

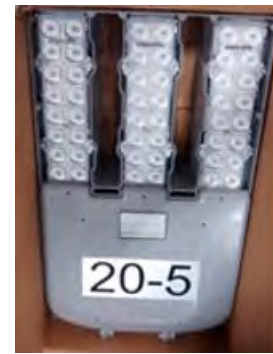
Figure 28: 200W equivalent-
Type 5

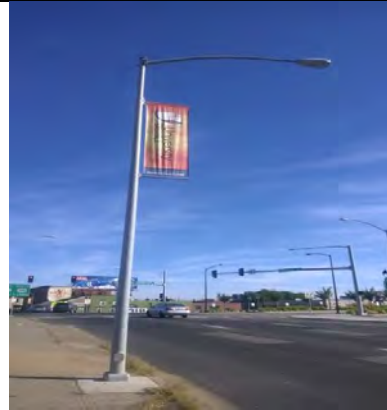
- Remove Unauthorized Attachments such as signs, posters, notices. Supporting structures should be kept free from climbing hazards such as tacks, nails, vines, and through bolts not properly trimmed.⁹⁵

Figure 30: Signs or other attachments

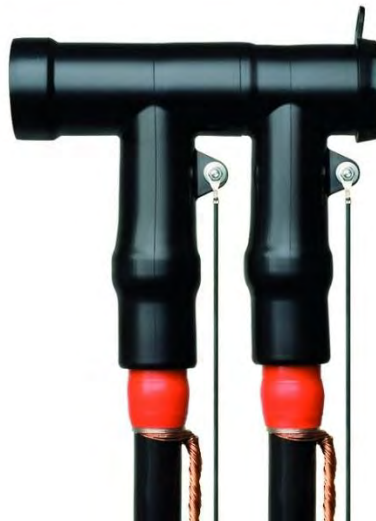
- Install a Hand Hole at the base of a secondary riser pole when future services may be anticipated. The installation of a Hand Hole is preferred to underground secondary splices.
- Install each phase of a primary riser in its own conduit. Replace risers with multiple phases in a single conduit that does not meet the current standard.¹⁰¹
- Remove all piggyback elbows and replace with a standard elbows and feedthrough bushings.

Figure 34: Standard Elbow
