DOCKET NO. U-170970

Two-Year Plan for Managing Select Pipe Replacement in Avista Utilities' Natural Gas System

Docket No. UG-120715

May 31, 2013

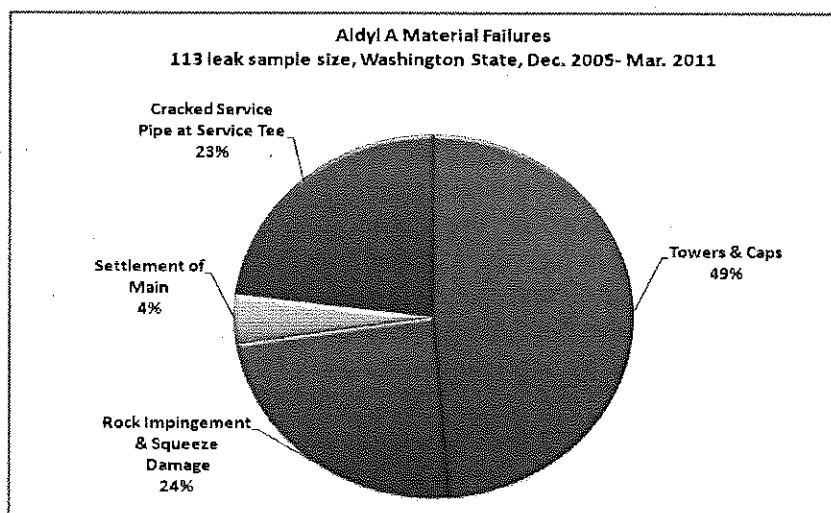
Figure 1. Modes or types of material failures documented in a sample of 113 leaks in Avista's Aldyl A piping in Washington State, December 2005 through March 2011.

In tackling the first objective of the assessment of its Aldyl A piping, Avista aggregated the gas leaks resulting from Aldyl A material failures found in its gas system in Washington State from late 2005 through March 2011. The sample included 113 material failures that were evaluated and summarized by component to offer an understanding of the specific failure modes for Aldyl A pipe. The 'modes' or types of material failures categorized are shown below in Figure 1.

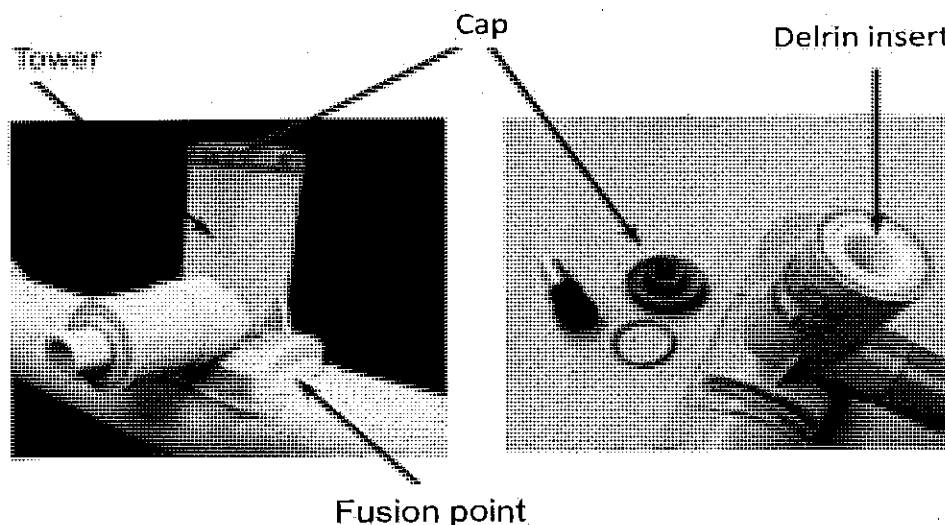
Figure 2. External features and internal components of a typical Aldyl A service tee, as fused to Aldyl A main pipe.

The largest percentage of material failures in the sample occurred in Towers and Caps, referring to failure of the service tapping tee itself, shown below in Figure 2. In these cases, the pressure applied to the tee as the cap was tightened onto the body during initial installation has resulted in slow crack growth and failure of the tower body, the cap, or the Delrin[®] insert many years later. Additionally, the saddle fusion point of the tower to the main pipe is another frequent point of failure in this assembly. The unavoidable stresses created during standard installation (using factory recommended procedures) have led to brittle cracking in these components many years later. This phenomenon clearly demonstrates the susceptibility of certain resins of Aldyl A piping to tend to fail by brittle cracking due to the slow crack growth initiated during installation.

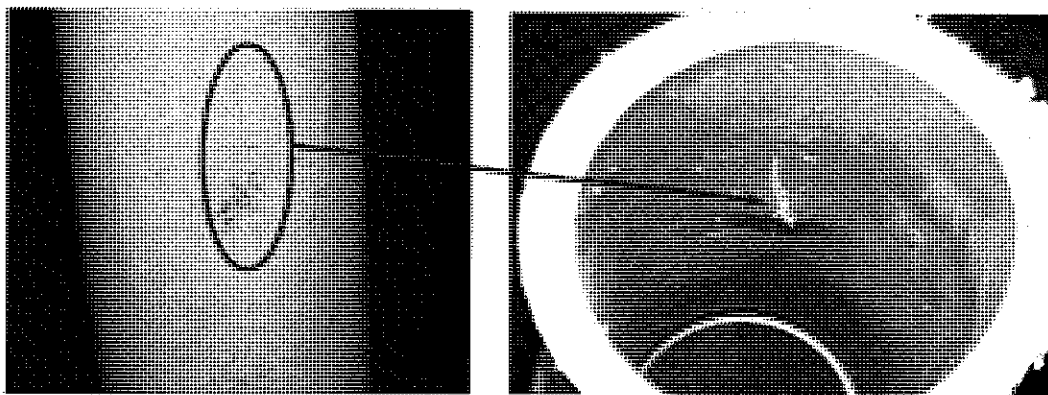
Figure 3. Typical brittle-like crack through the wall of Aldyl A pipe, resulting from rock contact directly on the pipe.

The second-most common material failure observed in Avista's Aldyl A pipe was due to localized, brittle cracking in Aldyl A mains that resulted from rock impingement – rock pressure directly on the pipe, or places where 'squeeze-off' was applied over the pipe's service life. These failures are very typical for certain resins of Aldyl A main pipe, having been consistently reported by other utilities since before the time of DuPont's 1986 letter. As described earlier, when these external stresses (rock impingement or squeeze-off) cause the pipe to fail, it always begins with crack initiation on the inside surface of the pipe wall, eventually resulting in slow crack growth that propagates toward the outer wall of the pipe, and finally, through-wall failure. These failures generally appear as short, tight cracks in the outer wall of the pipe that run either parallel, or slightly off-parallel with the length of the pipe. A typical failure in Aldyl A main pipe, showing a crack through the pipe wall as it appears on both the inner and outer surfaces, is shown below in Figure 3.

Although the duration of the stress caused by rock contact with the pipe is very different from that associated with squeeze-off, they both result the same pattern of crack initiation and slow crack growth leading to failure of the pipe. Other sources of external stress that can result in brittle failure of Aldyl A pipe, as mentioned earlier in the report, include bending of the pipe, soil settlement, dents or gouges to the pipe, and improper installation of fittings.

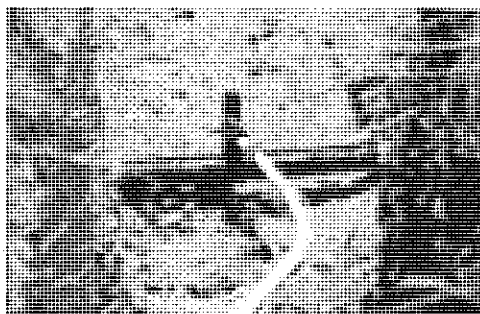
Figure 4. Typical polyethylene service tapped from a steel main.

The third most-common failure in Avista's sample occurred where small diameter Aldyl A service pipe is tapped from steel main pipe. In this application, a steel service tee is welded to the steel main pipe and the small-diameter Aldyl A service pipe is then connected to a mechanical transition fitting on the tee, as pictured below in Figure 4.

It is at this transition point, between the rigid steel fitting and the more-flexible Aldyl A service pipe, that brittle-like cracking has been observed. This failure mode in older plastic pipe is well understood, and was one of the three study objectives reported by the

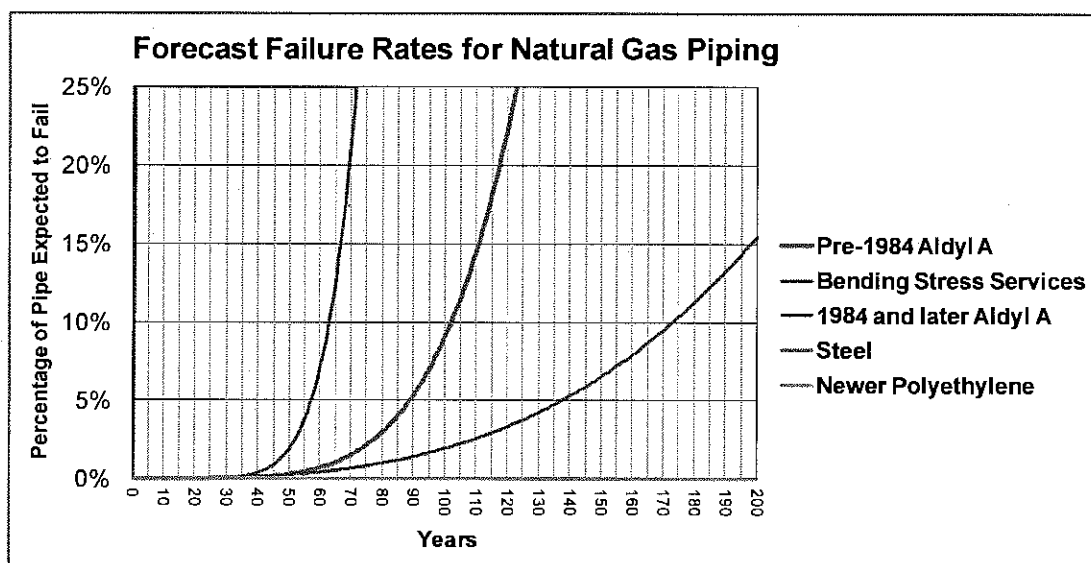
Figure 5. The expected failure rates for several classes of pipe in Avista's system, as forecast by Availability Workbench Modeling. The "Steel" curve is obscured by the "Newer Polyethylene" curve, both of which are essentially flat lines.

Results of the forecast modeling, for the pipe classes evaluated, are represented as 'curves' showing the percentage of the amount of each pipe class that is projected to fail in each year of the forecast time period. The resulting reliability curves are shown in the graph below in Figure 5.

The failure curves show dramatic differences in the expected life for the pipe classes evaluated. The difference in expected life between the Aldyl A products as a group, compared with that of steel and newer-generation plastic pipe, is particularly evident. Striking also, are the expected performance differences among the classes of Aldyl A pipe evaluated, providing some clear trends useful in designing remediation strategies.

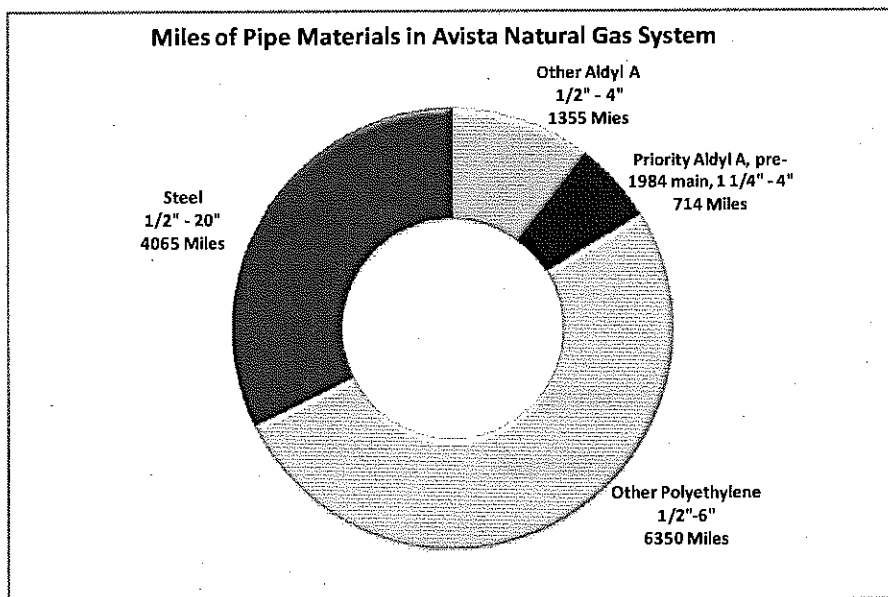
Figure 6. Avista's priority Aldyl A pipe, shown as a proportion of the different pipe classes in Avista's natural gas system (items 2 and 3 from the list above).

Main Pipe - Avista has approximately 12,500 miles of natural gas main pipe in its service territories in the States of Washington, Oregon and Idaho. Approximately seventeen percent of this total, or 2,000 miles, is Aldyl A pipe of all classes and sizes. Proportions of various classes of piping in Avista's system, including priority Aldyl A pipe (pre-1973 and pre-1984 mains) is shown below in Figure 6.

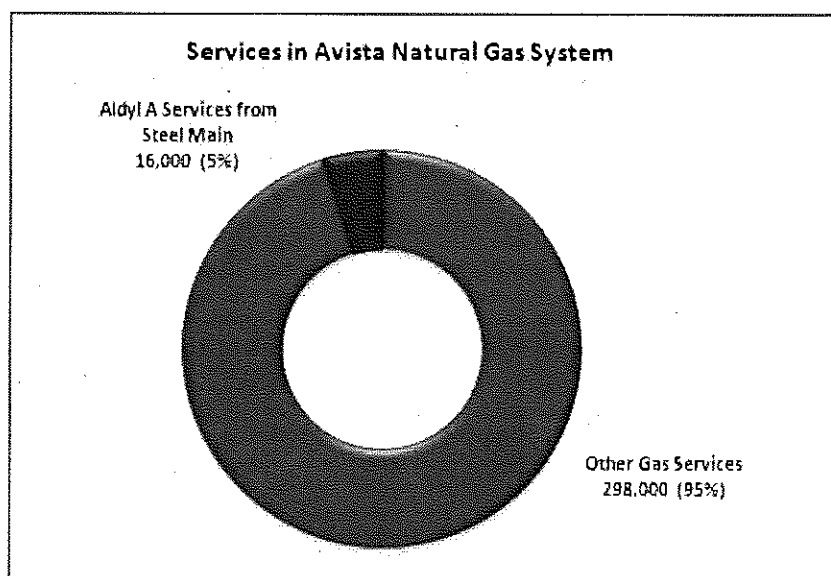
Figure 7. Avista's priority Aldyl A gas services (tapped from steel mains), shown as a proportion of Avista's total gas services.

Gas Services - Avista has approximately 314,000 natural gas services, of which approximately 16,000, or five percent, are Aldyl service pipe tapped to steel main pipe, shown below in Figure 7 as priority Aldyl A services.

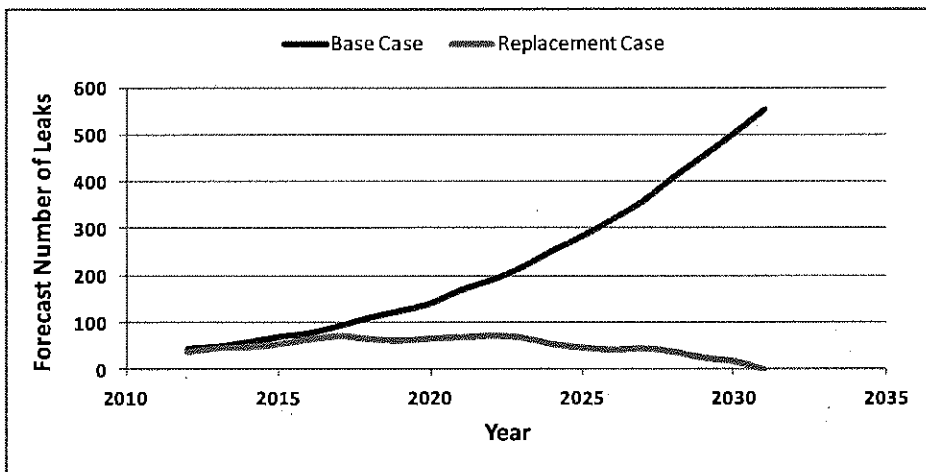
Figure 8. Expected numbers of material failures in Avista’s priority Aldyl A piping in two cases: Replacement Case - piping replaced over a twenty year horizon in the manner proposed by Avista in this report, and Base Case – assumed that priority piping was not remediated under any program.

failures each year is expected to increase slightly until 2017, at which time the cumulative effect of priority piping replaced since 2012 begins to check the failure count and then drive it toward zero over the remaining course of the program (Figure 8).
