Re: WA Isolated Steel Settlement Agreement Report (Docket PG-100049)
Completion of Survey Phase of the Program

Isolated Steel Identification and Replacement Program

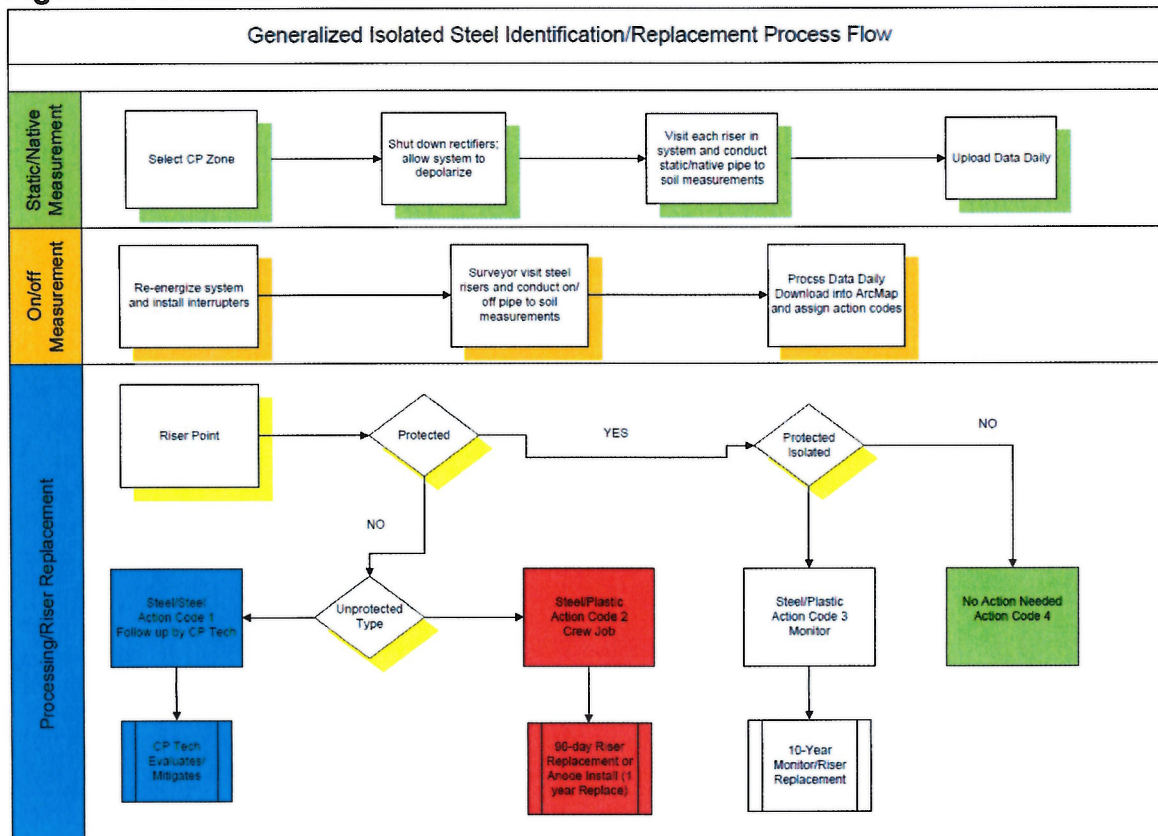
Figure 1. Generalized Work Flow

The methodology for identifying sections of isolated steel was a programmatic survey in which pipeline-to-soil voltage potential measurements were taken using a high input impedance multi-meter in conjunction with a Copper-Copper Sulfate (CuCuSO4) reference electrode. (Regarding the subject system, the program covers 133,995 inspection points). The overall program area is divided into subareas based on Avista’s established CP zones. A two- to three-man team conducted the survey; first obtaining “native” measurements with the CP system de-polarized and then “on/off” measurements with the system polarized and electric current interrupters installed. Data was recorded digitally by each survey technician using a Trimble (Juno) handheld device. The data was tracked and processed using the ArcGIS platform. Based on survey results, replacement job orders were dispatched and the replacements executed. A Generalized Work Flow is provided in Figure 1.

Note; GIS records analyses completed inspections were assigned an “Action Code 5”
