**EXH. DJL-3 (Apx. K)  
DOCKETS UE-240004/UG-240005  
2024 PSE GENERAL RATE CASE  
WITNESS: DAVID J. LANDERS**

**APPENDIX K (NONCONFIDENTIAL) TO THE SECOND EXHIBIT TO THE  
PREFILED DIRECT TESTIMONY OF**

**Puget Sound Energy  
Pipeline Replacement  
Program Plan  
June 2023**

**Docket No. UG-120715**

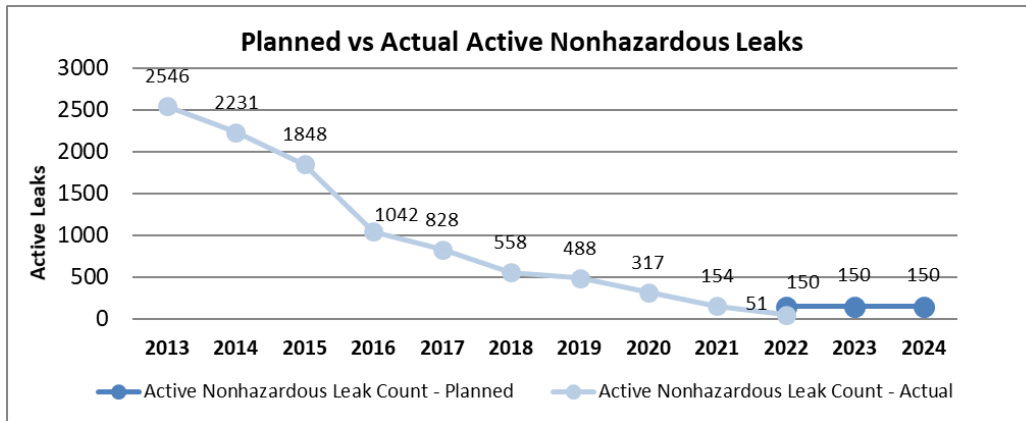
Figure 1 shows the number of active leaks in the distribution system is decreasing. The Active Leak Reduction Program has focused on expediting leak repairs to reduce the inventory of active leaks in the system. Pipe at risk of future leaks is also prioritized for replacement through existing Additional and Accelerated Actions.

Figure 1. Planned vs Actual Active Nonhazardous Leaks

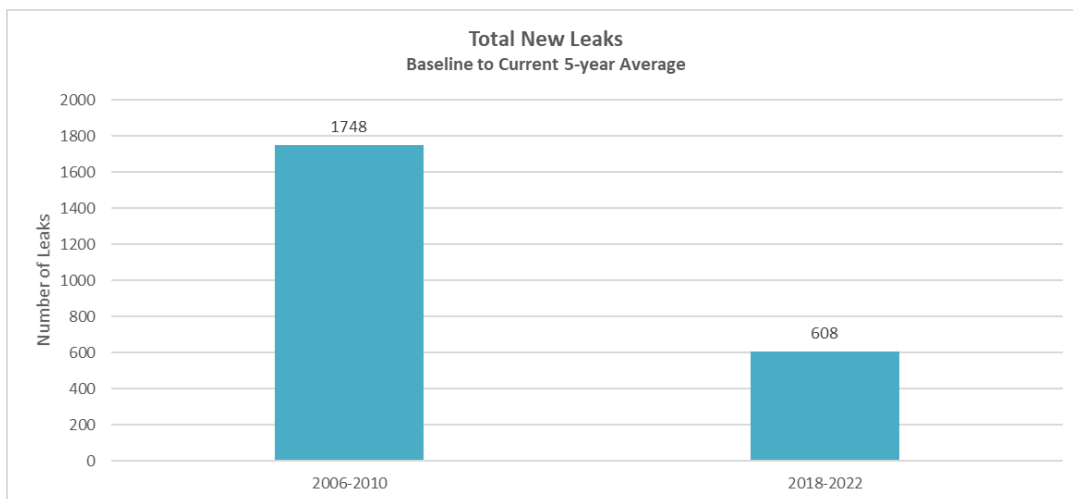
Figure 2 shows the number of new leaks has decreased over the last 10 years. The baseline five-year average of new leaks was 1,748 annually when DIMP was implemented in 2011. The current five year average of new leaks is 608 (a 65% reduction) annually.

Figure 2. Total New Leaks

There are fewer new leaks each year due to pipe replacement programs that replace pipe with the highest risk for future leaks. The majority of leak repairs excluding leaks from excavation damage are on older vintage wrapped steel mains and newer plastic services. The population of leaks is small relative to the number of leaks historically found on the legacy cast iron and bare steel systems that have since been fully retired.

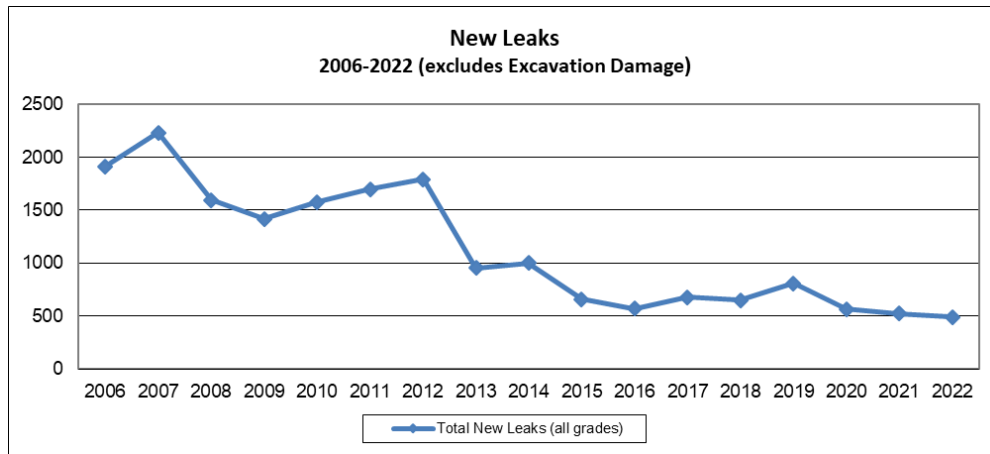
Figure 5. New Leaks

Figure 5 shows over time new leaks are decreasing in the distribution system due to pipe replacement, but now that most of the leakiest pipe has been replaced, new leaks have started to plateau. Cast Iron was eliminated from the system in 2007 and Bare Steel was eliminated in 2014. The reduction in leaks leading up to the elimination of both pipe assets can be seen on the graph of New Leaks above.

New leaks are evaluated to determine how the system performs over time. The trend of new leaks is an indicator of whether the system is improving or new risks are emerging. Leaks due to excavation damage are not included in the evaluation because they are independent of age and condition.
