Avista

This publication is an effort to increase your awareness of a particular type of plastic gas pipe in Avista gas distribution system. This type of pipe is known as Aldyl A. The pipe is pink to salmon in color, but has been known to turn shades of grey. Avista installed this type of pipe in the late 1960's through the early 1990's. Although it is very important to treat all gas lines with extreme caution and care, we would like to put a higher emphasis on the handling and care of our Aldyl A polyethylene pipe.

Aldyl A Pipe

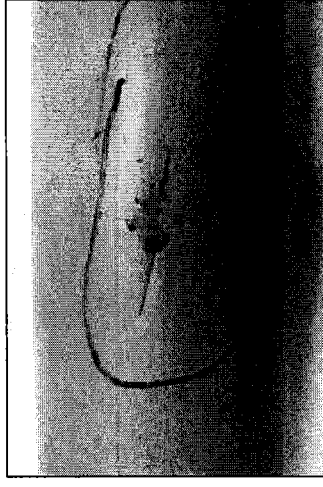
Example of a crack that leaked, caused by rock impingement

backfilling. This is very important when dealing with Aldyl A pipe as it is more susceptible to cracks and possible leaks from rock impingements (rock denting or embedding into pipe). Backfill must provide firm continuous support under and around the pipe. It must be free of sharp objects, rocks, frozen materials, and large clods.
