AVISTA CORP. RESPONSE TO REQUEST FOR INFORMATION

JURISDICTION: WASHINGTON DATE PREPARED: 02/23/2015 CASE NO: UE-150204 &UG-150205 WITNESS: Karen Schuh REQUESTER: ICNU RESPONDER: Karen Schuh

Electric Transmission System 2014 Annual Update

Rendall Farley, Tia Benjamin Asset Management Avista Corp. 03-31-2014

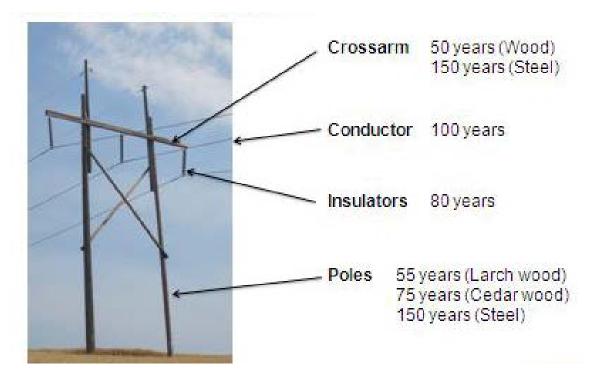
Figure 1: Example Transmission Asset Components and Expected Service Life

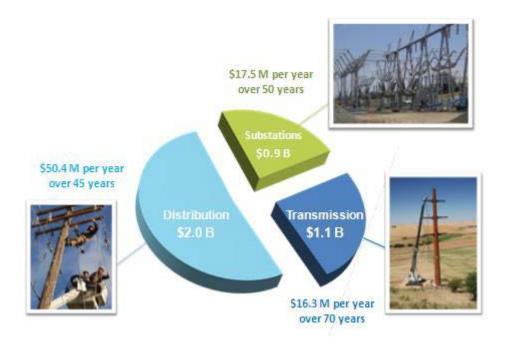
Relative to other major areas of the transmission and distribution (T&D) system, transmission assets have a longer service life, and the total replacement value of \$1.1B is on par with substation's \$0.9B and about half of distribution's \$2.0B. All together, levelized replacement spending is roughly \$84 M per year in perpetuity for Avista's T&D system (2014 dollars). However, as shorter lived wood materials are replaced with steel in the decades ahead, we expect overall service life to increase from 70 years to over 100 years for the transmission system. Assuming all other factors being equal, this in turn would reduce the minimum levelized spending to under \$12M/year, roughly 50 years from now.

Figure 2: Transmission and Distribution System Replacement Values, Average Service Life, and Levelized Replacement Spending

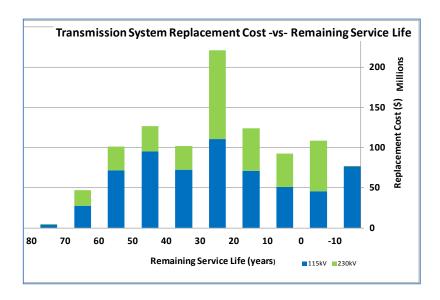
The next step is to look more closely at the replacement cost of actual installed assets compared to remaining service life. This provides the basis for levelized replacement budgets given an uneven profile, as summarized in the following chart:

Figure 3: Replacement Cost vs. Remaining Service Life

Note that \$185M of assets in the field, mostly 115kV, are currently beyond expected service life based on their age and statistical predictions of mean time to failure. This represents a significant risk to the continued reliability of the transmission system, particularly for those 115kV circuits with more than 10 years past normal service life.

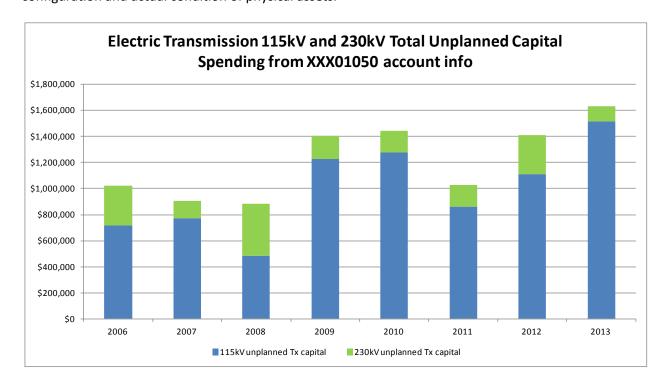
Unplanned spending represents capital replacement of those transmission assets that have unexpectedly failed and require prompt attention, typically by Avista crews (e.g. storm response events). Despite the variability that is correlated with fluctuations in weather intensity, unplanned spending is an especially important lagging indicator of system performance, trends, and the effectiveness of asset management programs. In addition to cost premiums incurred from overtime labor, unplanned work typically presents greater safety risks to the public and on-site Avista employees, as well as other risks including property damage, environmental, general liability, planned work delays, and additional rework costs following the event. We have set annual goals at the average of unplanned spending from 2009 through 2012 as shown in the chart and table below, reflecting a desire to maintain system reliability. This results in targets of \$1.1M for 115kV and \$210k for 230kV, for a total of \$1.3M per year. Note that we have consistently spent a much greater amount of total unplanned dollars on the 115kV system, at four times the proportional value of capital assets when compared to the 230kV system. Normalizing for respective system replacement values, each year we are spending an average of \$0.0017 unplanned capital for every 115kV asset dollar in the field, compared to \$0.0004 for 230kV.

This is consistent with the fact that 230kV assets are felt to pose a higher potential consequence should they fail, and therefore we maintain them accordingly – deliberately effecting a lower frequency of unplanned events on the 230kV system, relative to 115kV. While this may be the case, it remains that the optimal target of unplanned spending has not been quantitatively determined for either system. This is a desired output from a future system model and analysis, involving the quantification and simulation of all significant risks and costs associated with unplanned events and maintenance/replacement work. Note that zero emergency spending is actually sub-optimal unless there is zero tolerance for any risk – otherwise, it represents over-investment in the design configuration and actual condition of physical assets.

2005	2006	2007	2008	2009	2010	2011	2012	2013	Avg 2009-2012
115kV - WA	\$127,835	\$312,958	\$609,438	\$265,221	\$874,996	\$649,760	\$585,250	\$499,341	\$1,123,122	
115kV - ID	\$170,725	\$406,111	\$161,470	\$221,343	\$349,459	\$626,503	\$274,517	\$608,163	\$389,492	
115kV - all	\$298,560	\$719,070	\$770,908	\$486,564	\$1,224,455	\$1,276,263	\$859,767	\$1,107,505	\$1,512,614	\$1,116,997
230kV - WA	\$79,136	\$215,228	\$97,946	\$215,416	\$57,721	\$73,482	\$156,491	\$58,976	\$89,984	
230kV - ID	\$10,018	\$74,783	\$32,856	\$120,056	\$89,364	\$79,950	\$12,979	\$228,681	-\$134,091	
230kV - MT w/ Colstrip	\$6,015	\$0	\$286,338	\$257,879	\$249,429	\$368,855	\$574,428	\$298,059	\$436,991	
230kV - MT w/o Colstrip	\$6,015	\$0	\$1,590	\$59,590	\$27,525	\$13,275	\$0	\$72	\$18,910	
230kV - OR	\$0	\$12,273	\$0	\$0	\$2,475	\$0	\$360	\$14,738	\$9,435	
230kV - all w/o Colstrip	\$95,170	\$302,285	\$132,392	\$395,062	\$177,085	\$166,706	\$169,830	\$302,467	\$118,329	\$204,022

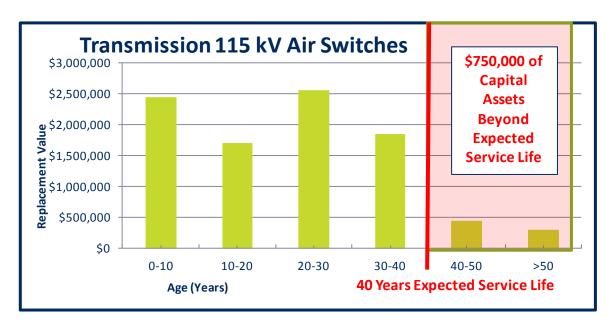
Typically three to four TAS are replaced each year. A detailed inventory of 115kV TAS outside substations was completed in 2013, including determination of age where formerly 20% of the assets were unknown. TAS inventory includes 180 switches of various types and configurations, as shown below according to remaining service life. Based on this profile, levelized replacement should increase to five replacements per year (increase to \$264M annual budget), prioritized according to a rational condition assessment and quantitative risk assessment, rather than ad-hoc requests from field personnel and anecdotal observation.

Figure 7: Air Switch Replacement Value vs. Remaining Service Life

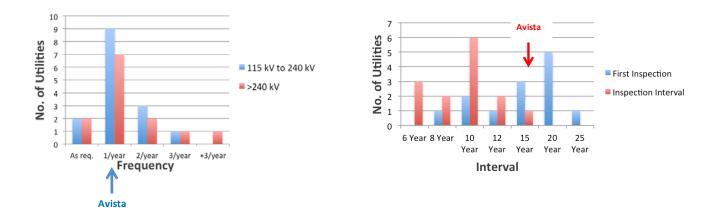
utilities responding, we have the longest ground inspection interval at 15 years, as compared to the most common interval of 10 years.

This does not necessarily mean that our inspection interval needs to be shortened. However, it does at least indicate where we stand relative to other utilities participating in the survey, and at minimum would tend to discourage extending our inspection interval any further.

Figure 8: Maintenance Benchmarking: Aerial Patrols (left) and Pole Inspections (right)

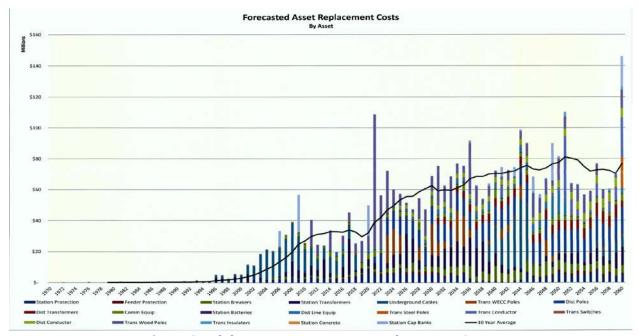
Idaho Power is also projecting a significant rise in capital replacement of aging infrastructure in the next several decades, as shown below. Over just the next 10 years, this indicates a total capital spend for Idaho Power of \$211 M for replacement of wood poles alone, or \$21 M per year levelized. This is similar in magnitude to the recommended replacement of aging wood infrastructure at Avista over the next several decades.

Figure 9: Idaho Power Long-term Replacement Costs

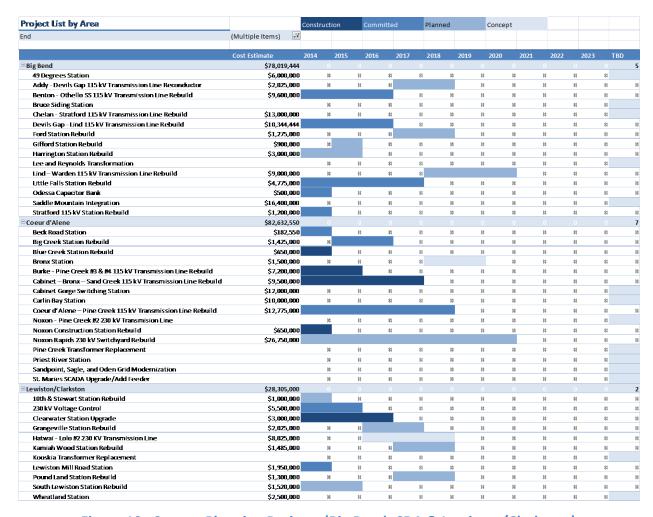
The following table lists substation and transmission projects at various stages from study through construction, as provided by system planning on Sharepoint. This list is a snapshot of current plans and is subject to frequent change. In particular, projects to create a looped 230kV system around Spokane is in development and not included here. See the Area Work Plans section of this report for more detail on transmission specific projects and inspection plans.

Figure 10: System Planning Projects (Big Bend, CDA & Lewiston/Clarkston)

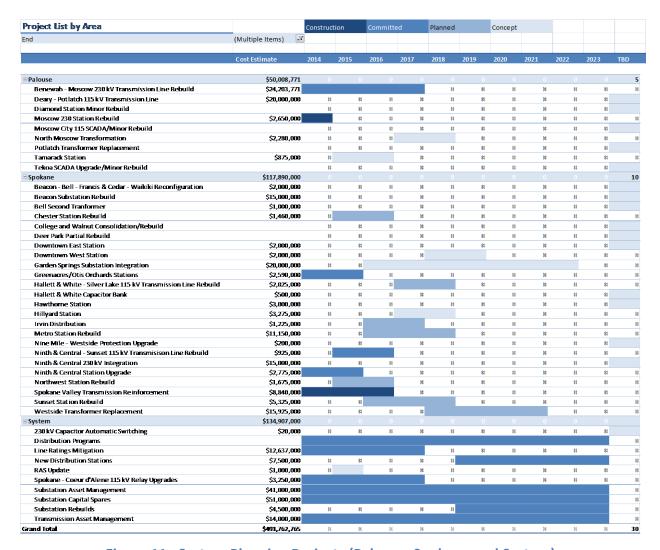
Figure 11: System Planning Projects (Palouse, Spokane and System)
