EXHIBIT NO. \_\_(SML-3) DOCKET NO. UG-10\_\_\_ WITNESS: SUSAN MCLAIN

## BEFORE THE WASHINGTON UTILITIES AND TRANSPORTATION COMMISSION

**PUGET SOUND ENERGY, INC.'S**

## SECOND EXHIBIT (NONCONFIDENTIAL) TO THE PREFILED DIRECT TESTIMONY OF SUSAN MCLAIN ON BEHALF OF PUGET SOUND ENERGY, INC.

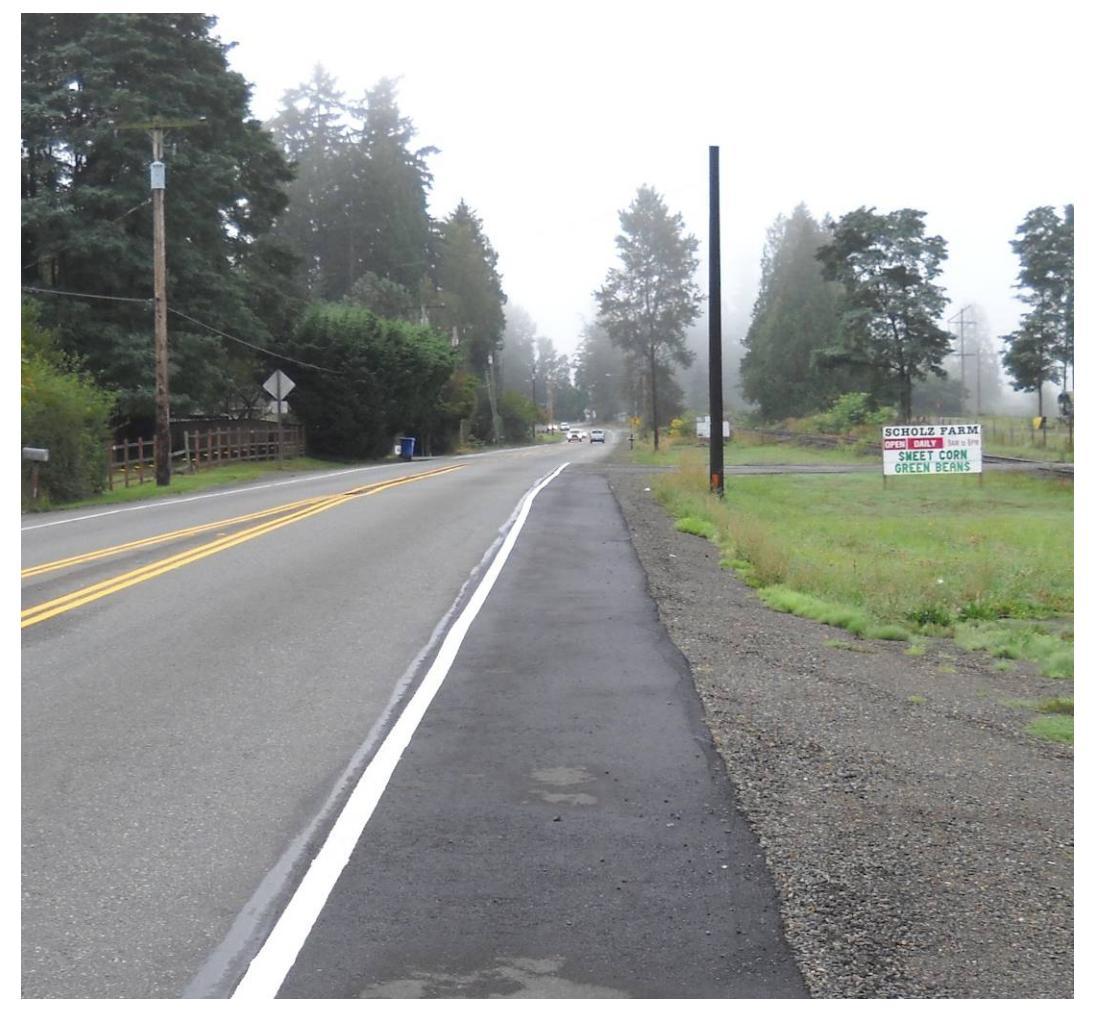
- 1.1 This series of comparative photographs illustrates the changes in road restoration construction practices that are often now required by some municipalities and counties where PSE constructs natural gas system projects.
  - 1.1.1 *Figure 3-1* represents an example of a project where PSE was able to work in the shoulder where restoration was minimal and less expensive.

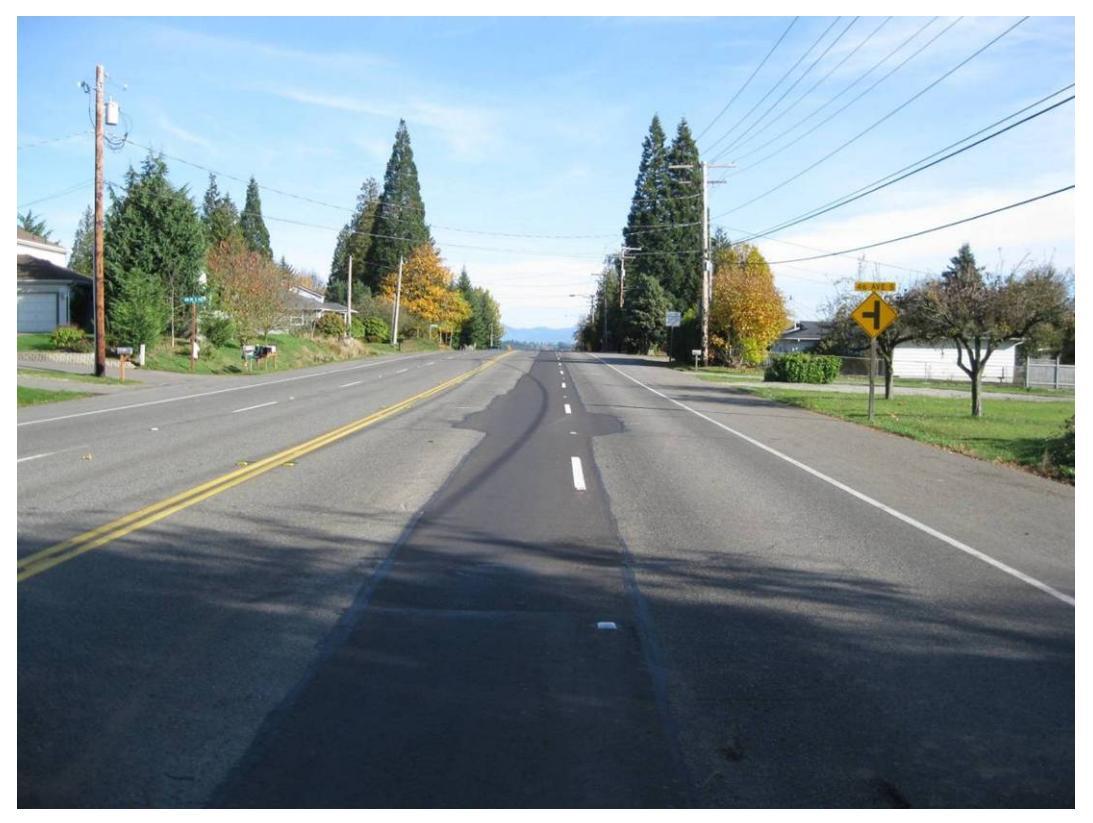
Figure 3-2: Kent Black Diamond Phase II Project, 16-Inch Diameter Supply Pipeline, In-Service October 2009

1.1.2 *Figure 3-2* shows an example of a project where PSE was required to work in the roadway and installed a temporary patch. PSE incurred approximately \$2.5 million in costs to install this patch that is approximately five feet wide over a five mile length of roadway.

Historically, this patch would have been an acceptable final restoration practice. More recently and more frequently, as in this project, the Company was required to return to add roadway asphalt overlay which varied from one lane to five lanes, plus shoulders. This was at an additional cost of \$2 million (yielding a total cost of \$4.5 million for paving restoration).

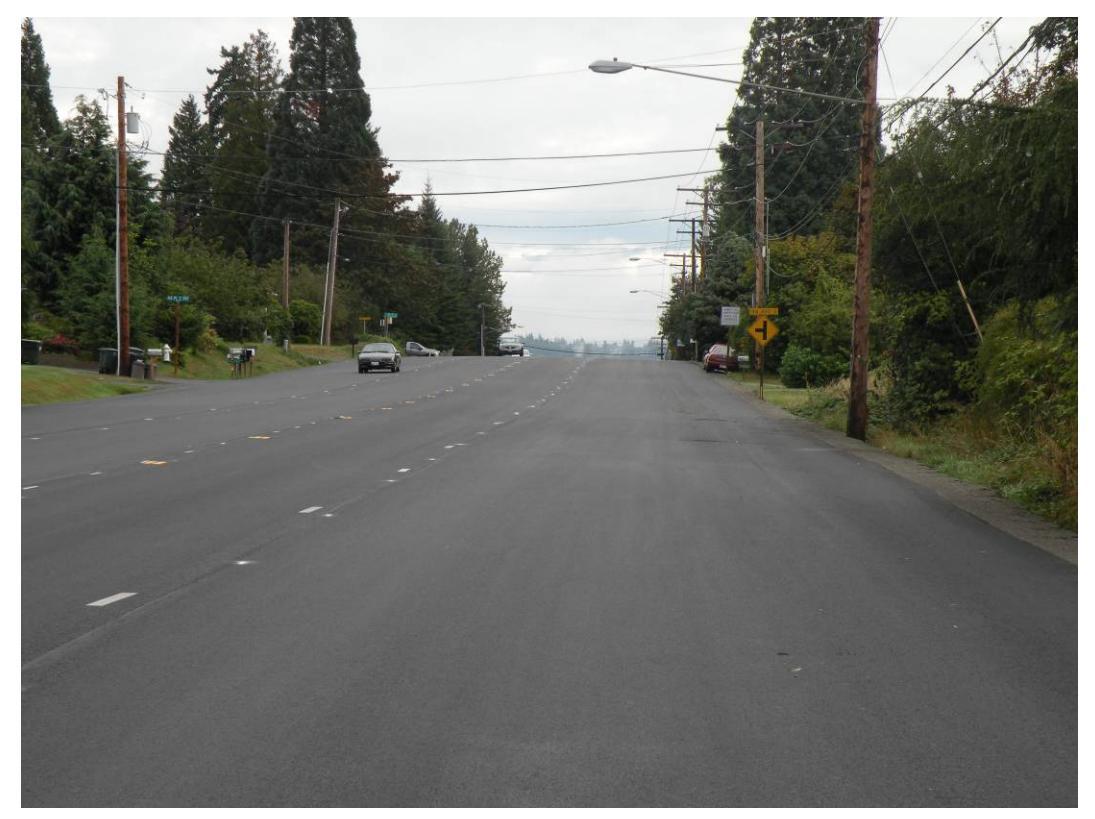
- 1.1.3 *Figure 3-3* depicts the required full roadway asphalt overlay on a section of the project where the road is a four-lane road. The photo was taken after the required full roadway overlay was completed, but before line striping.
- Figure 3-3: Kent Black Diamond Phase II Project, 16-Inch Diameter Supply Pipeline, In-Service October 2009

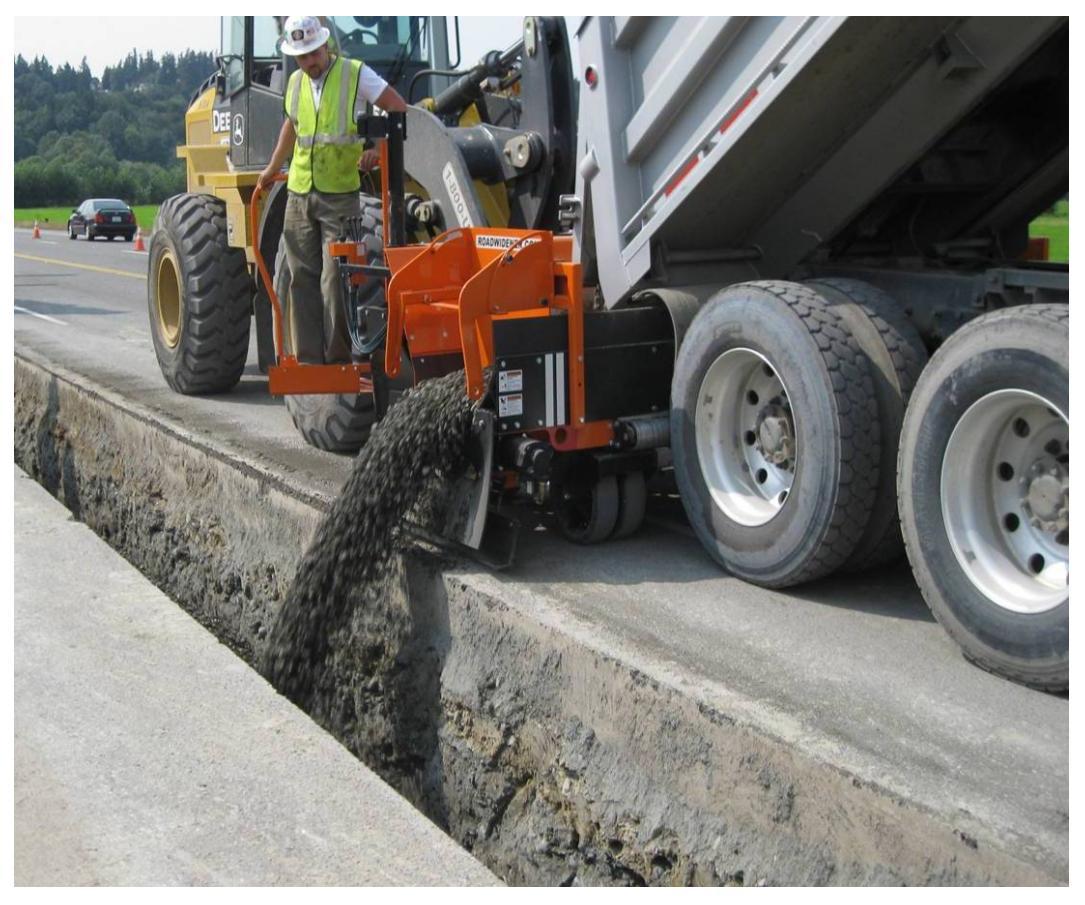
- 1.1.4 *Figure 3-4* shows a project where a soil spreading machine was used to install select material that was hauled in to meet backfill compaction permit requirements. Since specific backfill material had to be hauled in, the existing soils that had been removed had to be hauled away.
- Figure 3-4: Kent Black Diamond Phase II Project, 16-Inch Diameter Supply Pipeline, In-Service 2009

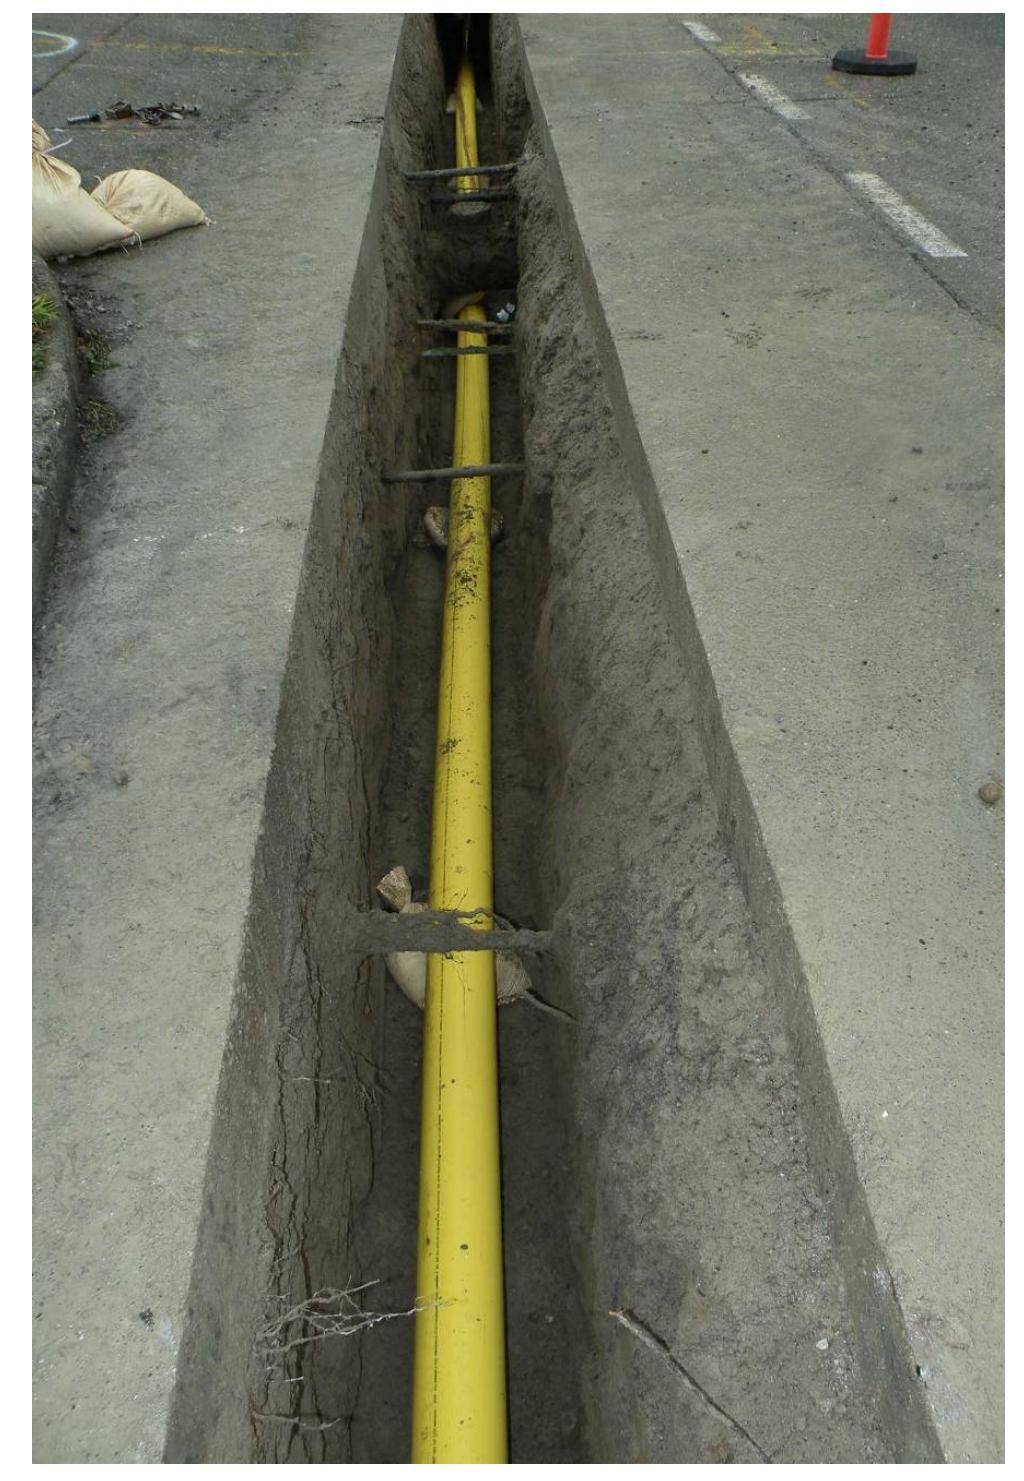
**Figure 3-5:** 6501 Beacon Ave S, 6-Inch Bare Steel Main Replacement, In-Service Expected 2010

1.1.5 *Figure 3-5* illustrates the trench depth for six-inch PE pipe in accordance with PSE standards that require three feet of cover.

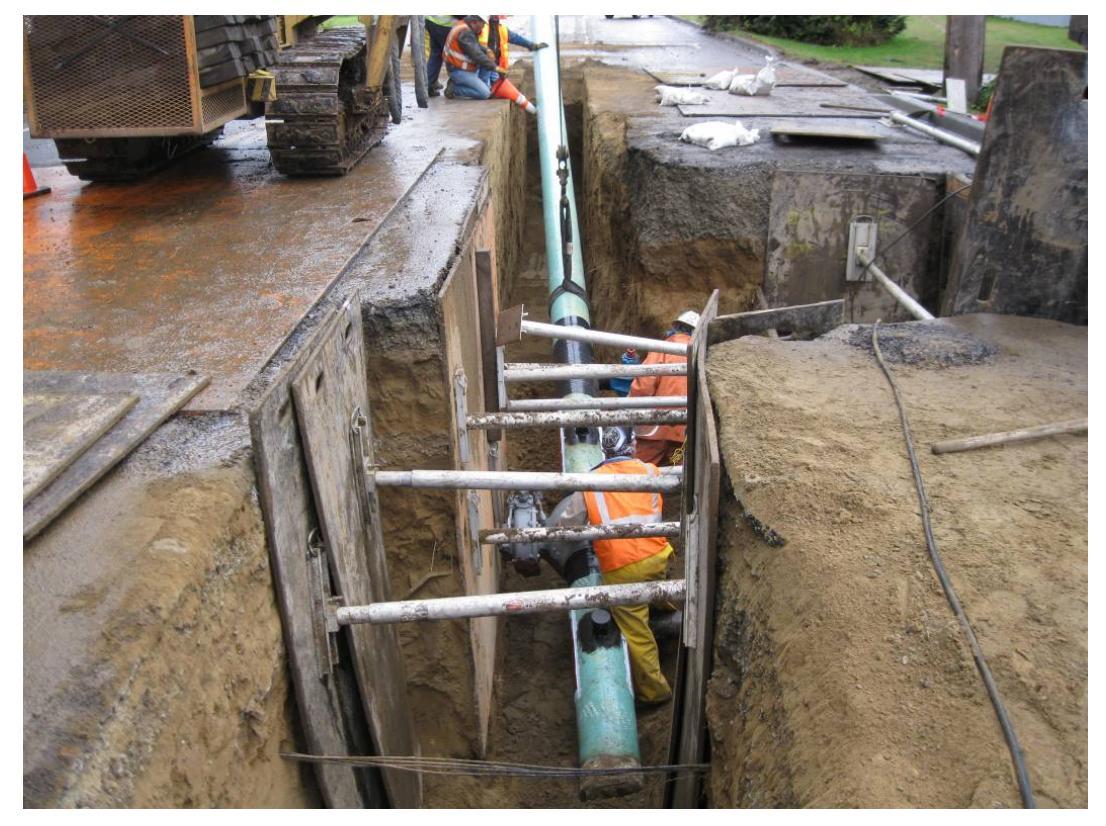
- 1.1.6 *Figure 3-6* shows the trench depth for 12-inch high pressure pipeline where the permit required seven feet of cover although PSE standards would have required three feet of cover. The seven-foot trench depth mandated the use of additional worker safety protections, such as shoring.
- Figure 3-6: Lacey-Fones Road, 12-Inch Diameter Supply Pipeline, In-Service 2009

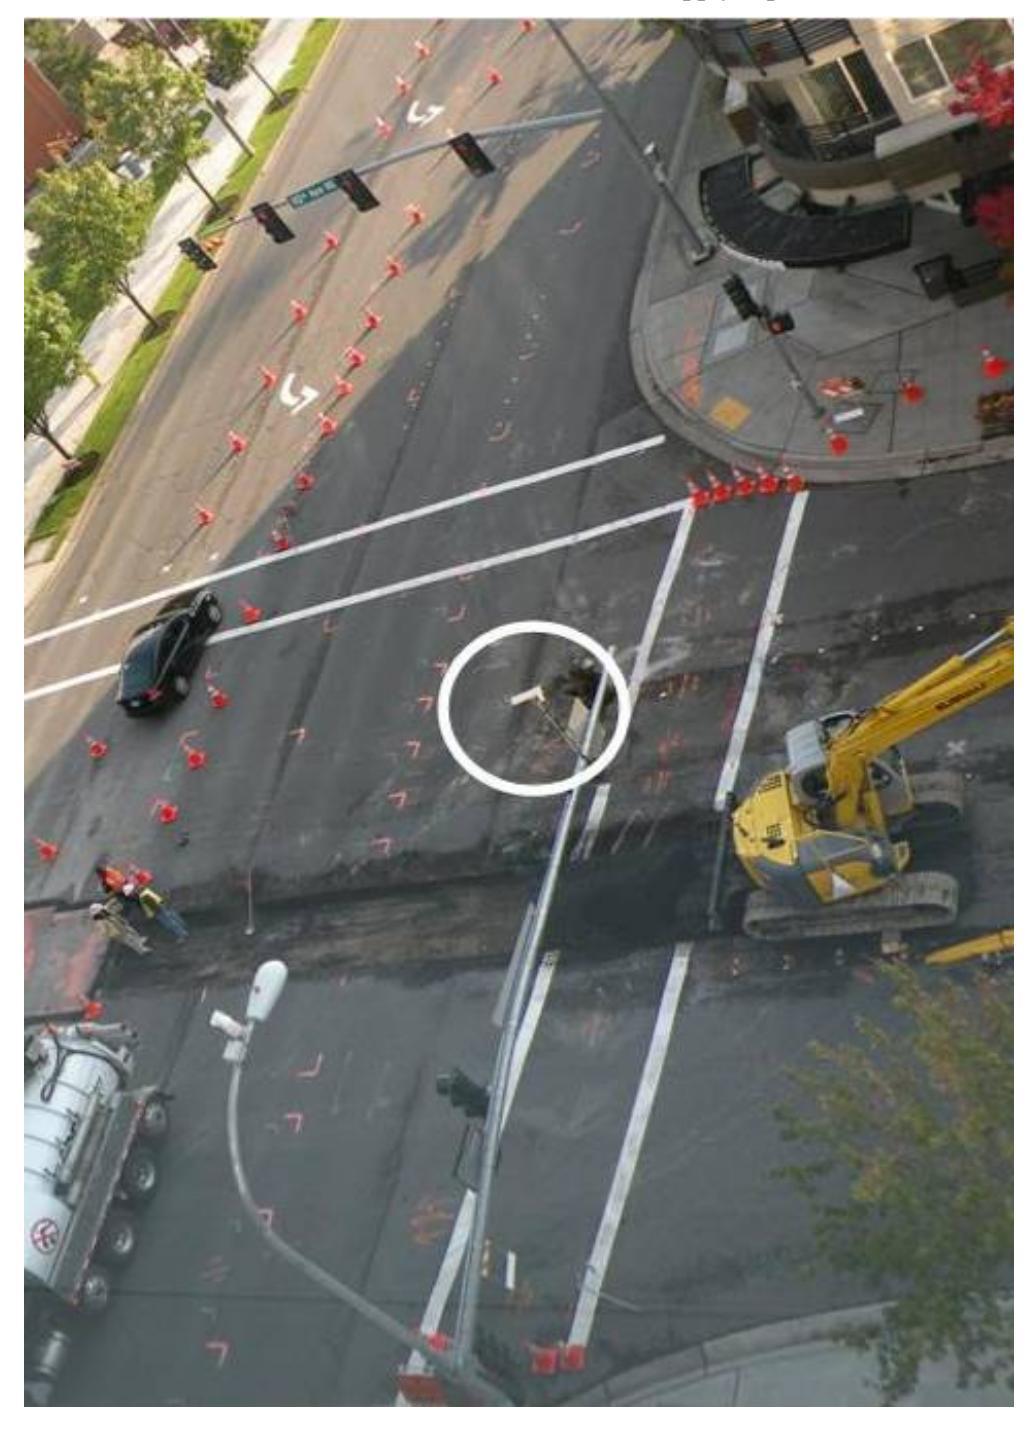
- 1.1.7 In *Figure 3-7*, the required traffic control cameras which allowed the City to perform automated traffic control were installed prior to initiating construction and removed upon project completion. PSE incurred camera installation and removal costs of approximately \$300,000.
- Figure 3-7: Bellevue Lake Hills 12- and 16-Inch-Diameter Supply Pipeline, In-Service 2009

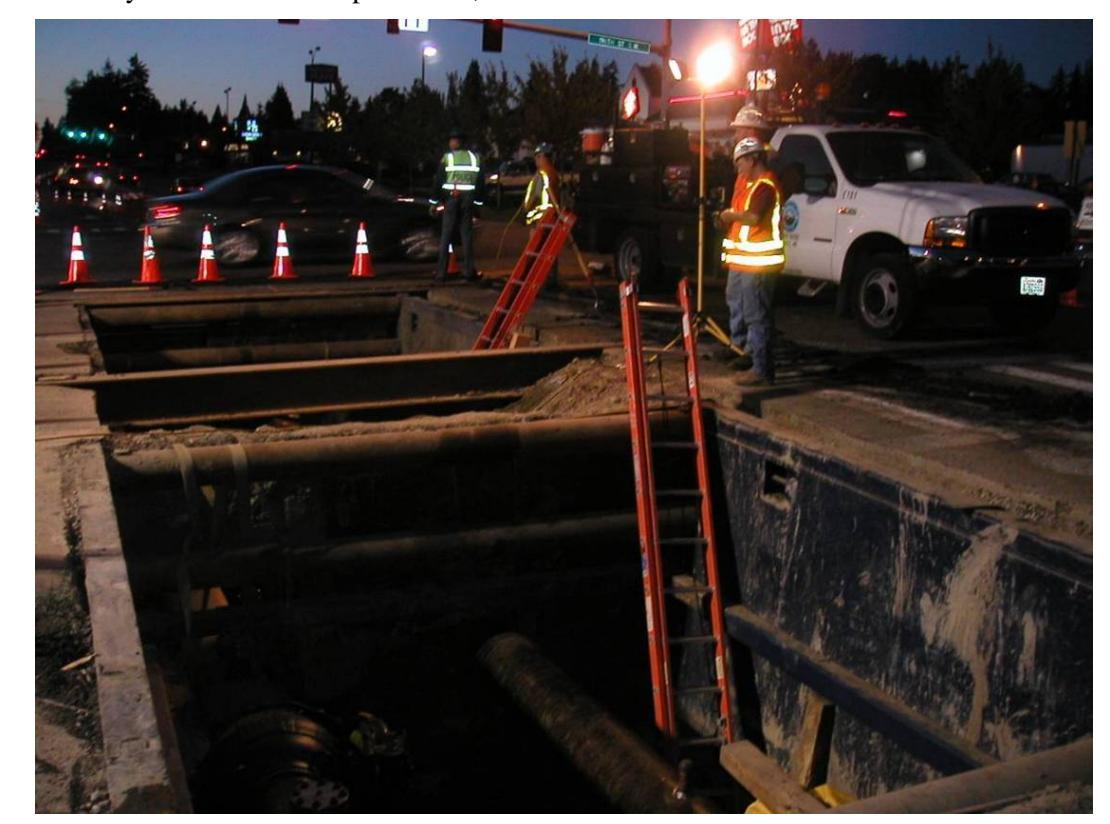
Figure 3-8: Lynnwood Valve Replacement, In-Service 2007

1.1.8 *Figure 3-8* depicts work that had to be performed at night as a condition of the construction permit. This increased project costs for added traffic control (off-duty police), lighting, overtime or shift differential, and extended hours for concrete mixing batch plants to supply backfill material.

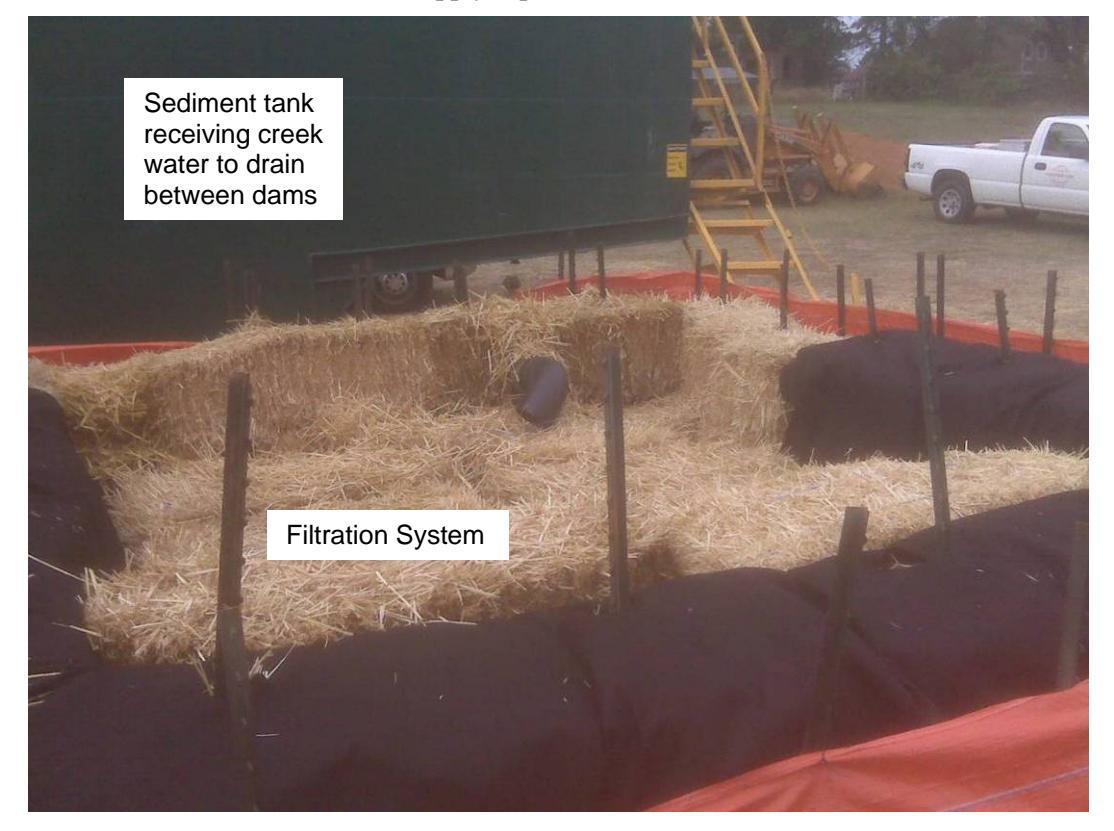
Figure 3-9: Frederickson 16-Inch HP Supply Pipeline, In-Service 2008

1.1.9 In the past, an acceptable practice was to naturally filter water by discharge through a grass field or hillside. More recent regulations require a water quality treatment and monitoring system.

*Figure 3-9* shows Clover Creek open cut crossing and the environmental protection steps that were required to preserve water quality and salmon migration. Geotechnical studies of soils indicated that conditions were not conducive to directional drill or traditional bore construction methods, therefore, PSE was required to open cut Clover Creek. Water that passed through the cut had to be filtered to meet water quality requirements. This was achieved by constructing upstream and downstream barriers – providing the water a place to settle before reentry to the creek.
