EXH. HLR-2

Avista Utilities
Electric Distribution Infrastructure Plan
JUNE 2017

AVISTA ASSET MANAGEMENT GROUP

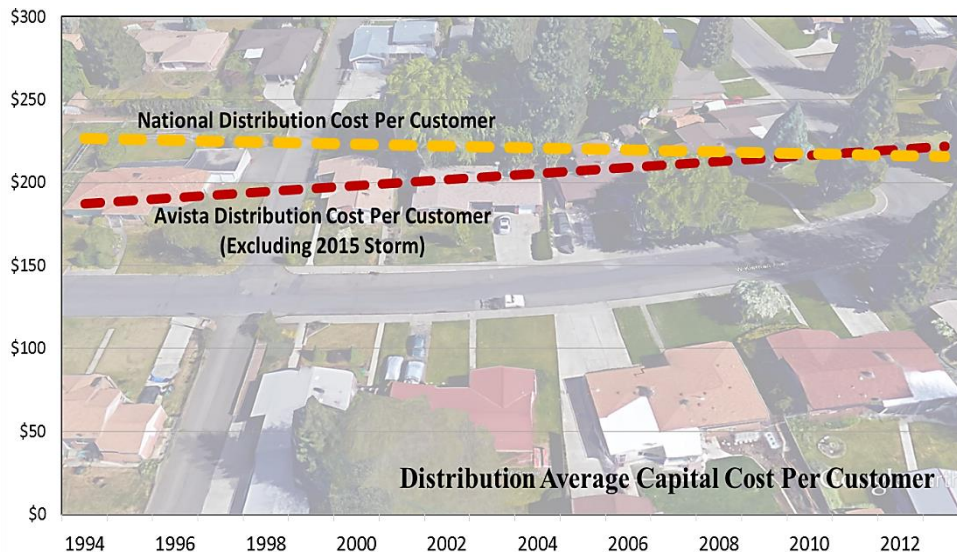
Figure 3. National & Avista Distribution Cost Per Customer
Source of National Data: FERC Form 1

cost to the national average and slightly above; however, our above-average costs are largely the result of the significant spending in repairing and replacing equipment damaged by the windstorm of November 2015. Excluding these significant costs, the Company’s per customer cost would be essentially equal to the national average.

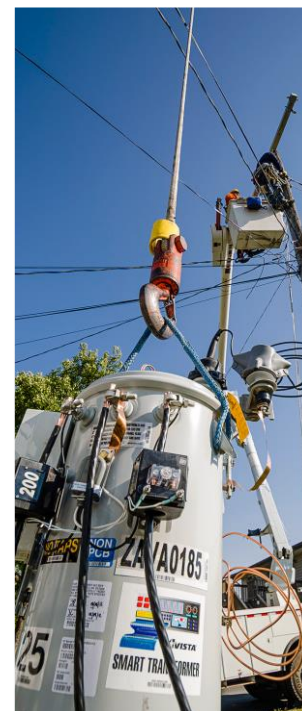
Avista “Smart” Transformer

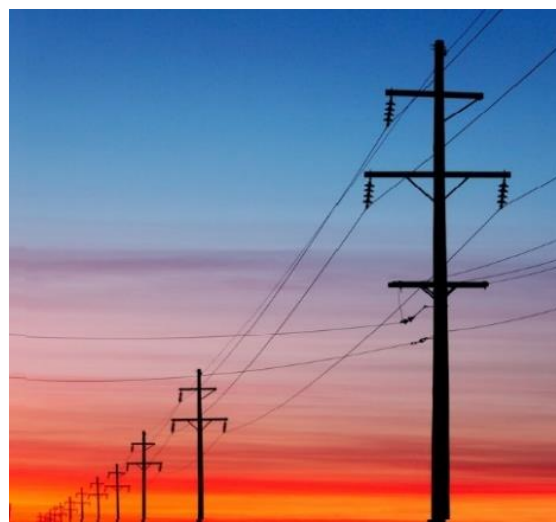
Transmission Poles showing distribution lines “underbuilt” below the transmission lines, which puts additional strain and wear on the poles

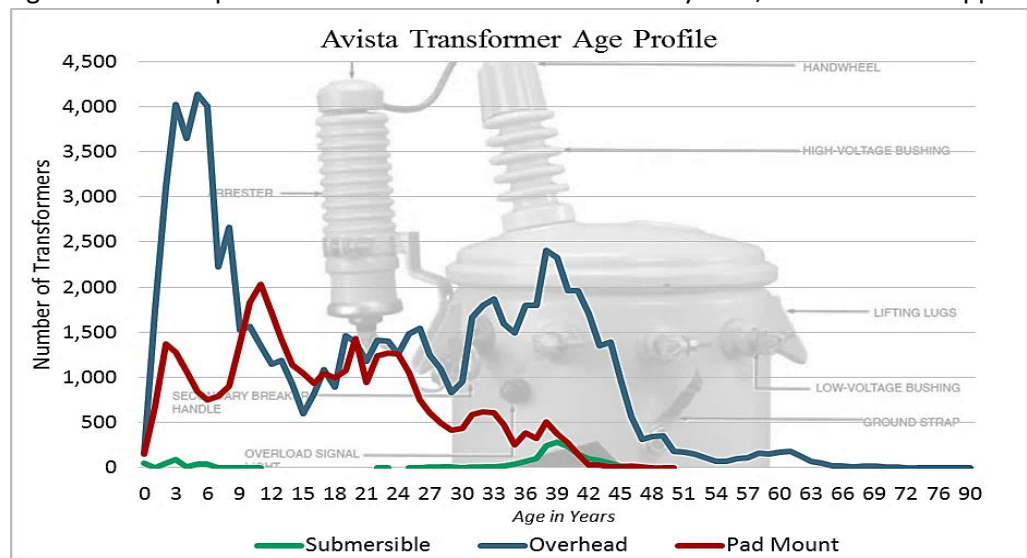
Figure 42. Avista's Distribution Transformer Inventory Age Profile
