BEFORE THE WASHINGTON UTILITIES AND TRANSPORTATION COMMISSION

EXH. HLR-5

Electric Transmission System 2016 Asset Management Plan

Mary Jensen, Rubal
Gill
Asset Management
Avista Corp.
02-01-2016

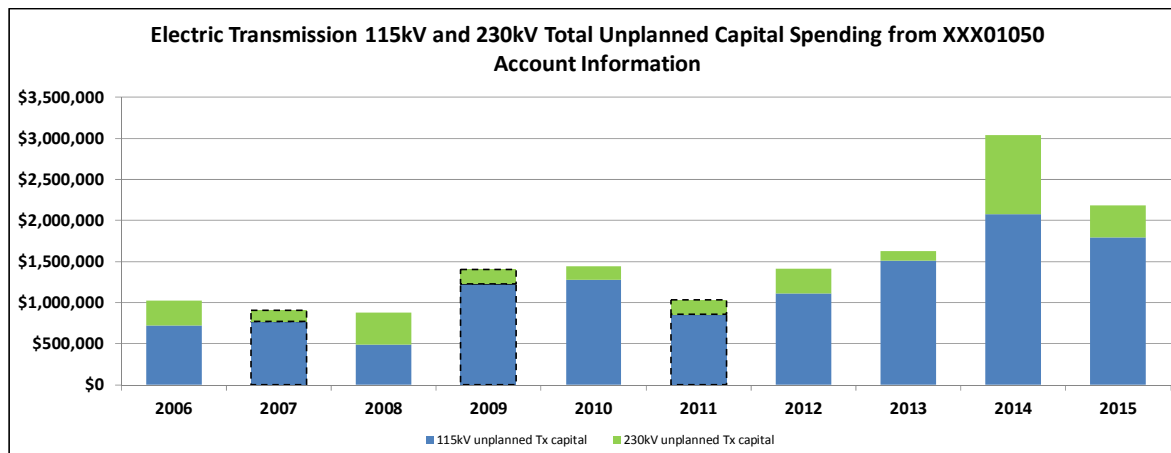
Unplanned spending represents capital replacement of those transmission assets that have unexpectedly failed and require prompt attention, typically by Avista crews (e.g. storm response events). Despite the variability that is correlated with fluctuations in weather intensity, unplanned spending is an especially important lagging indicator of system performance, trends, and the effectiveness of asset management programs. In addition to cost premiums incurred from overtime labor, unplanned work typically presents greater safety risks to the public and on-site Avista employees, as well as other risks including property damage, environmental, general liability, planned work delays, and additional rework costs following the event. We have set annual goals at the average of unplanned spending from 2009 through 2012, reflecting a desire to maintain system reliability. This results in “targets” of \$1.1 million for 115kV and \$210k for 230kV, for a total of \$1.3 million per year. Note that in past years we have consistently spent a much greater amount of total unplanned dollars on the 115kV system, at roughly four times the proportional value of capital assets when compared to the 230kV system. This is consistent with the fact that 230kV assets are felt to pose a higher potential consequence should they fail, and therefore we maintain them accordingly – deliberately effecting a lower frequency of unplanned events on the 230kV system, relative to 115kV. While this may be the case, it remains that the optimal target of unplanned spending has not been quantitatively determined for either system. This is a desired output from a future system model and analysis, involving the quantification and simulation of all significant risks and costs associated with unplanned events, maintenance and replacement work. Note that zero emergency spending is actually sub-optimal unless

Figure 6: 115kV and 230kV Total Unplanned Capital Spending

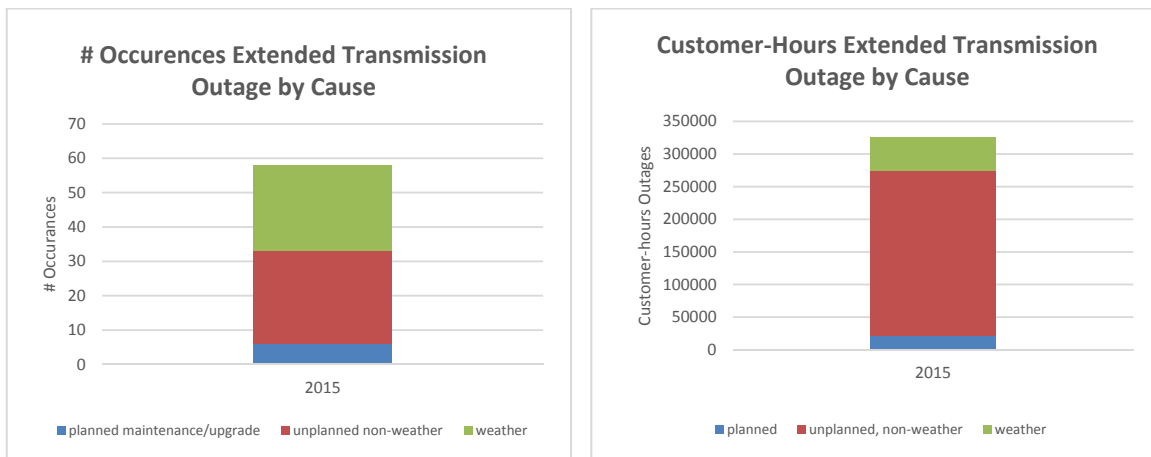
As can be seen from Figure 5 below, unplanned, non-weather and weather events dominate both the number of occurrences and customer-hours outages for the transmission lines.

Figure 7: Transmission outage causes affecting customers in 2015

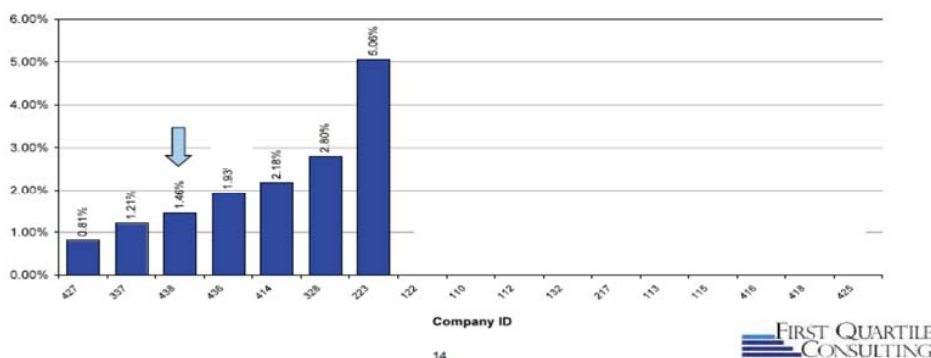
Figure 9: 3-year Transmission Lines Replacement Capital Spending per Asset (First Quartile Consulting, 2008)

This shows that out of seven companies providing data, the median was 1.93% and the mean was 2.41% over a three year period. Avista's comparable replacement spending over the last two years and the recommended annual replacement spending over a 30-year period are shown in the table below.

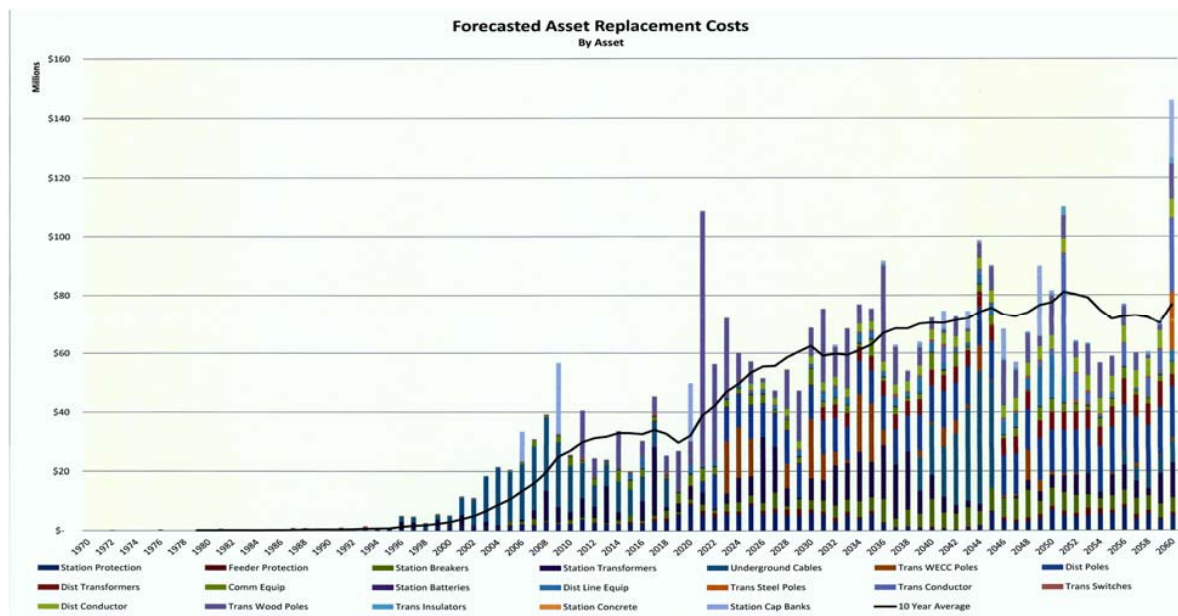
Idaho Power is also projecting a significant rise in capital replacement of aging infrastructure in the next several decades, as shown below. Over just the next 10 years, this indicates a total capital spend for Idaho Power of \$211 million for replacement of wood poles alone, or \$21 million per year levelized. This is similar in magnitude to the recommended replacement of aging wood infrastructure at Avista over the next several decades.

Figure 10: Idaho Power Long-term Replacement Costs
