DOCKET NOS. UE-200900 and UG-200901 (*Consolidated*)

EXHIBIT PADS-28

Avista Response to Public Counsel Data Request No. 105, Attachment A

Avista Utilities Electric Distribution Infrastructure Plan JUNE 2017

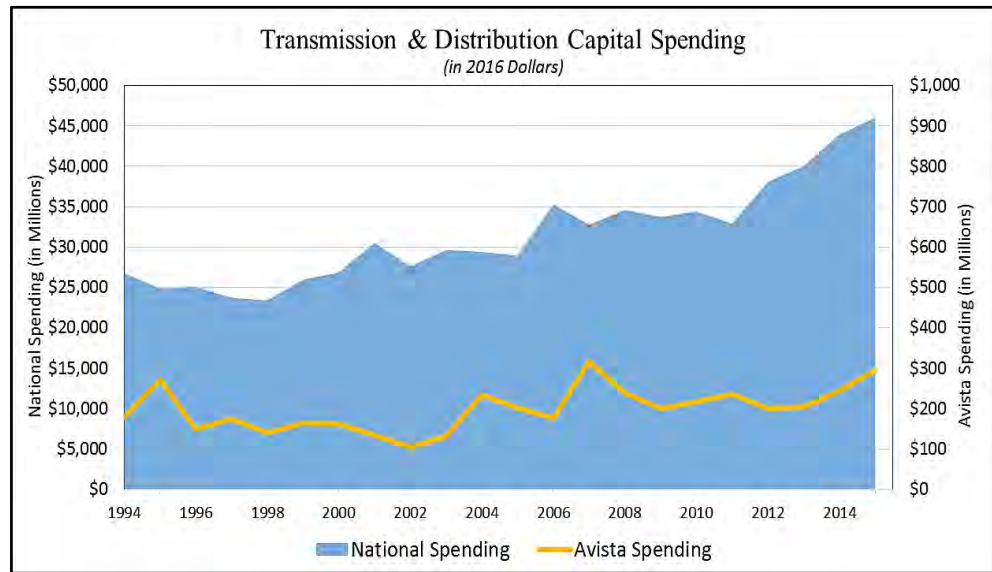
Figure 10. National & Avista Transmission & Distribution Capital Spending
 Source of National Data: FERC Form 1

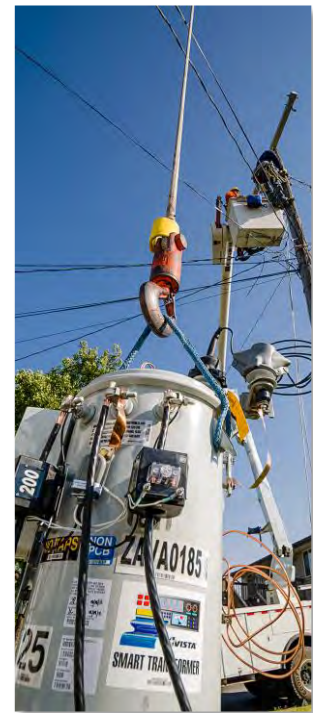
Avista “Smart” Transformer

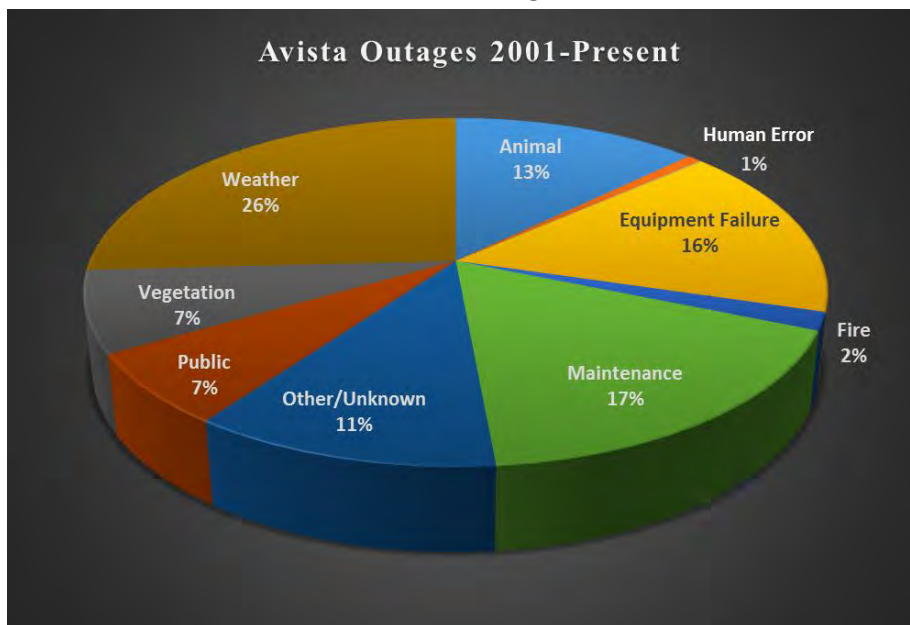
Figure 22. Outage Causes 2001 - Present

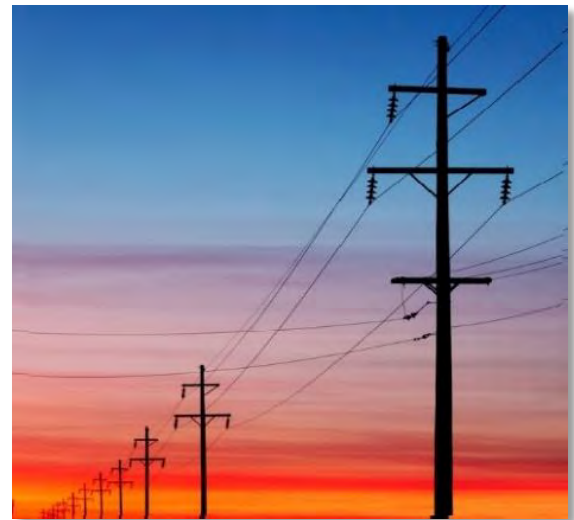
Transmission Poles showing distribution lines “underbuilt” below the transmission lines, which puts additional strain and wear on the poles

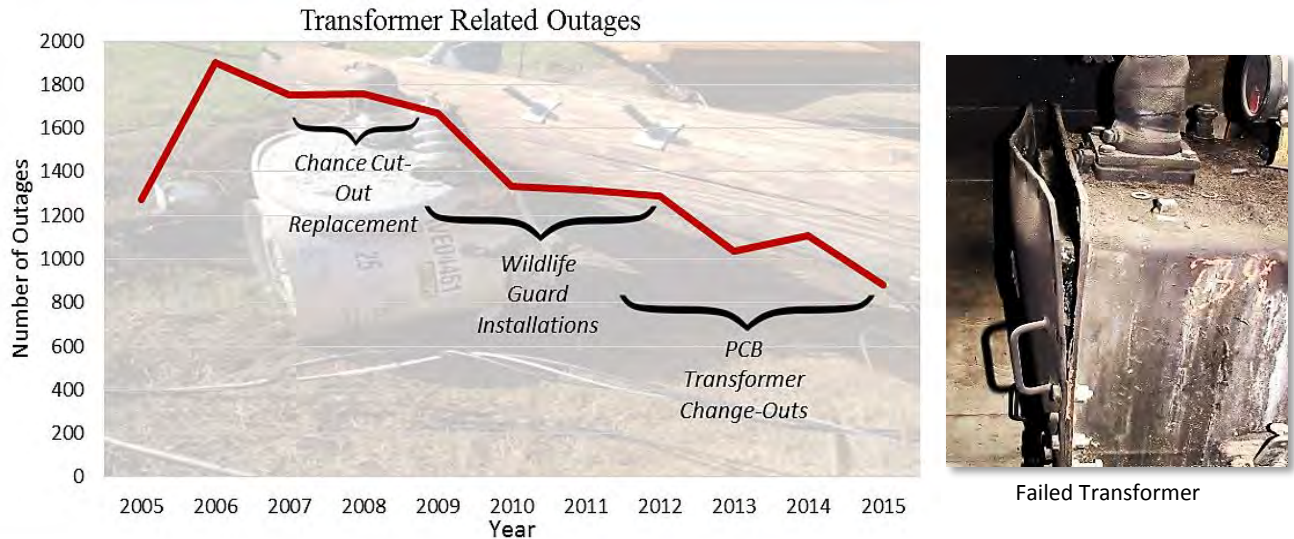
Figure 41. Transformer Related Outages
