Friday to Mount Constitution

This shot consists of 4 separate radio systems transmitting through 2 separate antennas at each location. The additional pages in this spreadsheet contain screen shots of the summary pages for each system.

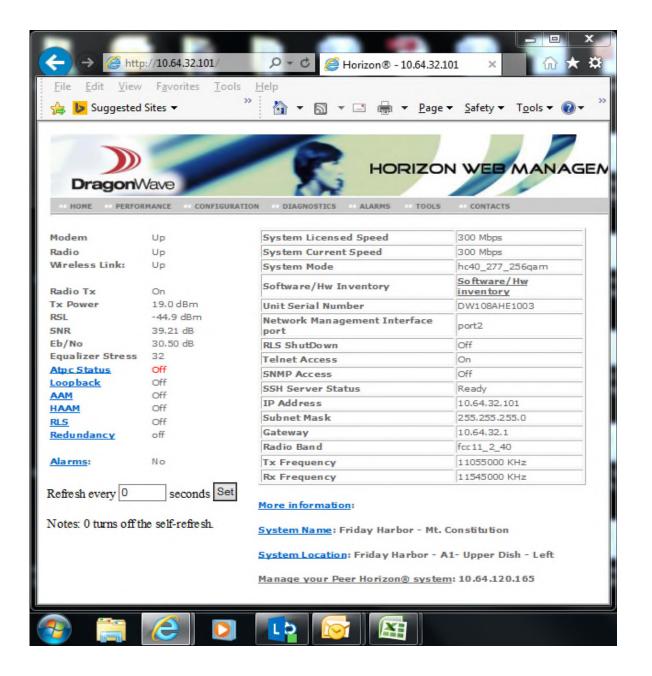
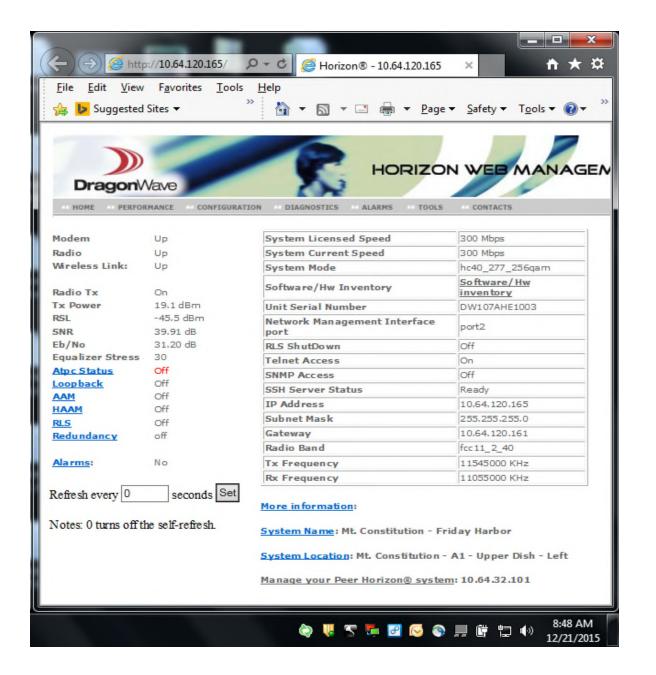
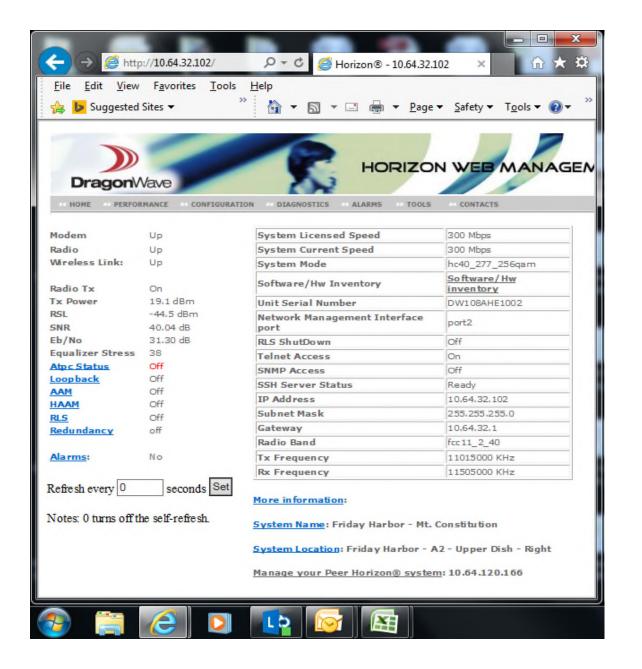
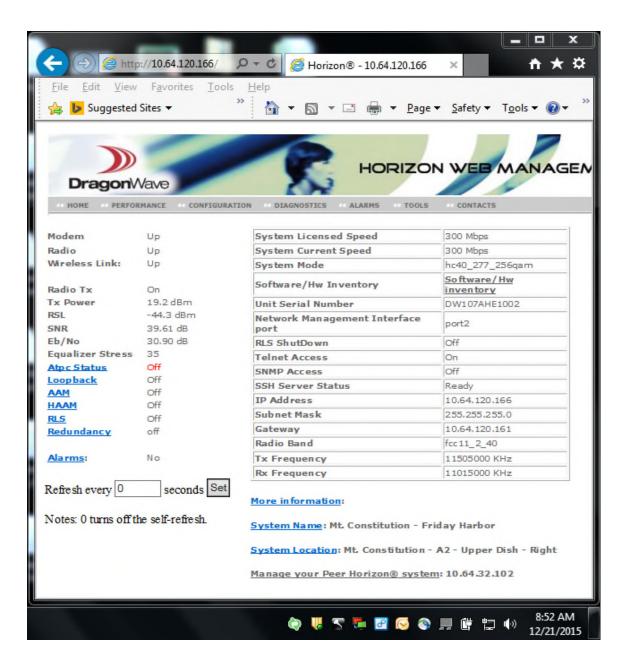
Indications of a properly operating link: No Alarms
RSL within \pm 3 dB of calculated
Eb/No \geq 19 dB
Signal to Noise Ratio (SNR) \geq 24 db
Equalizer Stress typically 30, but < 150

Each radio indicates a properly operating link, despite the ATPC Alarm indication. That alarm indicates that the Automatic Transmit Power Control circuit is off, which is the normal operating condition for microwave radio systems operating within CTL.

Currently, Radio Systems 2 &3 have zero thruput, while Radio 1 has approximately 18 Mbps thruput and Radio 3 has approximately 126 Mbps thruput.

Systems 2 & 3 are set up to take service in case of a fiber cut, thus the zero thruput.
