Case 16-055

PSE Complaint No. 11

Violation: Digging without locates; RCW 19.122.30 (1), (2) and (5); Failure to notify facility operator about damage to an underground utility 19.122.050 (1); Removal of temporary marking for underground utilities prior to its intended use 19.122.075

**REPORT OF DAMAGE TO
ELECTRIC FACILITIES**
PREPARED FOR LEGAL COUNSEL

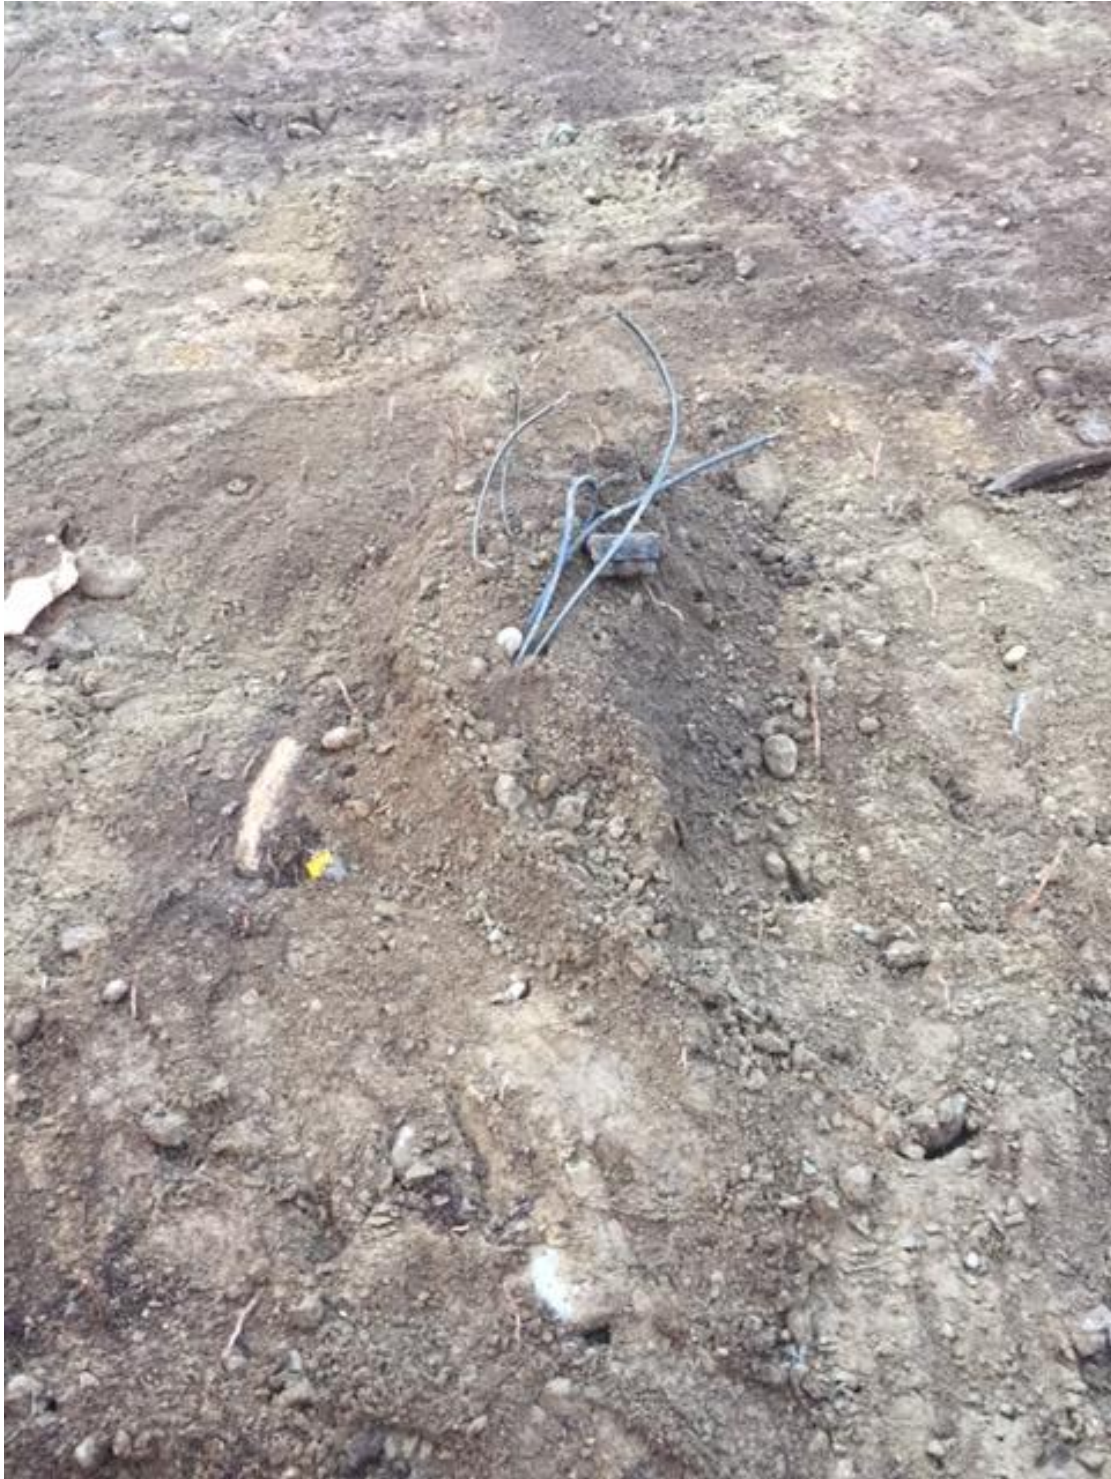
CONTRACTOR DUG-UP DIRECT BURIED HANDHOLE . NEED CREW TO REPAIR

Electrical facility that was damaged.

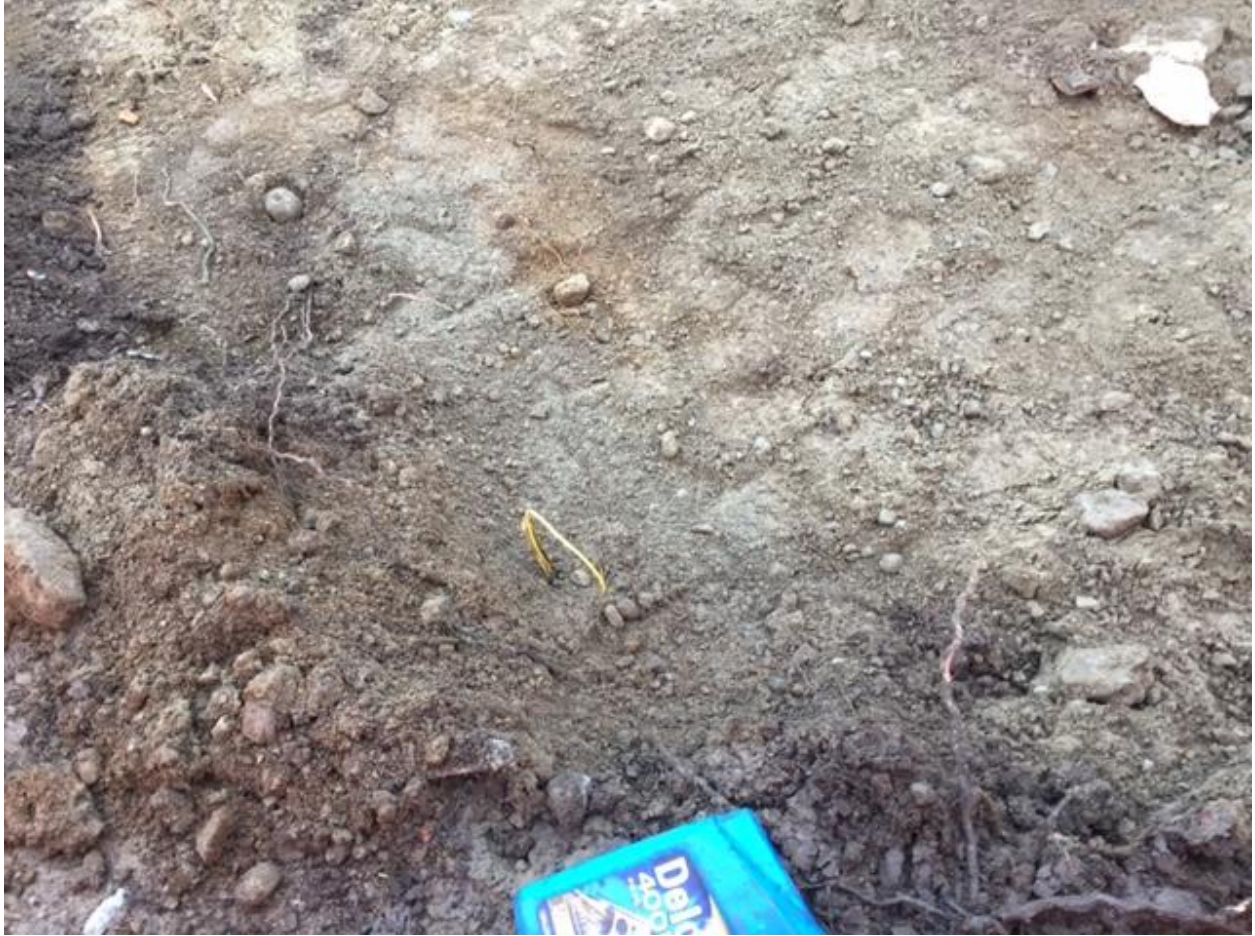
Gas Stub Marker that had been damaged and covered
