BCA Directional Drilling, LLC
11205 NE Hurleys Ln
Newberg, OR 97132

RE: Complaint Case Number: 14002

I am writing this letter to clarify what happened during the damage on 08/14/2013. On 08/13/2013 we potholed all utilities that were marked by Century Link Telephone. During this time we shut down 2 lanes of traffic in order to pothole the utilities that were marked.

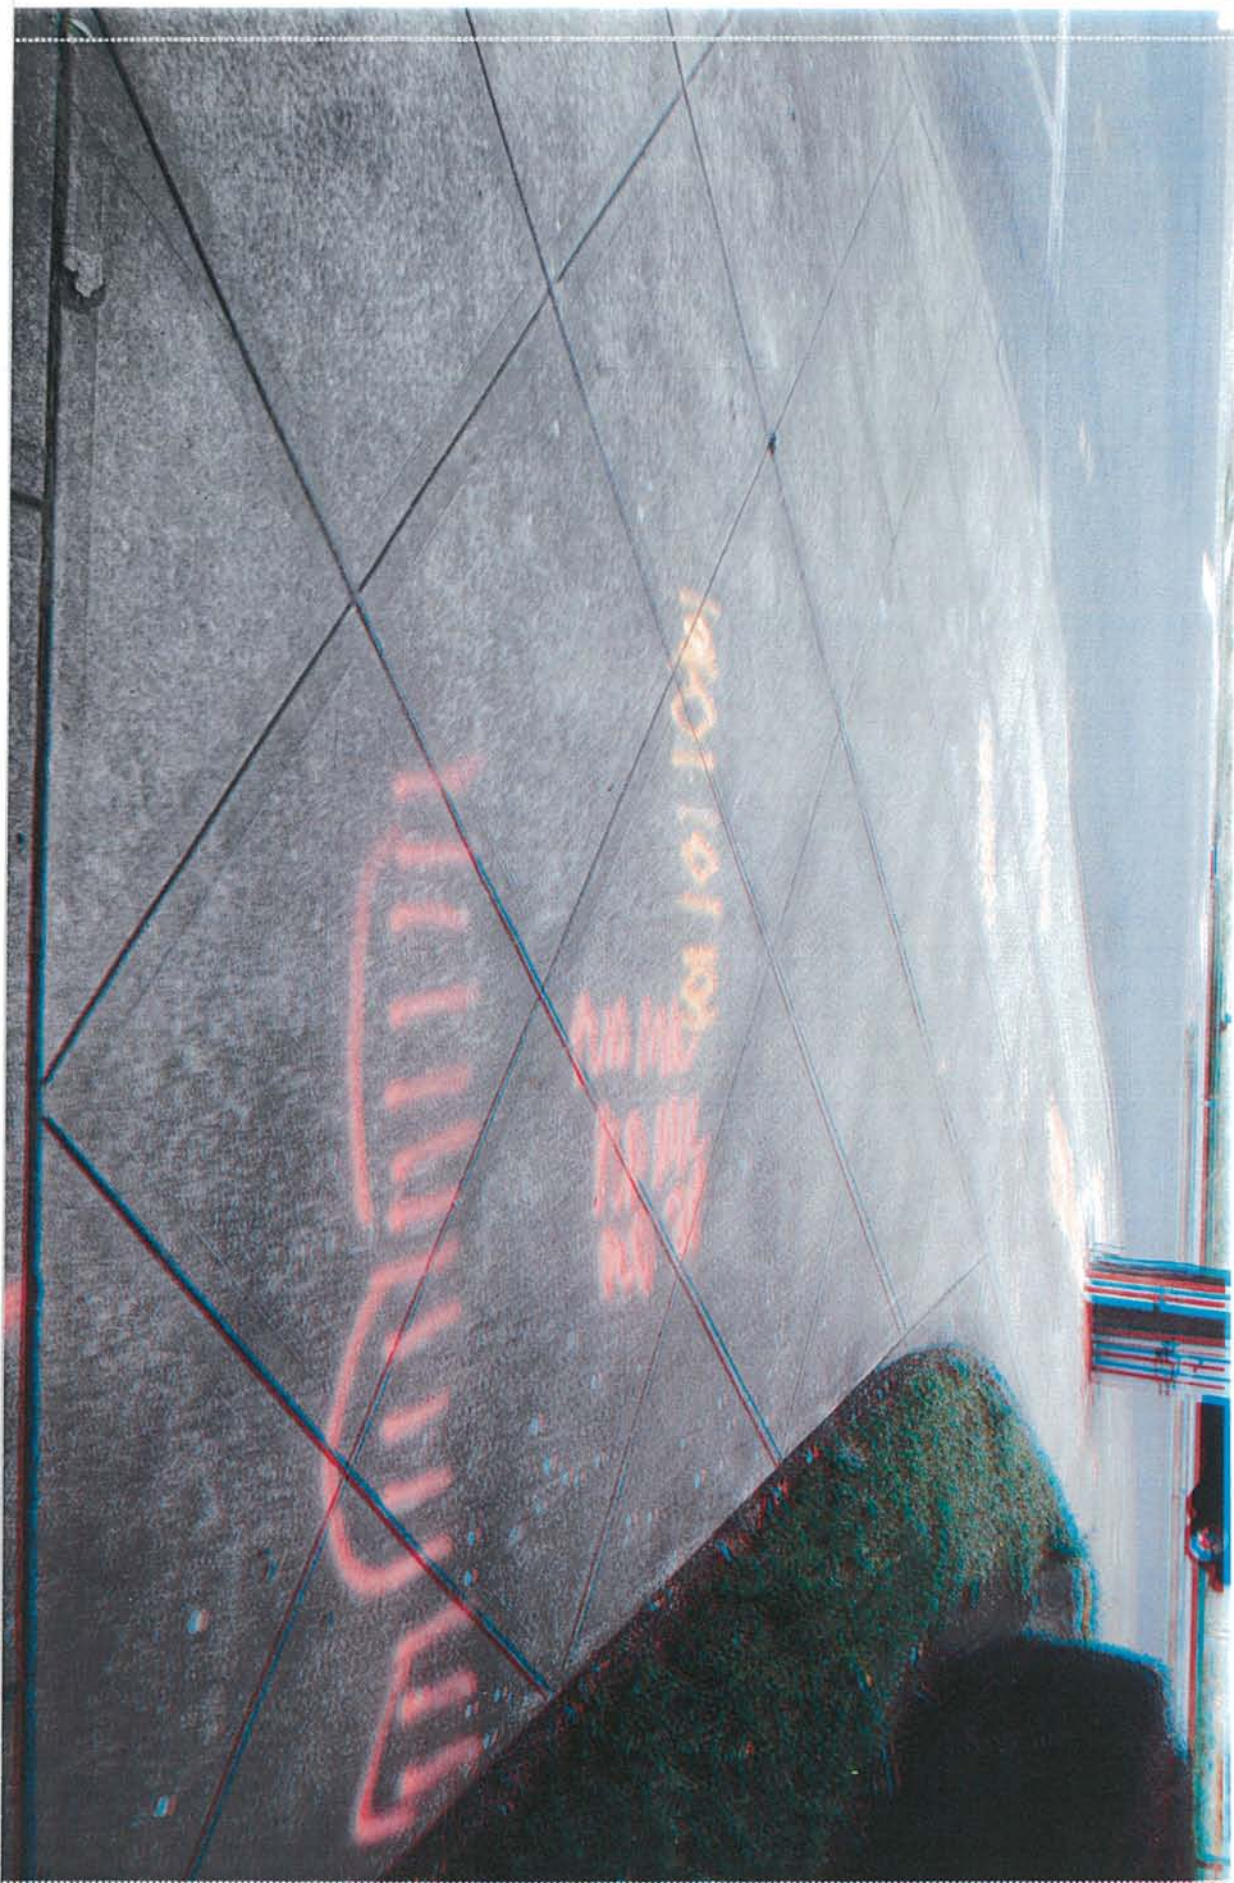
①

DIFFERENT JOBS, BUT CORRECT
WAY TO MARK MULT. DUCTS DIFF. DIRECT.

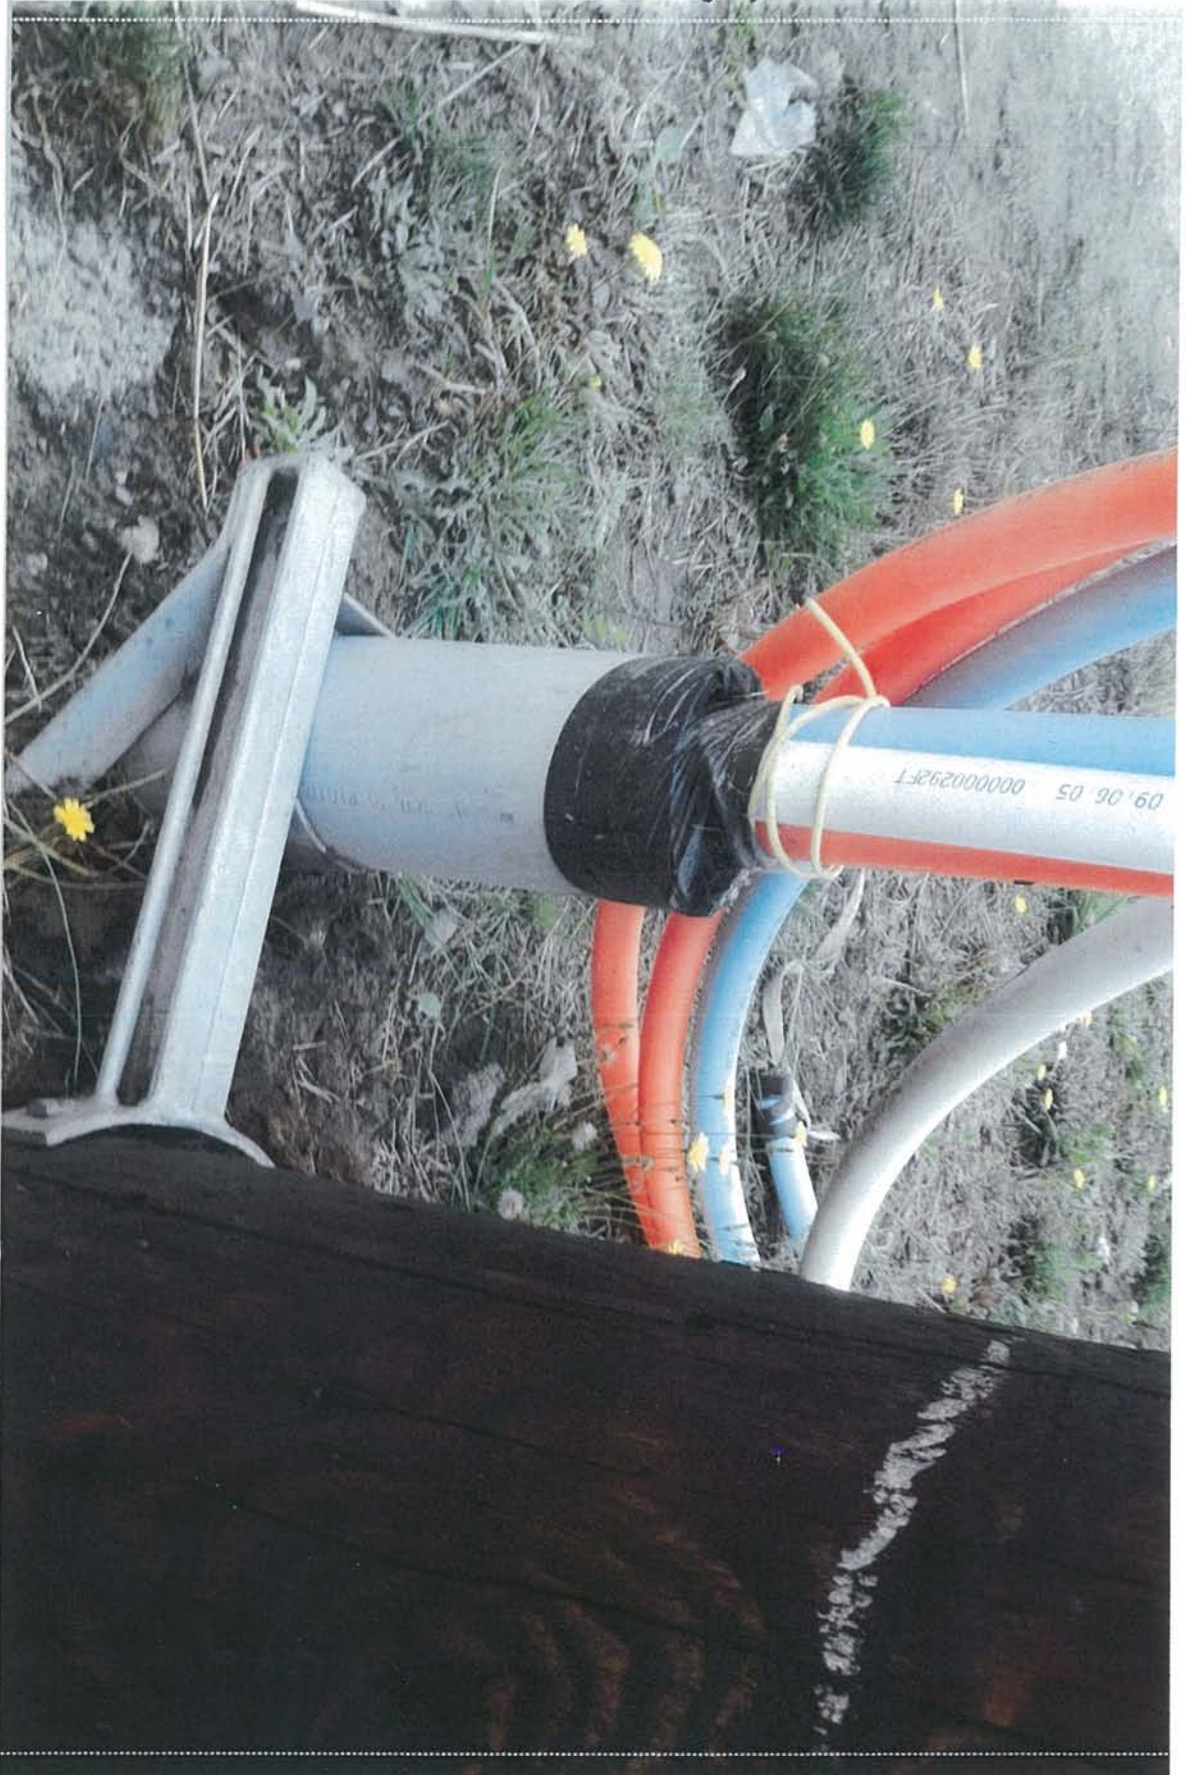
③

EXAMPLE OF MULTIPLE
CONDUITS INSIDE (1) - 4" CONDUIT

WOULD BE MARKED | 0 |

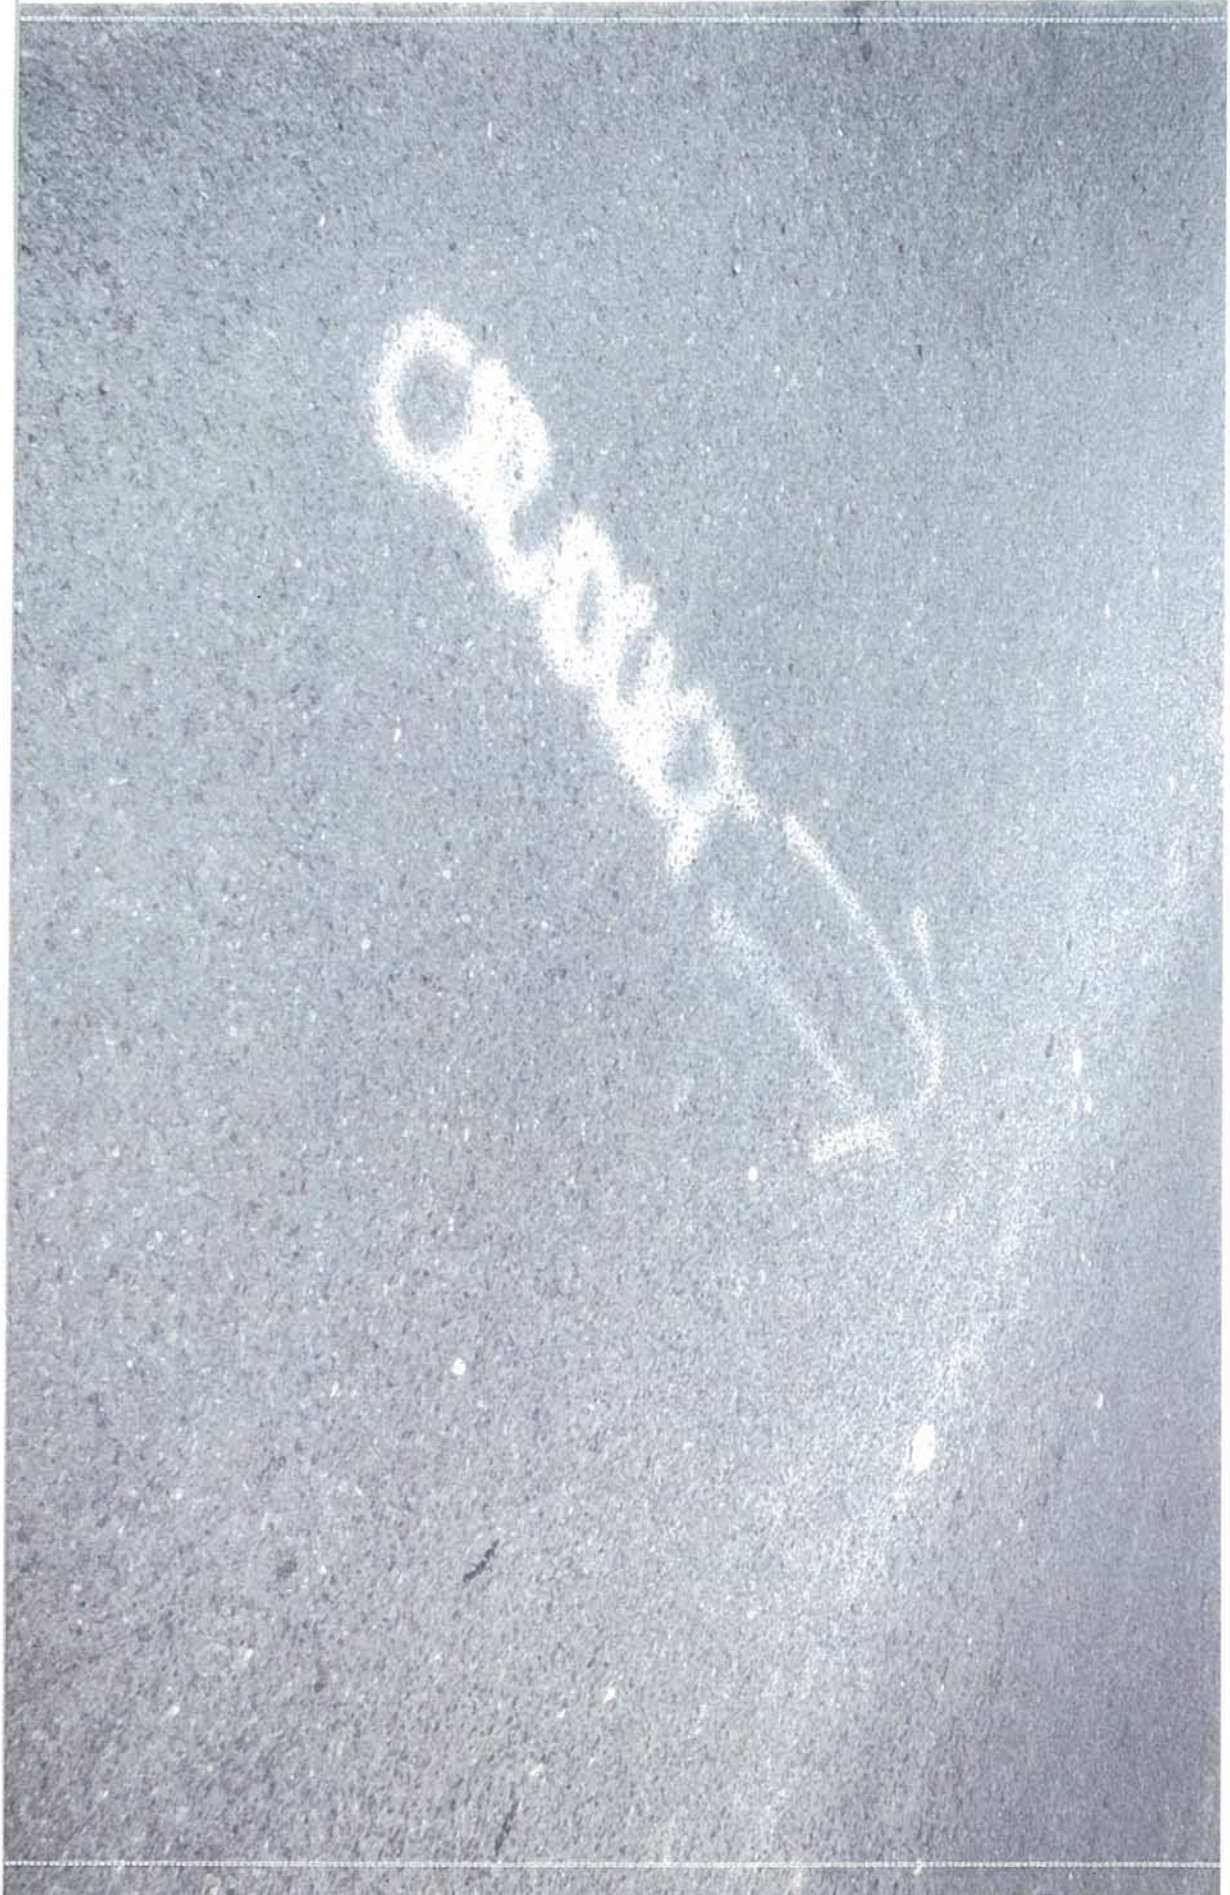
④

60' AWAY MARKED AS DUCT.
(1) 4" CONDUIT 2 LINES

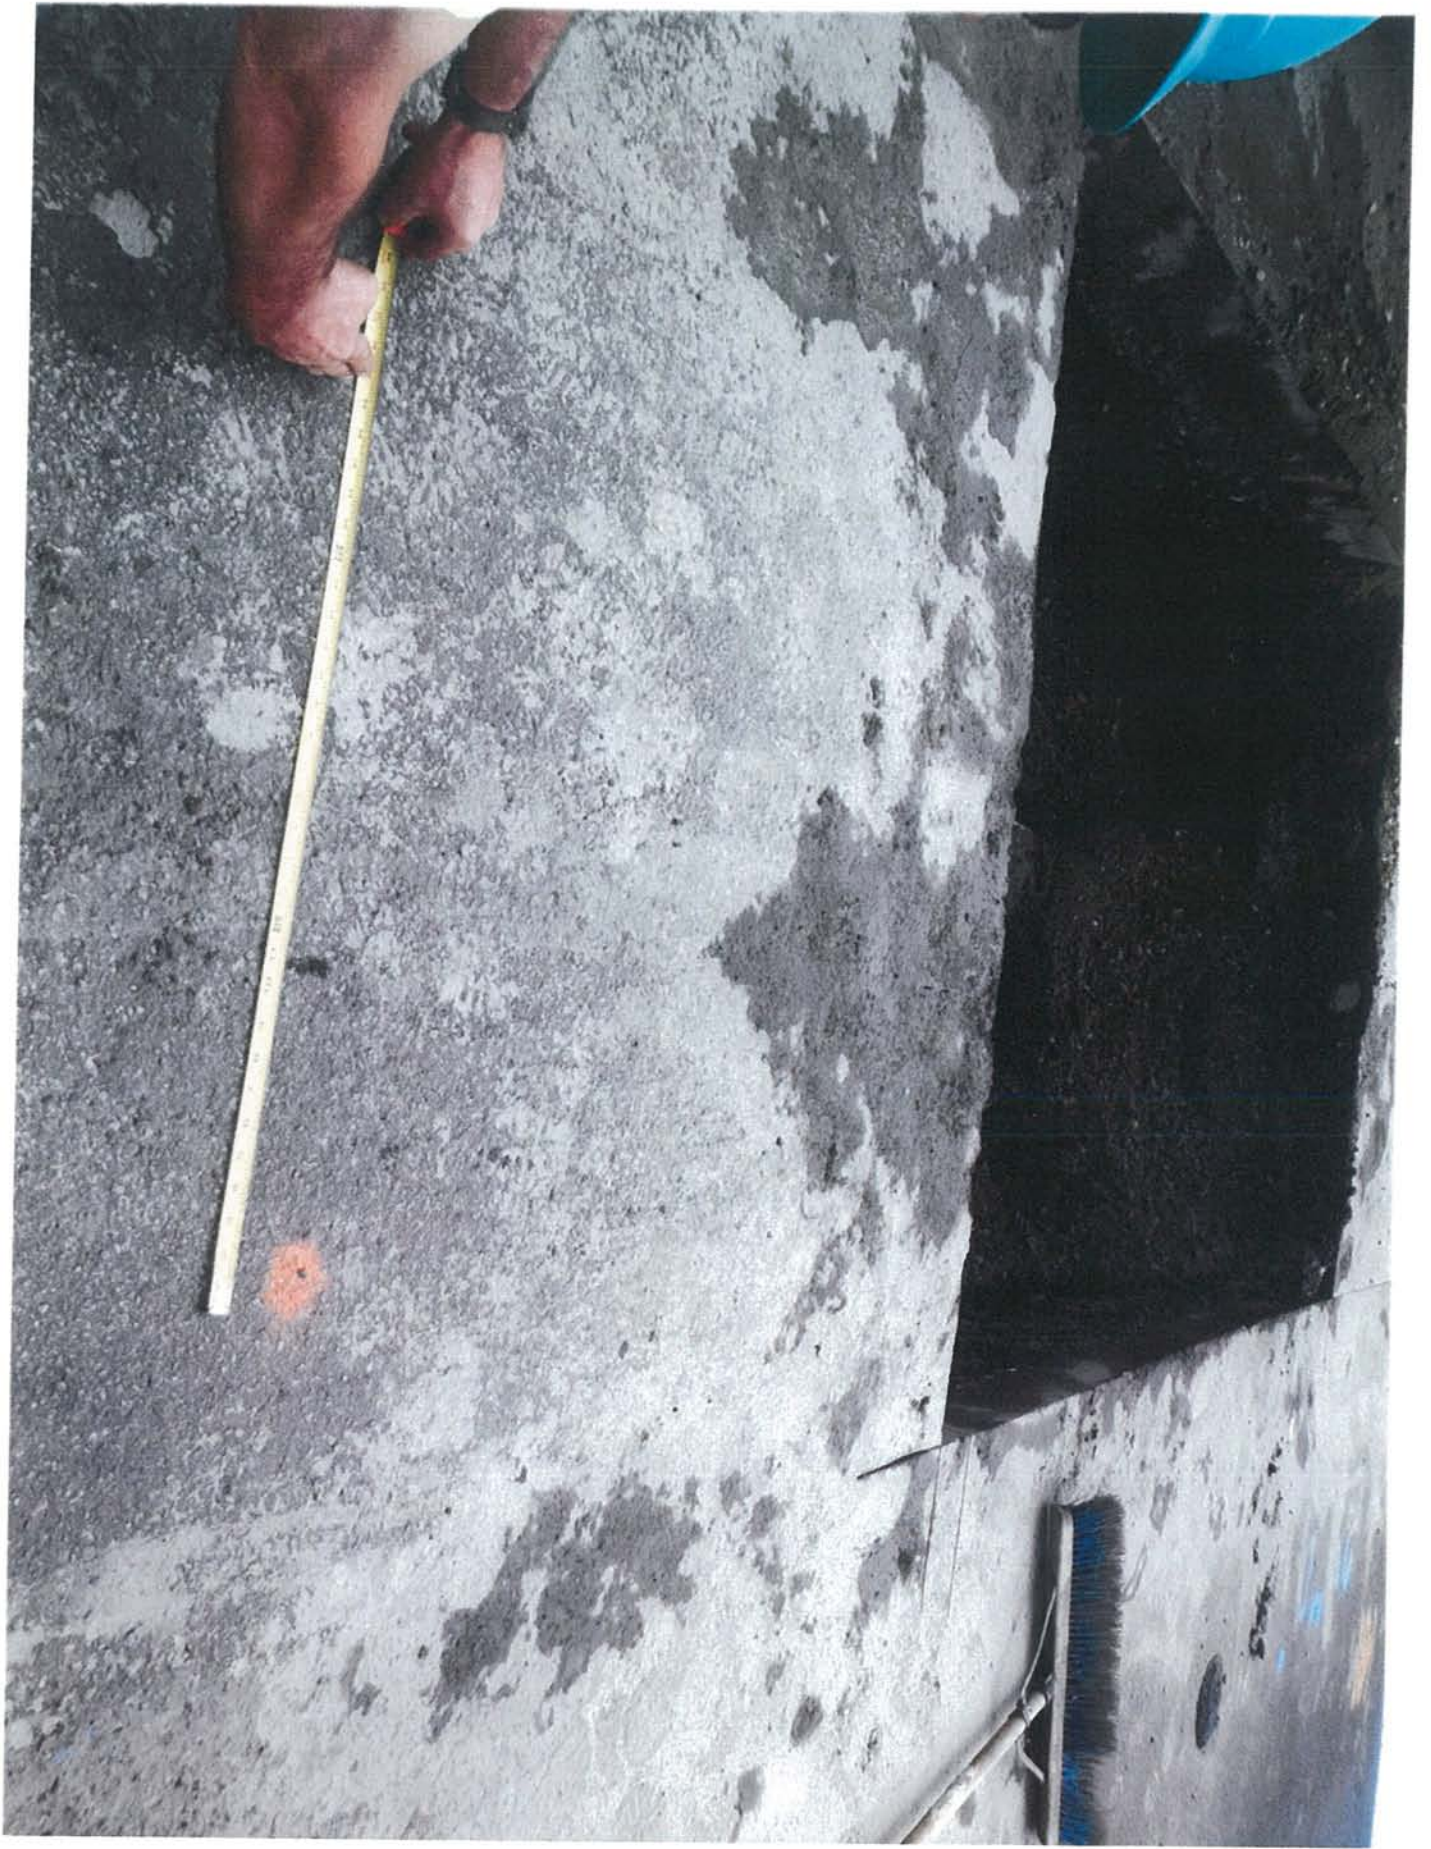
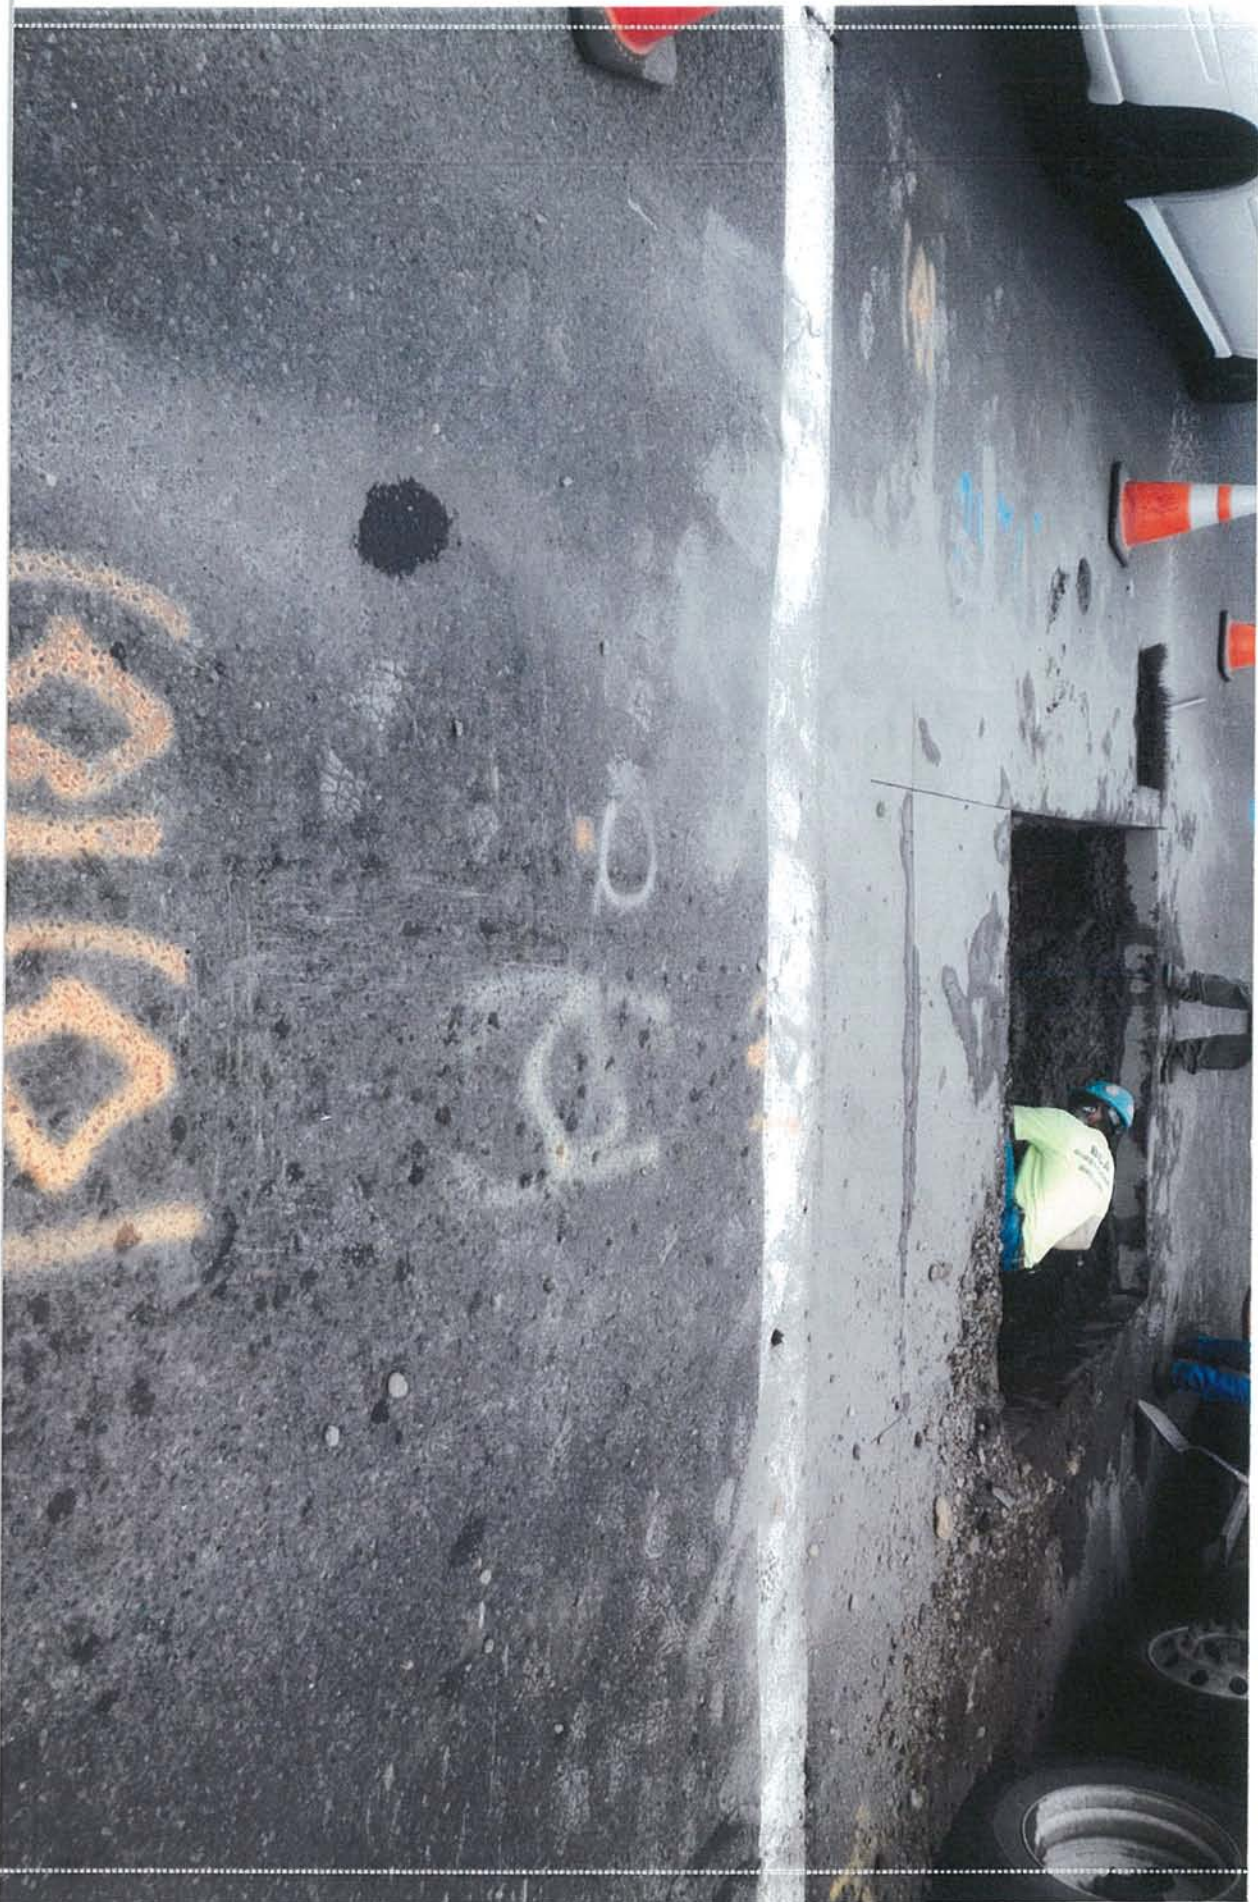
N ↖ ⑥

(2) DUCI RUNS MARKED

1- NORTH

1- ~~SOUTH~~ WEST

INCOMPLETE LOCATES.

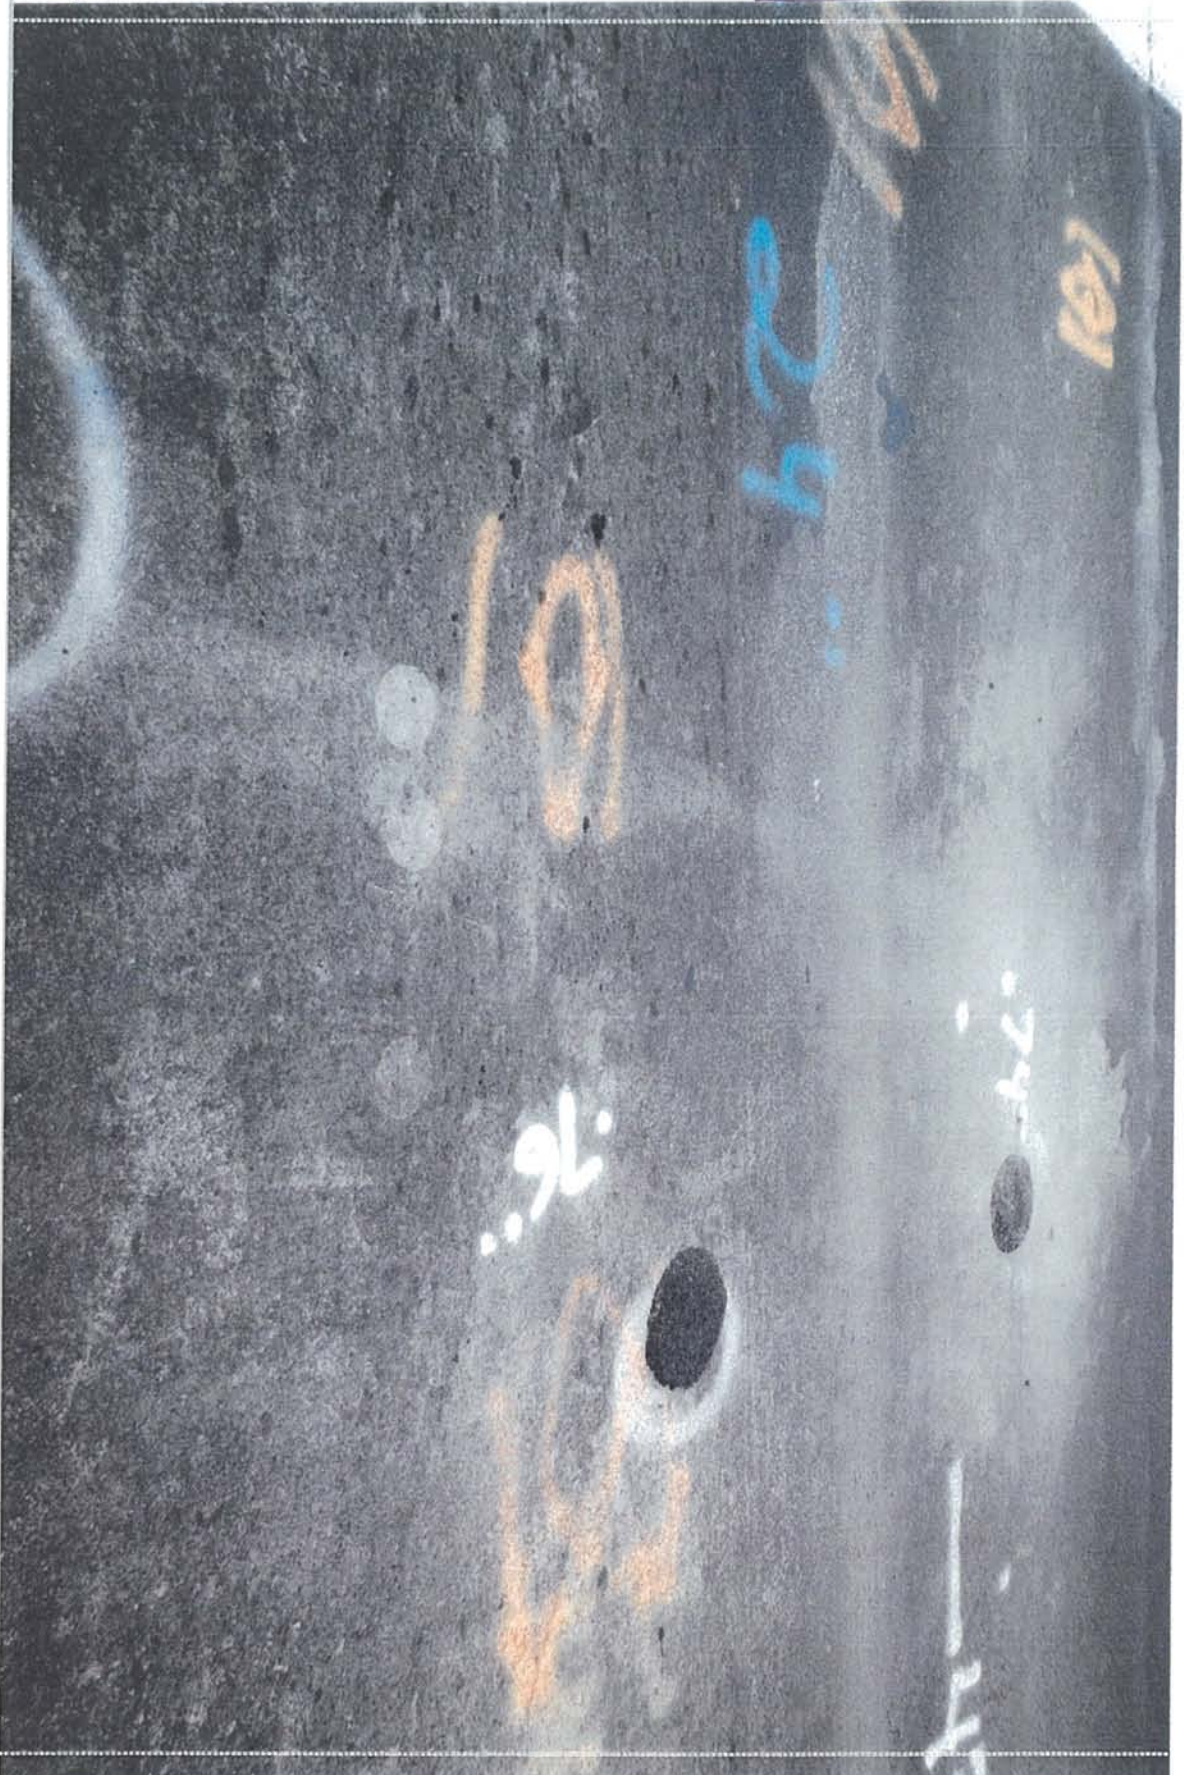
10

(1) DUCT RUN HEADED NORTH ?
(1) DUCT RUN HEADED WEST

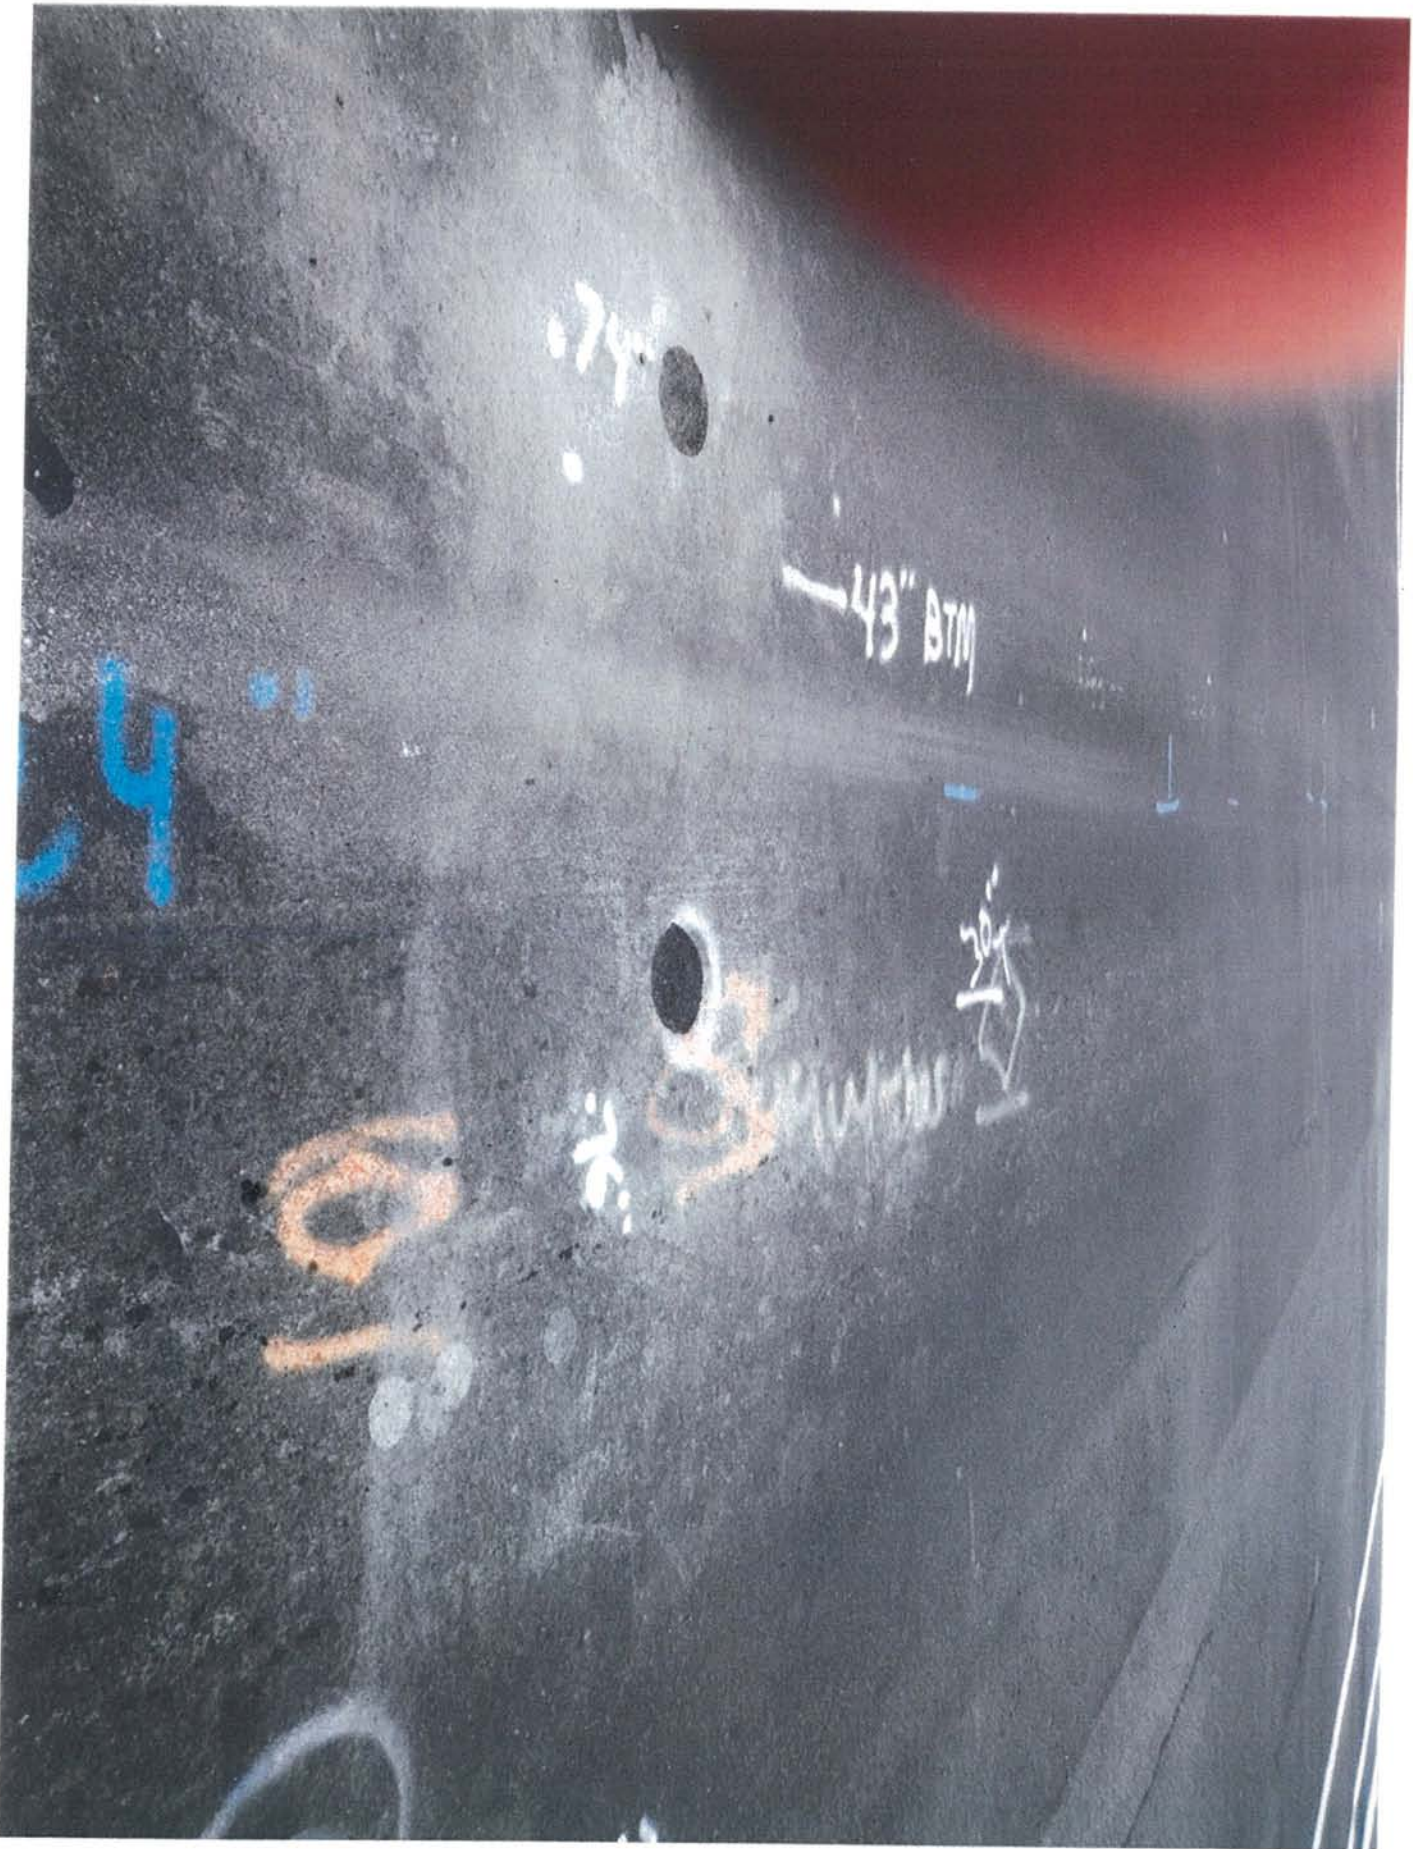
① ~~A~~ N V

• 76" HIT THOUGHT TO BE 1 DUCT
AT 30" DEEP.

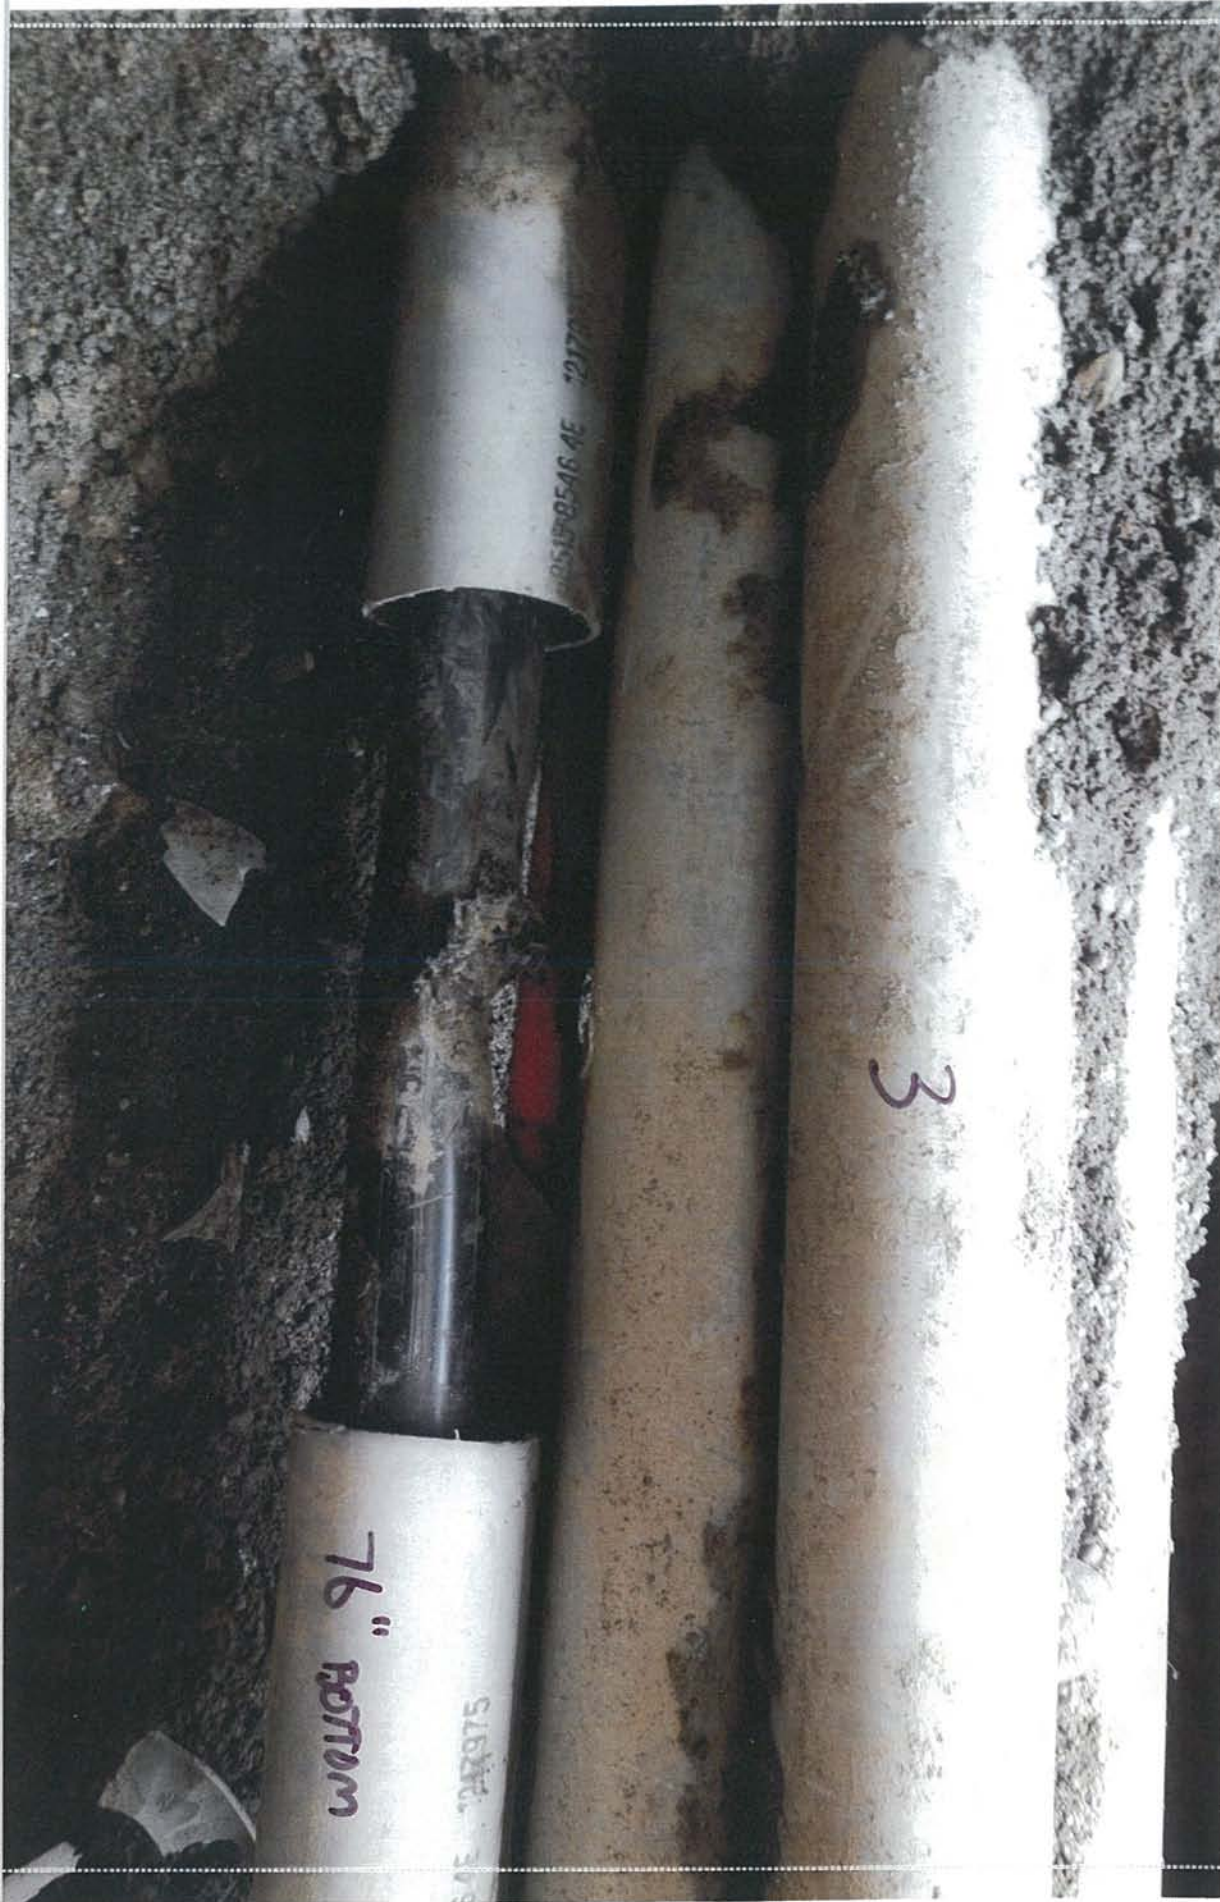
(2) N →

DAMAGE

76" DEEP
