BCA Directional Drilling, LLC
11205 NE Hurleys Ln
Newberg, OR 97132

RE: Complaint Case Number: 14002

I am writing this letter to clarify what happened during the damage on 08/14/2013. On 08/13/2013 we potholed all utilities that were marked by Century Link Telephone. During this time we shut down 2 lanes of traffic in order to pothole the utilities that were marked.

DAMAGE DETAIL : 900 PAIR BURIED CABLE - TELEPHONE EXCAVATION
 DATE OF DAMAGE: 08/14/13 CABLE LOCATE WAS ACCURATE
 LOCATION : NE 162ND AVE & NE18TH ST, VANCOUVER WA

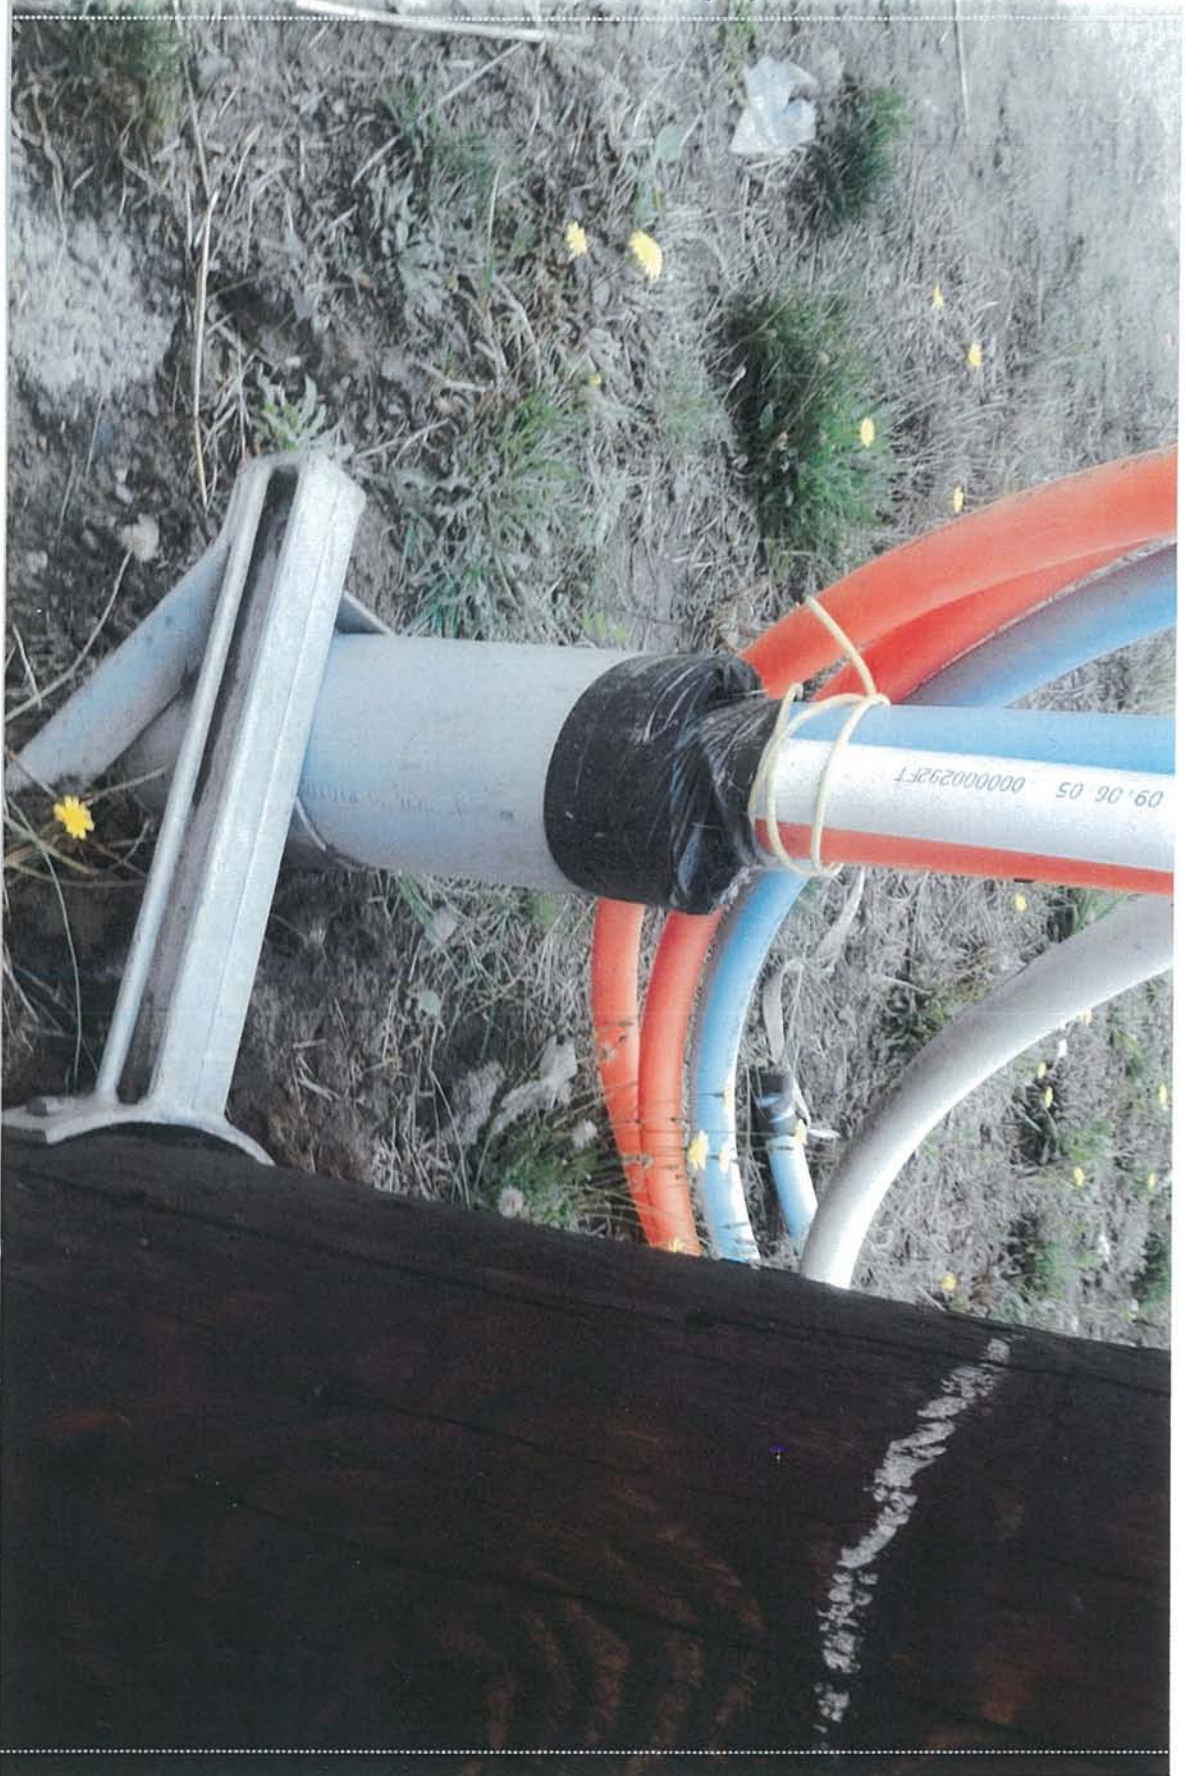
③

EXAMPLE OF MULTIPLE
CONDUITS INSIDE (1) - 4" CONDUIT

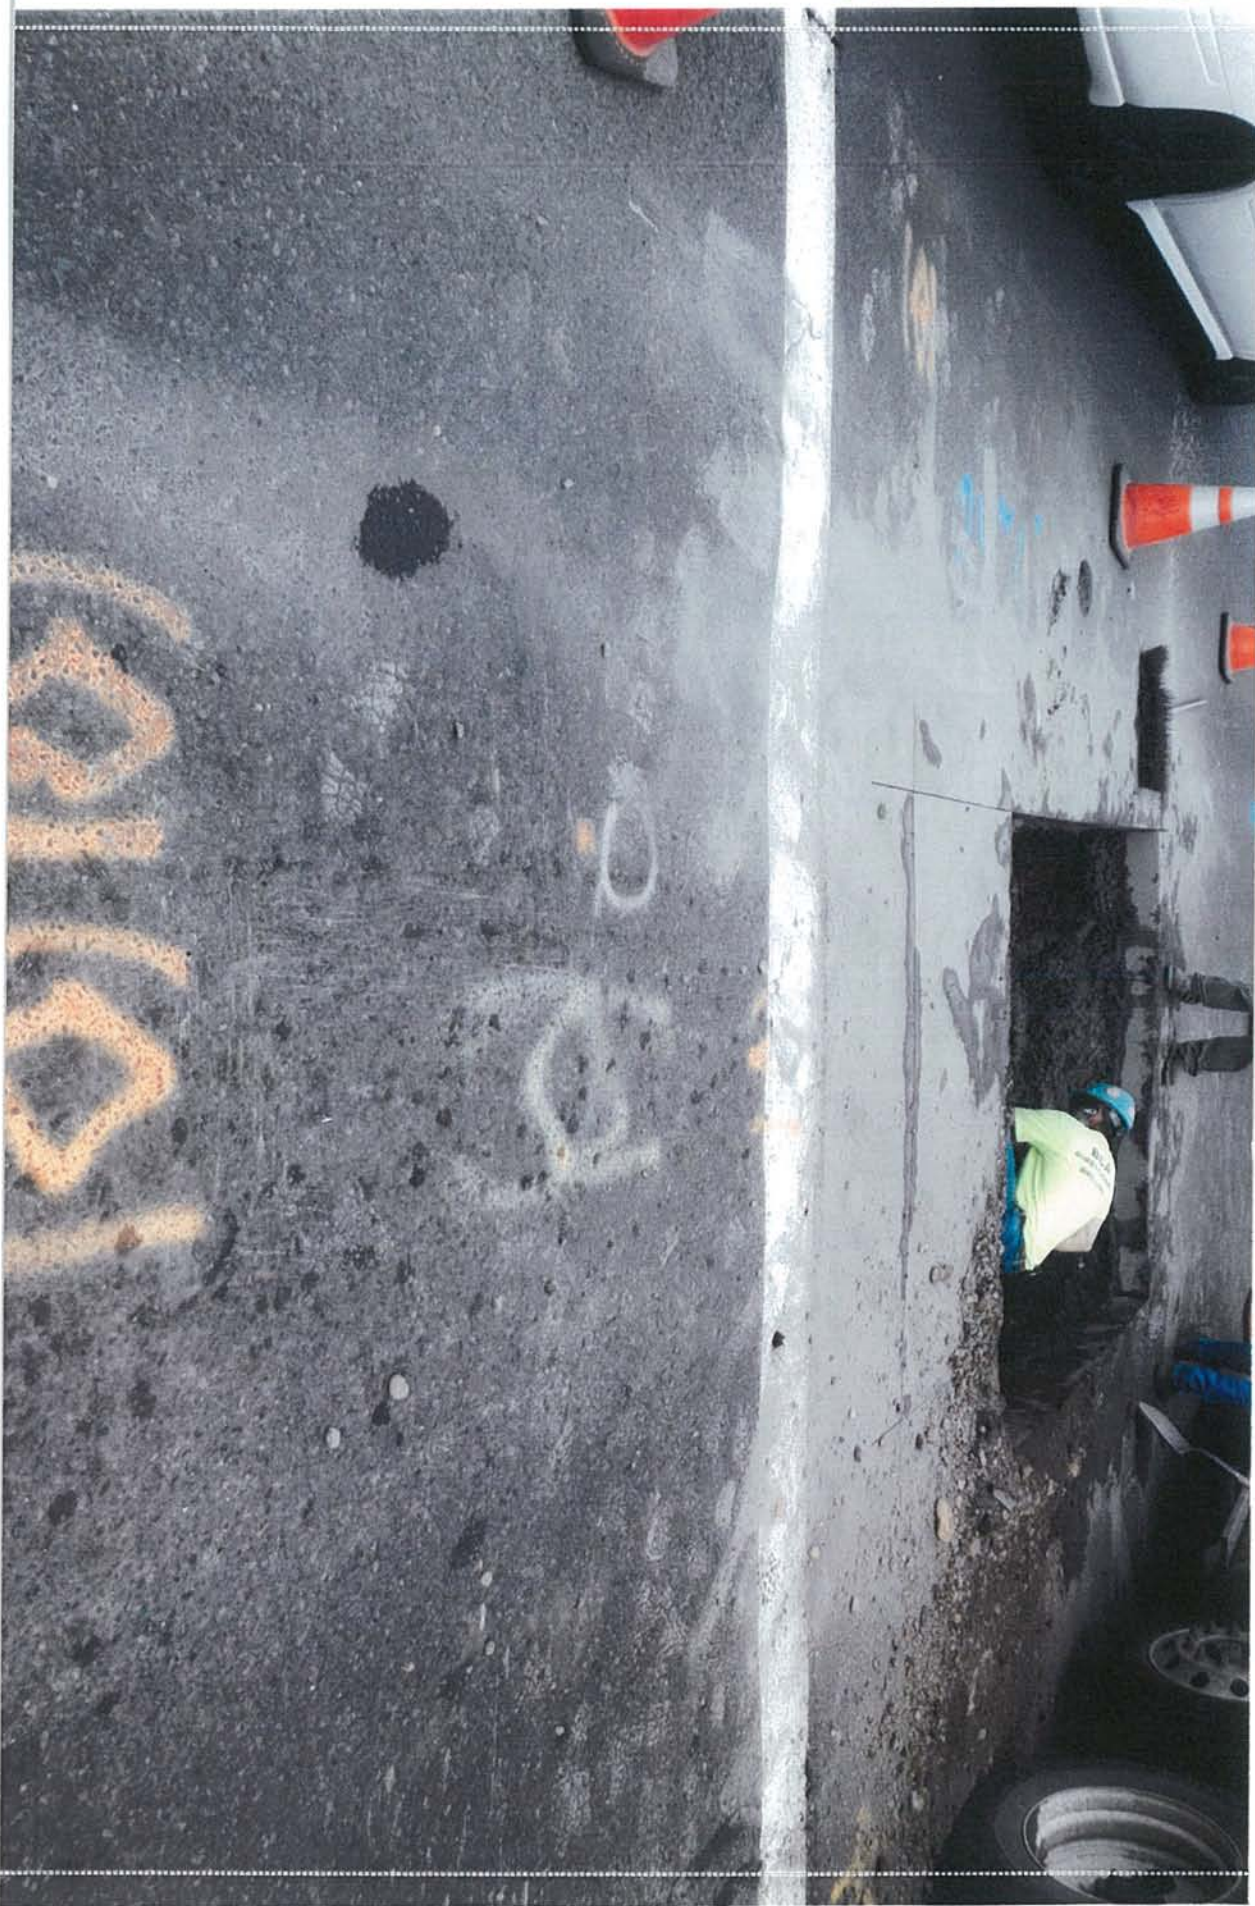
N ↖ ⑥

(2) DUCI RUNS MARKED

INCOMPLETE LOCATES.
