Washington State Dig law complaint 24-013

RE: Gas Damage

8103 N. Howard Dr

Ticket # 24082804

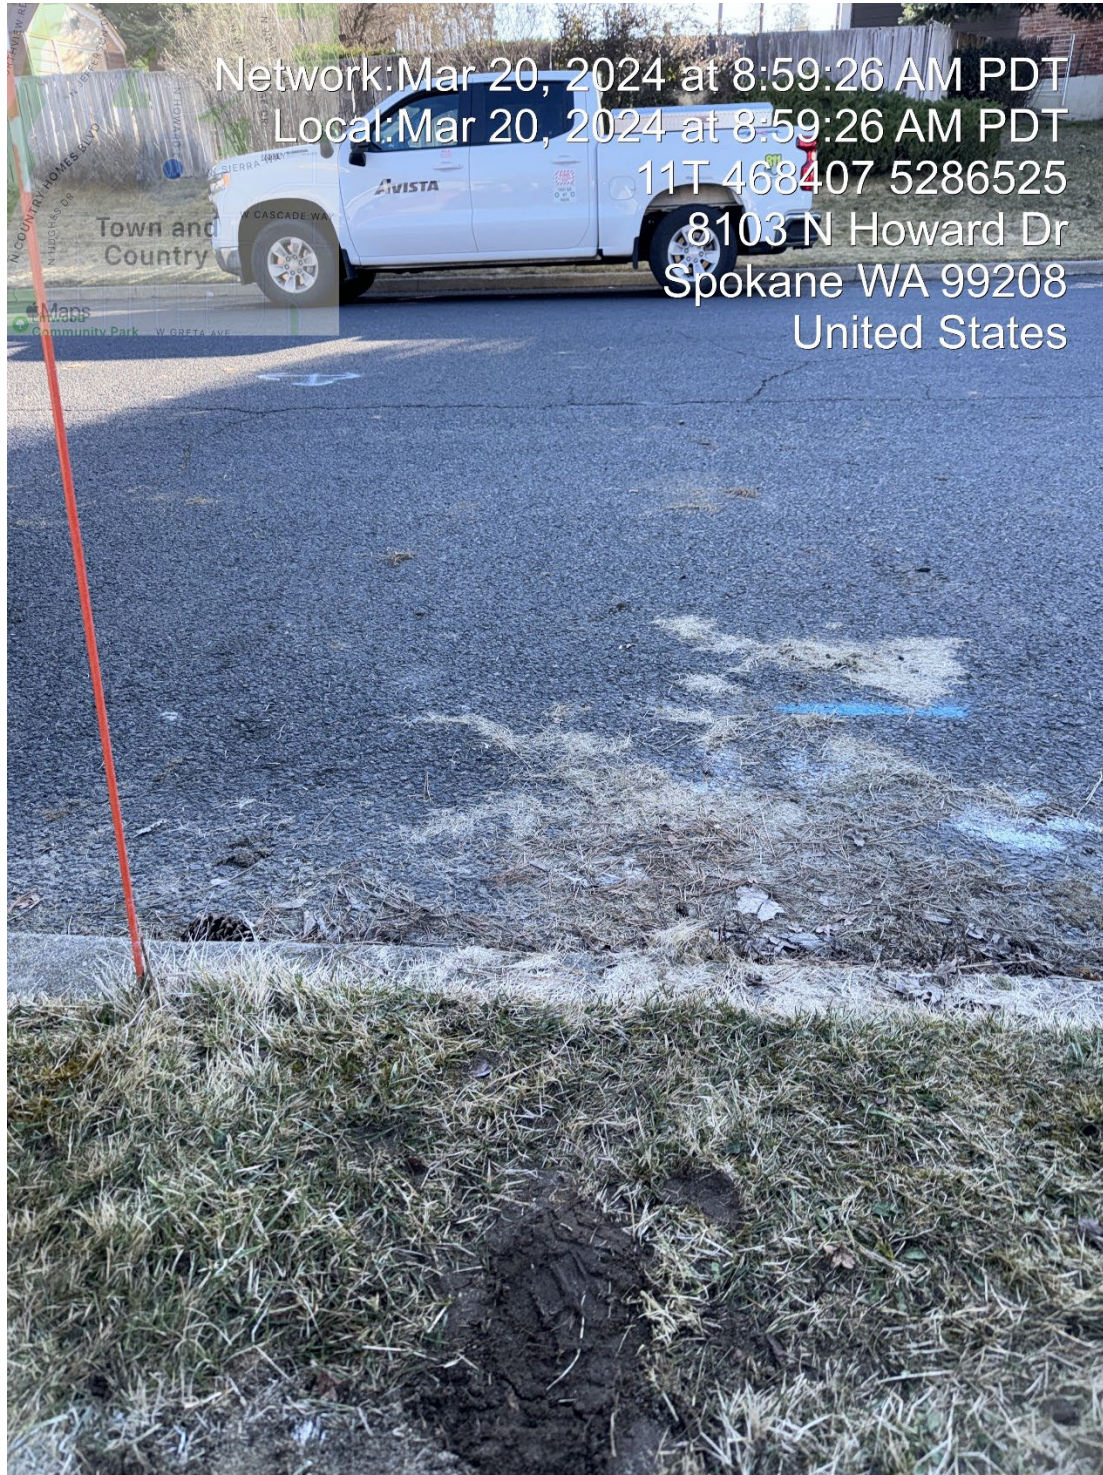
Figure 1 no locates crossing from the main under the Truck towards the camera.

Root Cause: 3rd party locator failed to locate a known service.

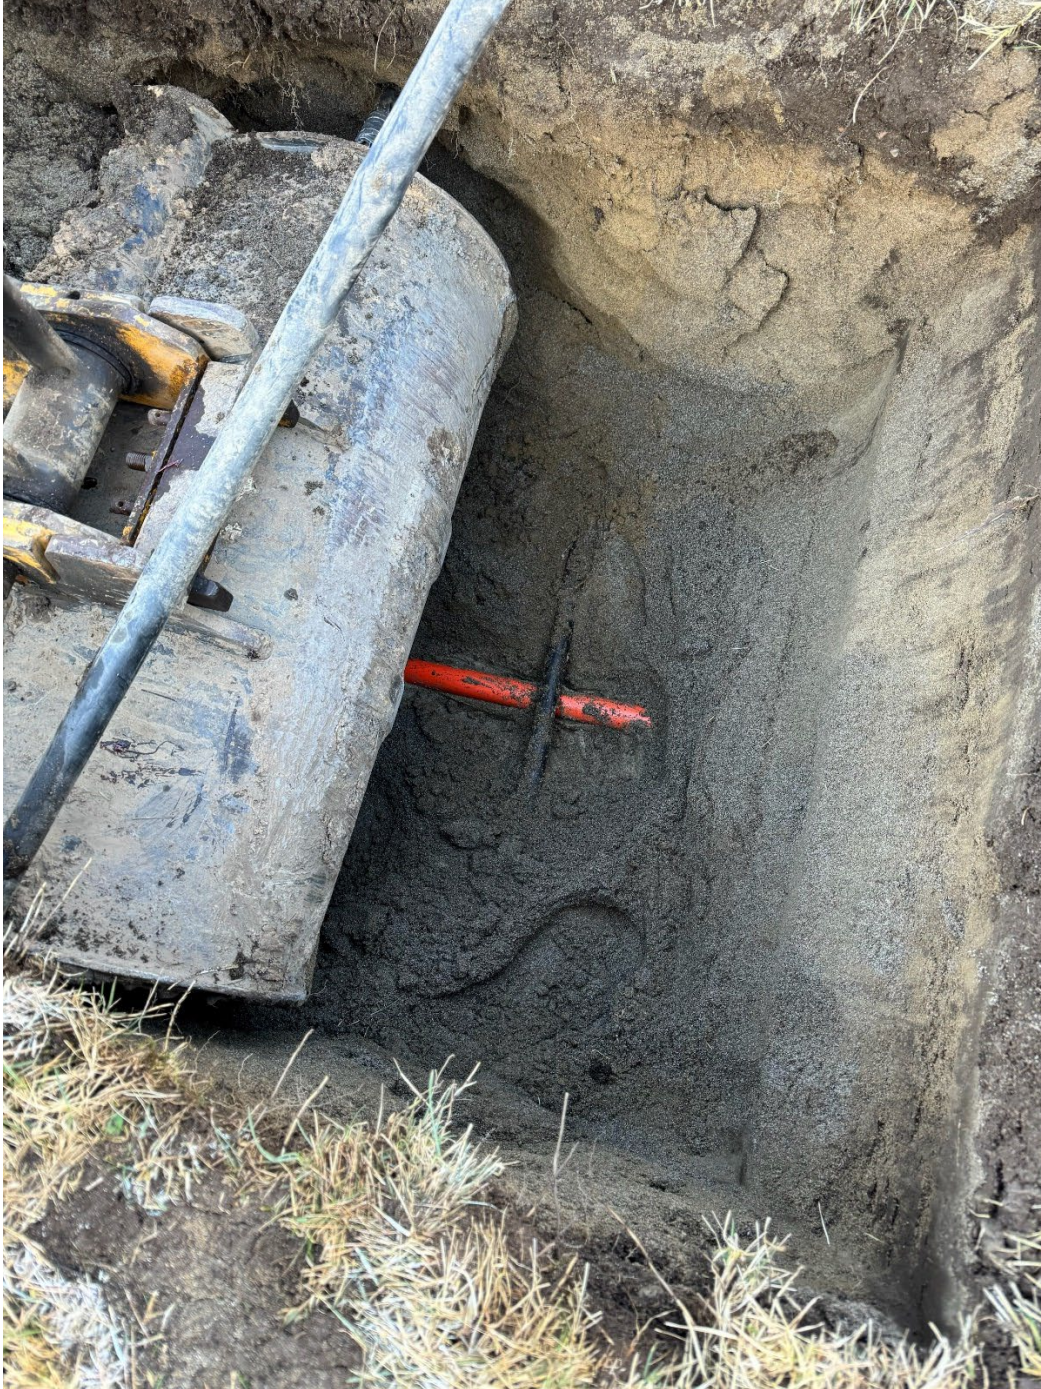
- The crew setting hand holes, dug down on the exact spot that the unlocated gas line was, and hit and damaged the pipe thereby finding it with the excavator
- After examination this Natural Gas line was also damaged by the directional drill.
- The bored in pipe was directly underneath the line with clear signs of damage from the directional boring drill head.

Figure 2 Damage above the service after hit by excavator bucket

- No gas leaking called a damage ticket
- Notified the Avista representative.
- Avista arrived, identified it as an active line and not located.
- He proceeded to apply tar compound to it and did not perform a repair.

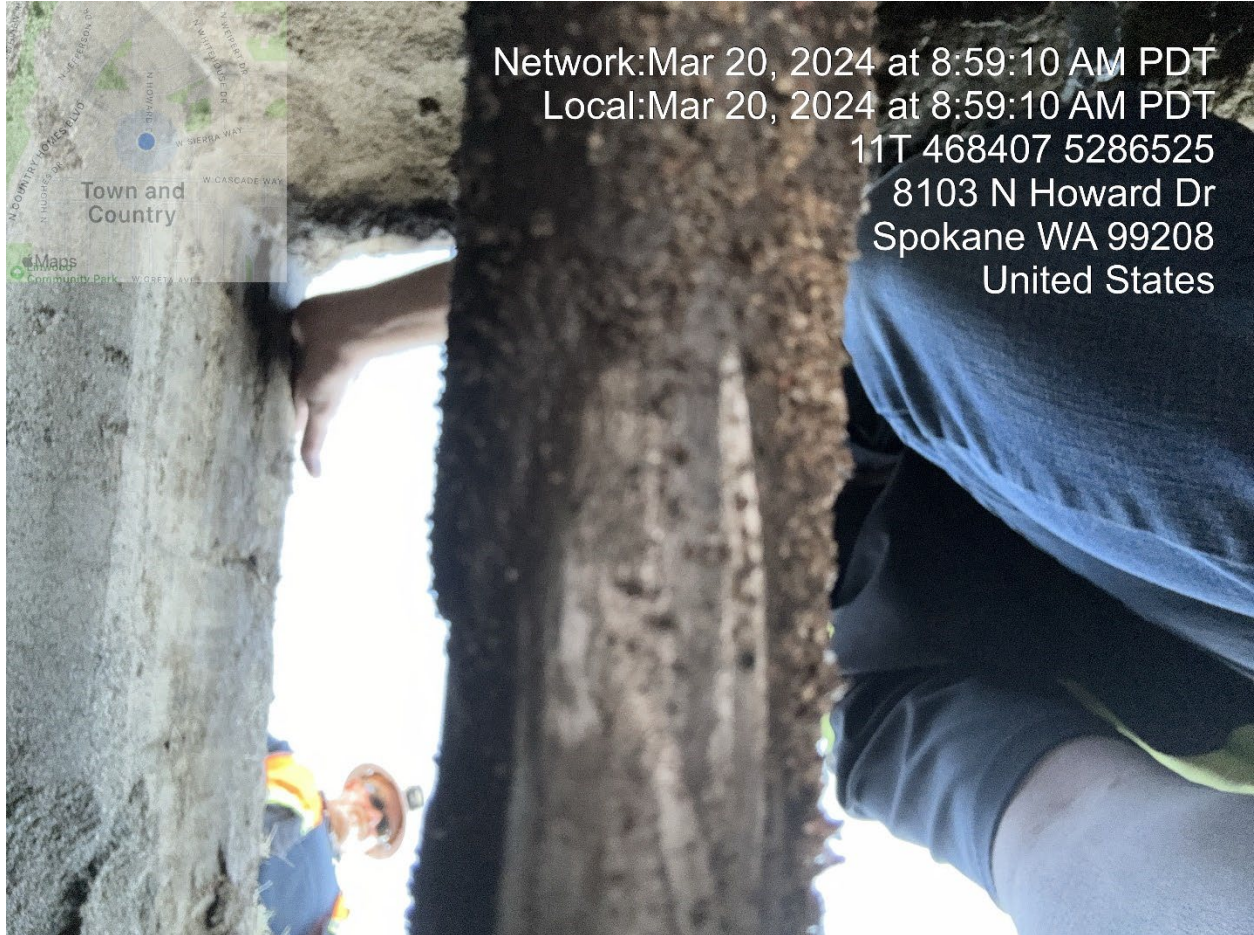
Figure 3 picture of damage to bottom of gas line

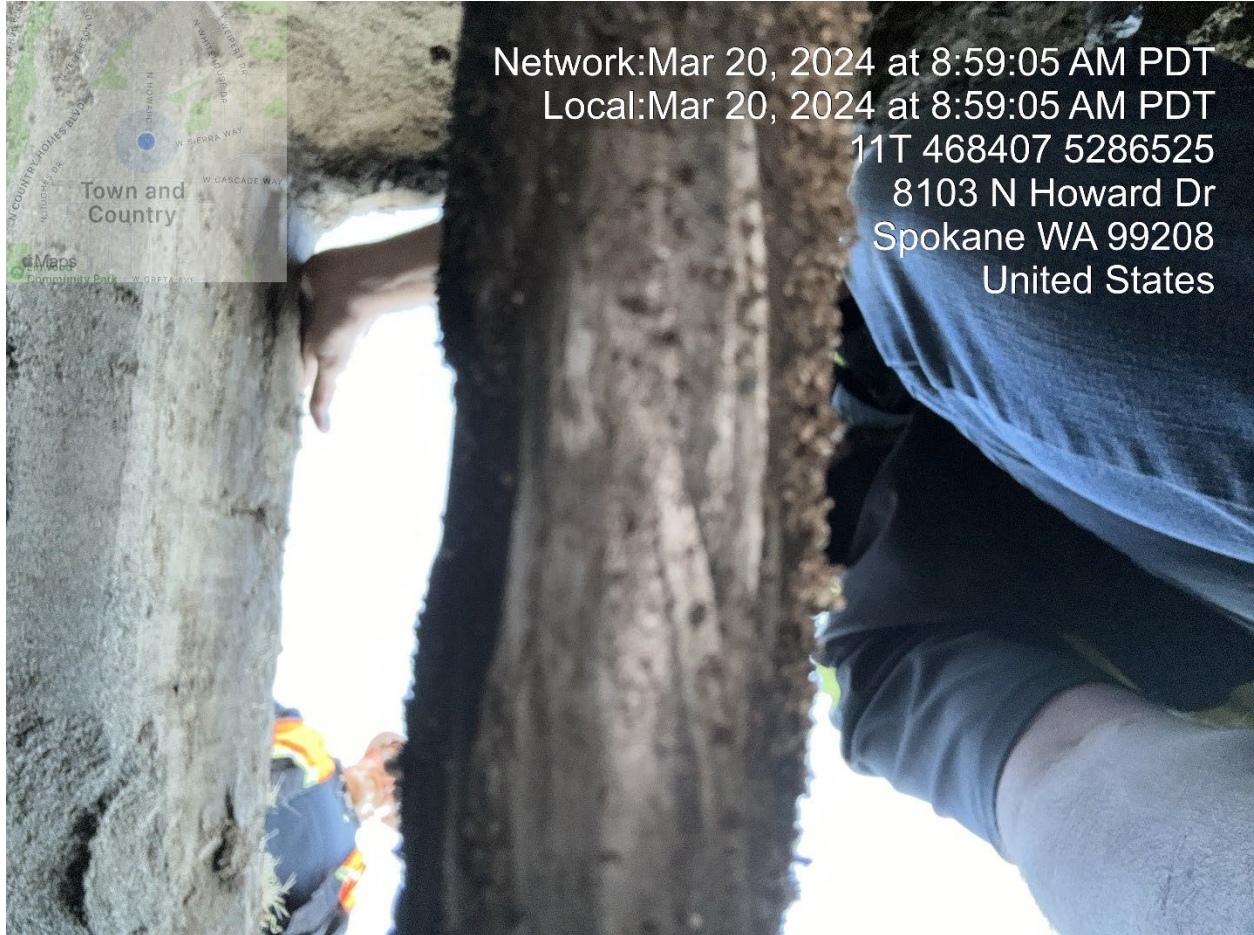
Figure 3 Damage to the bottom of the gas line

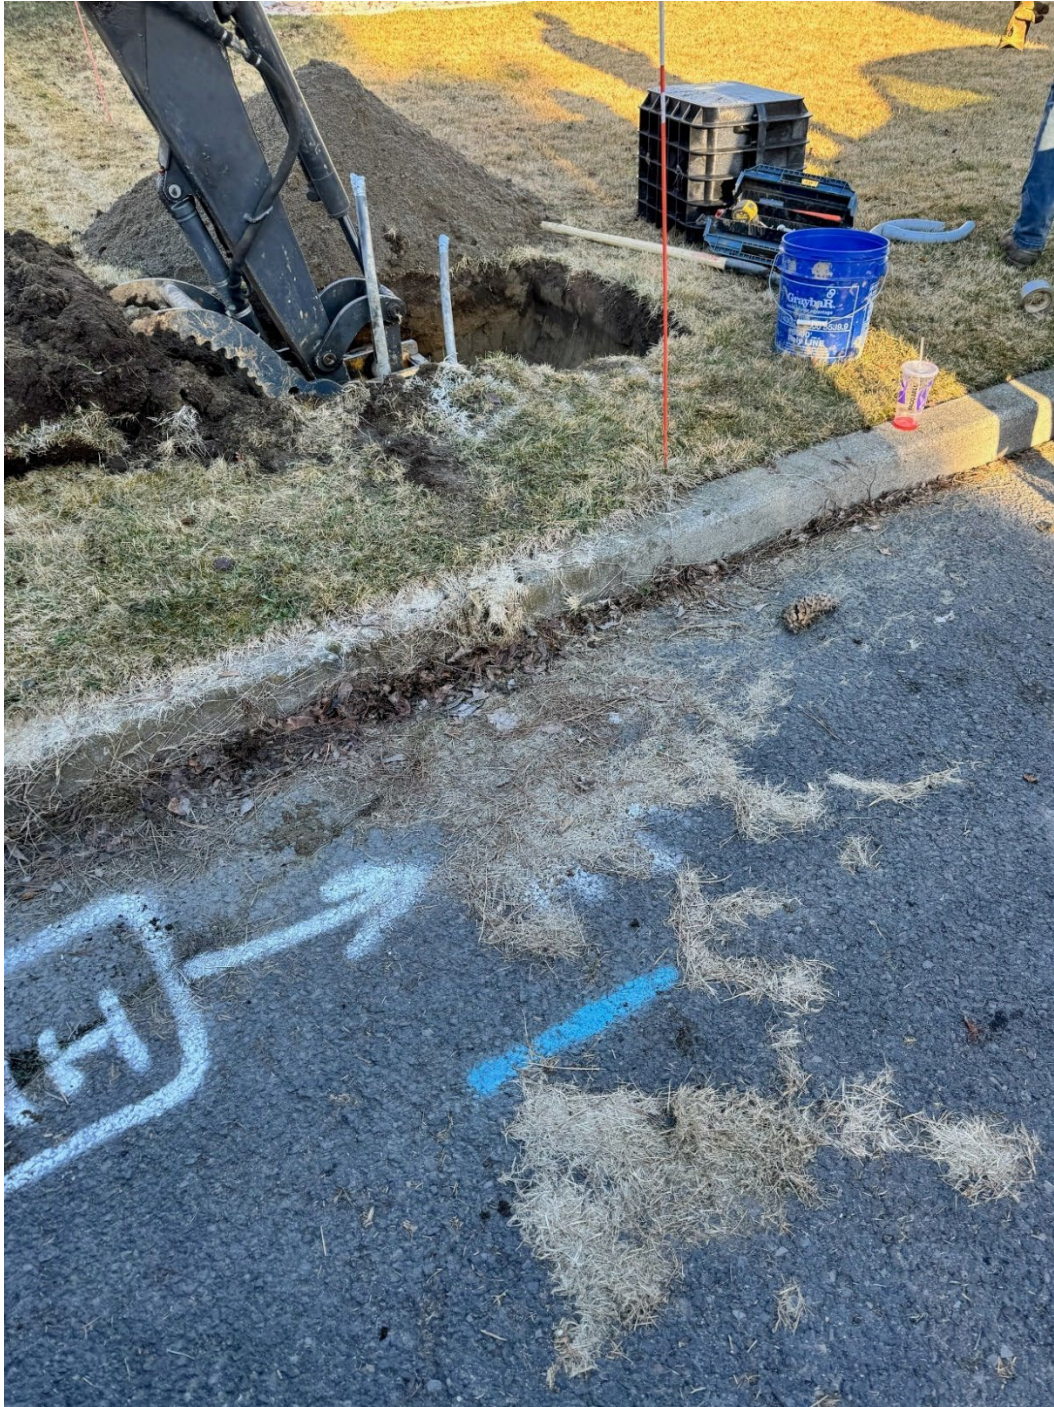
Figure 4 another picture of no locates.
