INTRODUCTION

I At-grade railroad crossings are inherently dangerous.¹ Once the Cliffside Drive railroad crossing is converted to a quiet zone—meaning freight and passenger trains will no longer sound horns to warn of their approach—supplemental safety measures will be necessary to continue to ensure the safety of roadway users and train crews.

13 3 The Commission should grant the County's petition to modify the grade
14 crossing at Cliffside Drive, in part, as follows:

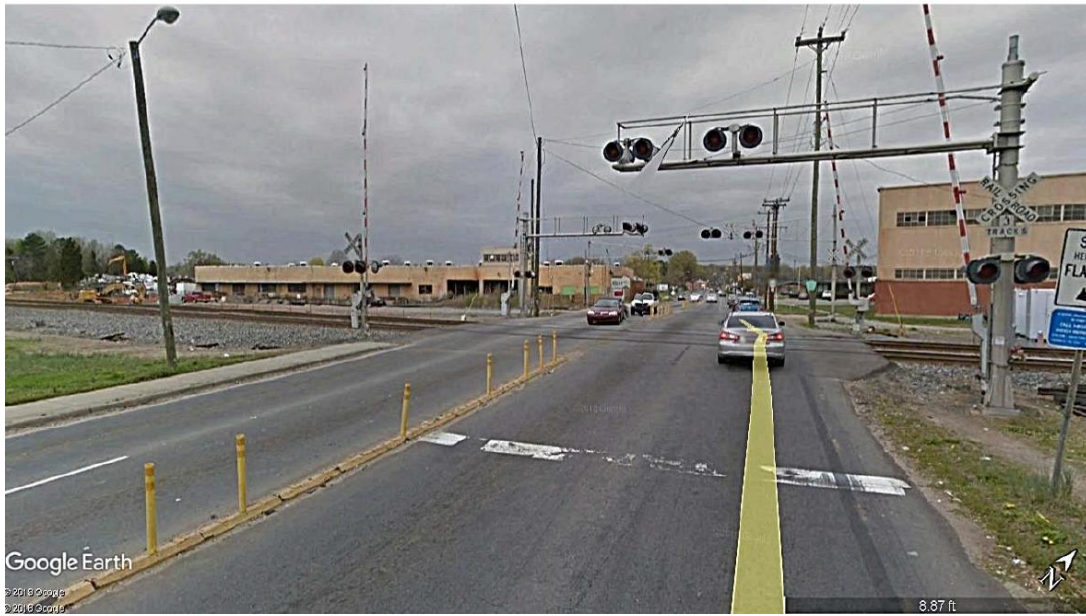
3 WUTC DOCKET: TR-180466 Exhibit DA-14
4 EXHIBIT: DA-14
5 ADMIT W/D REJECT

1 measured has had significant issues with broken channelization markers since the
2 initial data set was gathered.⁴⁵

9 25 BNSF's Manager Public Projects, Steve Semenick, has "frequently seen"
10 missing channelization paddles at railroad crossings throughout Washington State,
11 some of which have been in disrepair since 2017.⁵⁷ Both the Vancouver crossing
12 identified as an example in the County's quiet zone application, and the crossing used
13 by the FRA to set its risk reduction ratings, show broken channelization paddles on
14 Google Earth.⁵⁸
