**EXHIBIT NO. ___(SML-6)
DOCKET NO. UE-11___/UG-11___
2011 PSE GENERAL RATE CASE
WITNESS: SUSAN MCLAIN**

**FIFTH EXHIBIT (NONCONFIDENTIAL) TO THE
PREFILED DIRECT TESTIMONY OF
SUSAN MCLAIN
ON BEHALF OF PUGET SOUND ENERGY, INC.**

Sedro Woolley—Horse Ranch 230 kV Transmission Line

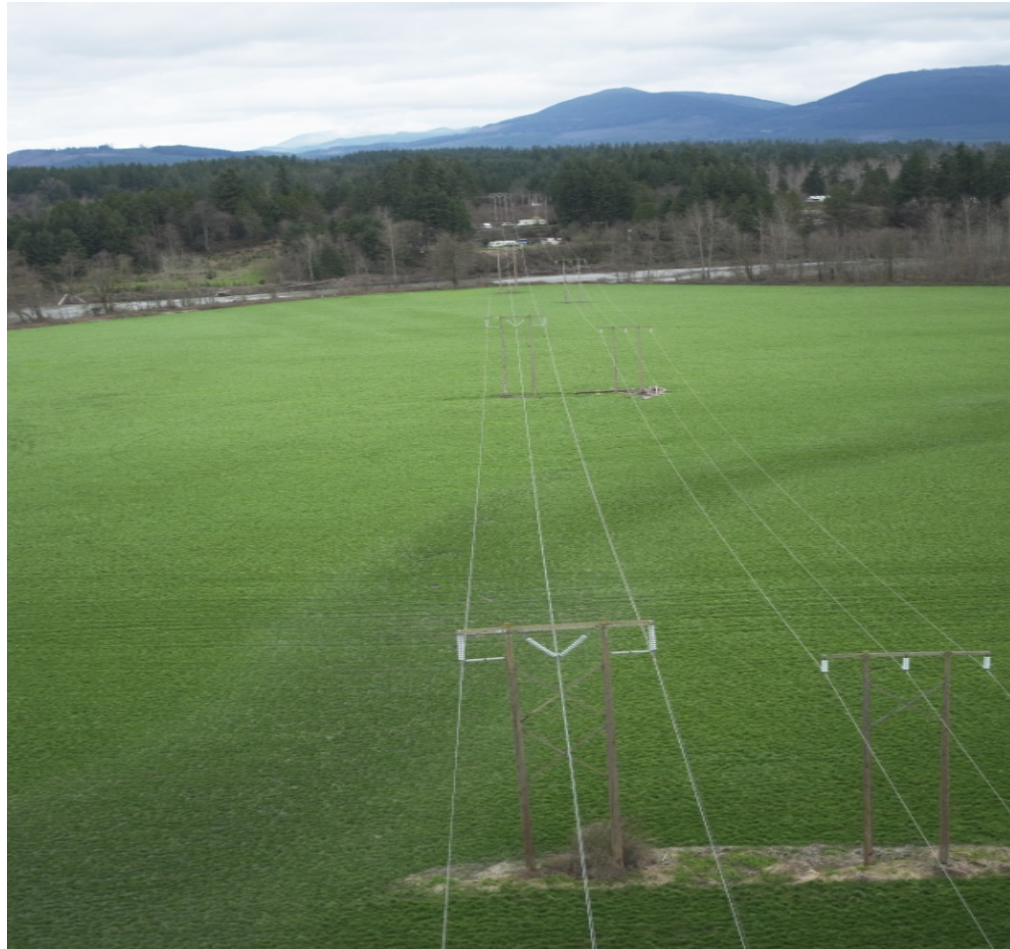
- 1.1 *Figure 5-1* shows a PSE transmission line that needed to be upgraded. The transmission line crosses the Stillaguamish River in unincorporated Snohomish County and was built of H-frame wood pole construction.

- 1.1.1 To cross the Stillaguamish River, PSE initially intended to use a design with three 90-foot steel poles having the poles directly embedded in the ground. It was determined that the line crosses the Channel Migration Zone of the Stillaguamish River.
- 1.1.2 Snohomish County required the Company to complete a Channel Migration Zone Analysis and a 100-Year Scour Analysis of the portion of the Stillaguamish River where this project would be constructed.

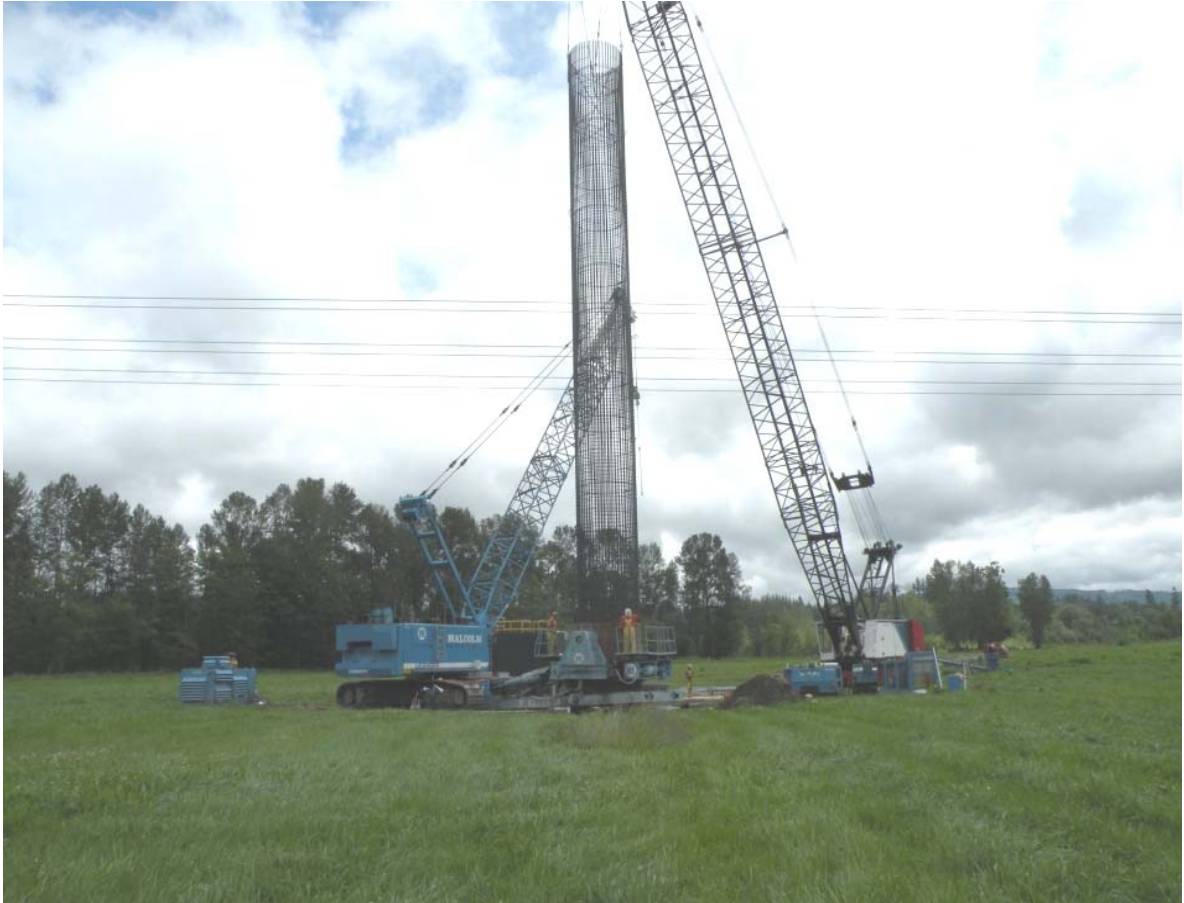
- 1.4 *Figure 5-2* shows a foundation cage that was inserted into the ground to house the concrete foundation for one of the 120-foot steel double circuit poles.

- 1.3.3 The PSE planning team believed that the 145-foot pole design would be more difficult to maintain, was not aesthetically pleasing, and would be rejected by nearby landowners, so PSE proposed an alternate design to the County. The County ultimately approved the use of two 120-foot double circuit steel poles installed on 70-foot and 60-foot foundations.

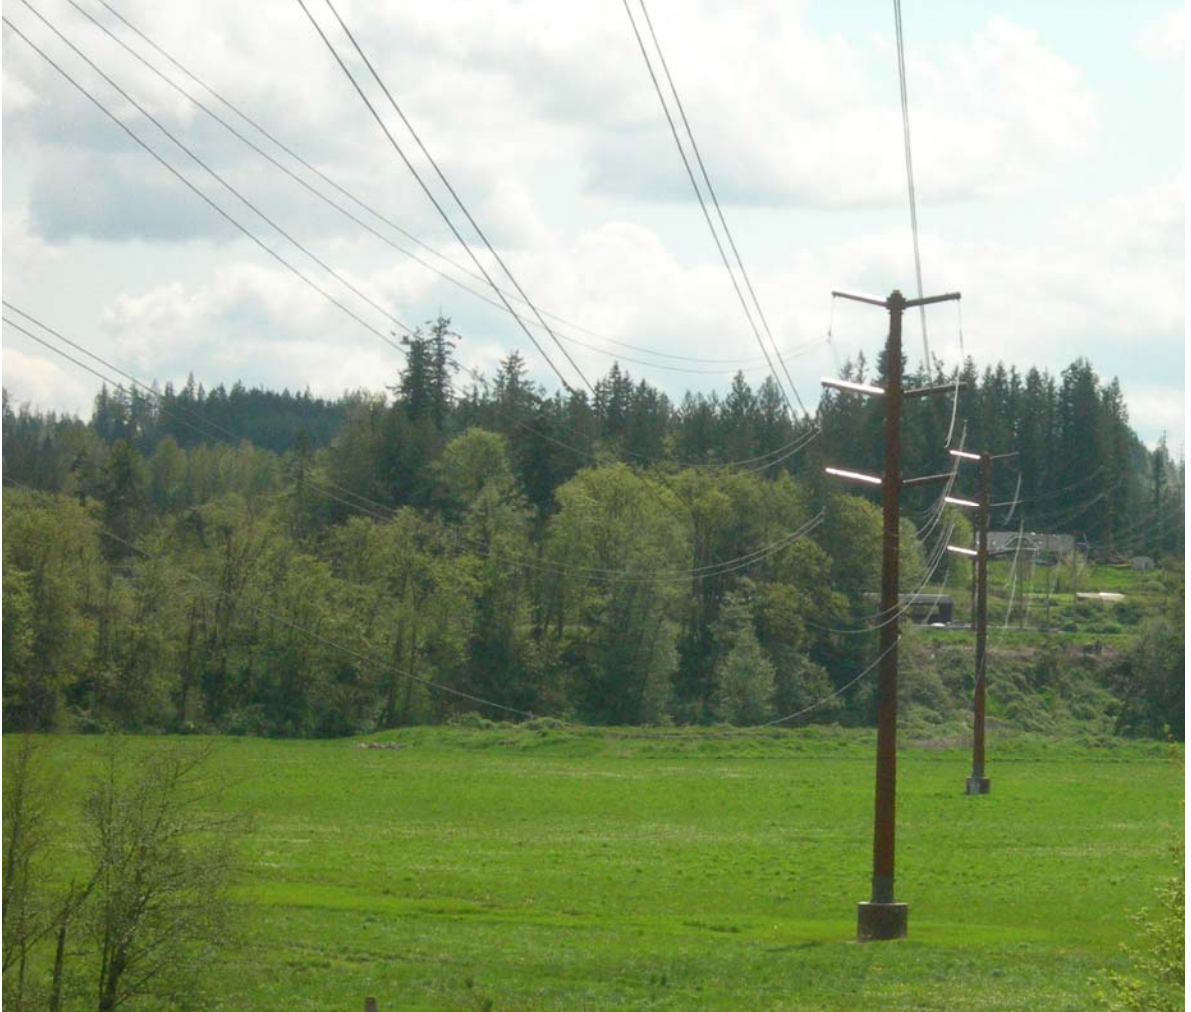
- 1.5 *Figure 5-3* shows the poles in the completed line segment as it crosses the Stillaguamish River.
