RE: Docket No. UE-051090, Commitment Wa25  
Report of Lightning Protection Study -- Kraft Substation and Wallula Substation

Item 3 - Prepare an engineering study analyzing the cost of installation of adequate lightning protection to the 69 kV sub-transmission system that is interconnected to the "Kraft Substation"

Item 4 - Prepare an engineering study analyzing the cost of installation of adequate lightning protection to the 230 kV transmission system that is interconnected to the "Wallula Substation"

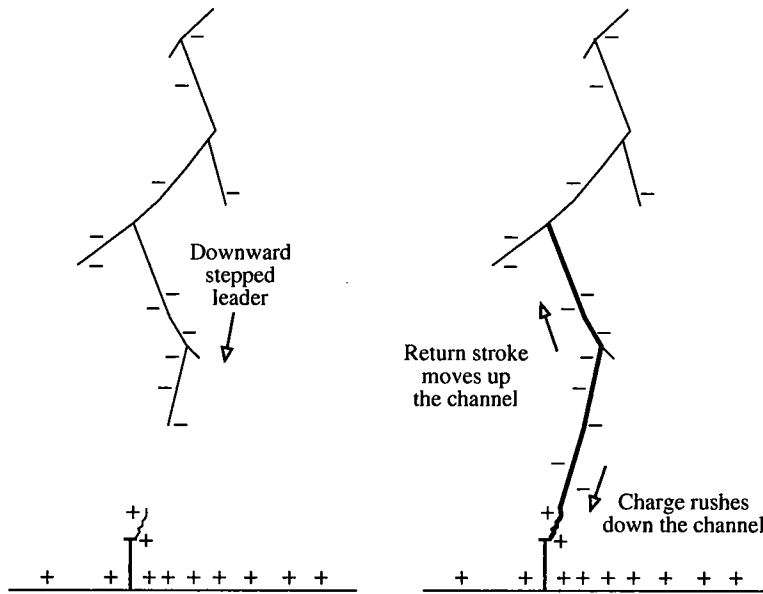
Lightning is the electric breakdown of the air from high electric fields generated when electric charge separates within a cloud. Lightning may flash within a cloud, from one cloud to another, or from the cloud to the ground. Transmission lines are only affected by cloud-to-ground lightning. In the normal scenario, charge separates within a thundercloud—the upper portion becomes positively charged and the lower portion becomes negatively charged. The ground just underneath the cloud becomes positively charged (being attracted to the negatively charged lower portion of the cloud). The lightning breakdown begins in the lower portion of the cloud. The air breaks down in steps called *stepped* leaders. Each step is about 150 feet (50 meters) with pauses of about  $50 \mu\text{s}$  between steps. The stepped leader may fork and form branches that each progress towards the ground. As the stepped leader progresses closer to the ground (see Figure 2-1), more charge is lowered closer to the ground. More positive charge collects on the earth in response—short upward leaders extend to meet the downward negative stepped leader.

**Figure 2-1**  
**Cloud-To-Ground Lightning**

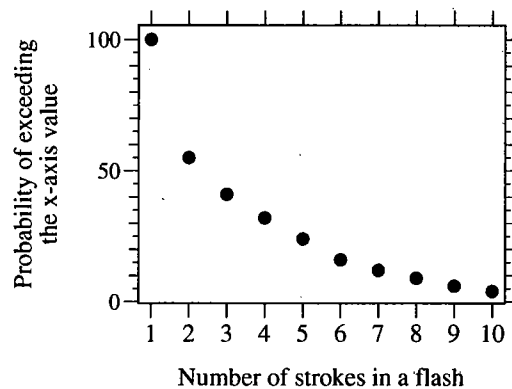
More than half of cloud-to-ground lightning flashes are composed of more than one stroke (see Figure 2-2). A quarter of them have at least four strokes. The subsequent strokes usually have less current than first strokes, but the rate of rise of current is higher (important for the inductive voltage rise,  $Ldi/dt$ ). Subsequent stroke characteristics are thought to be independent of the first stroke.

**Figure 2-2**  
**Number of Strokes in a Flash**

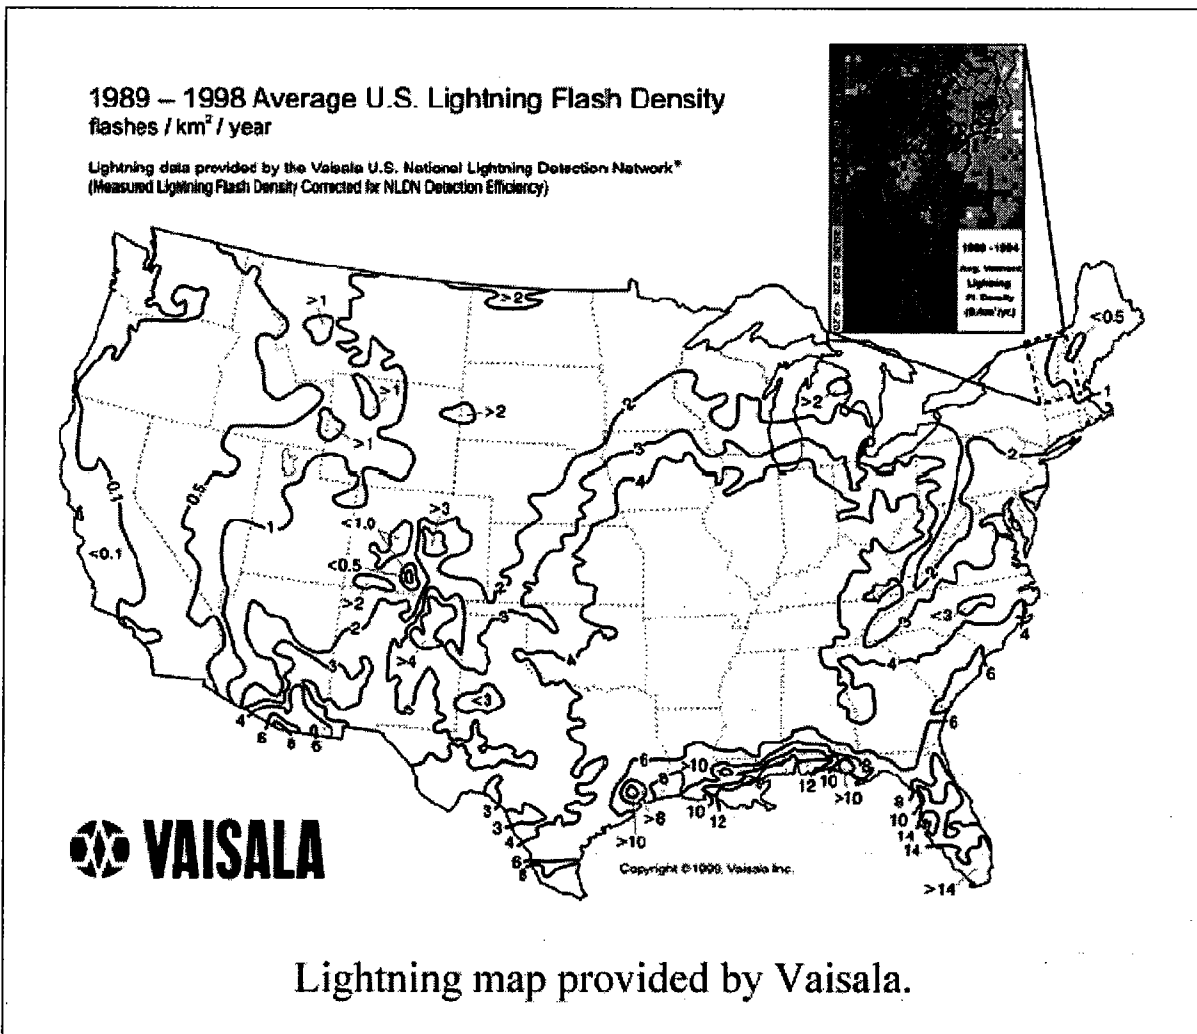
intensity, direction, and location helps determine the number of crews to call-up and where to send them. Maps generated from lightning detection networks of *ground flash density* (GFD or  $N_g$ ) are the primary measure of lightning activity. Figure 2-3 shows a ten-year ground flash density contour map of the United States from the US National Lightning Detection Network (NLDN), which has been operating since before 1990.

Figure 2-3  
Ground Flash Density from the United States National Lightning Detection Network

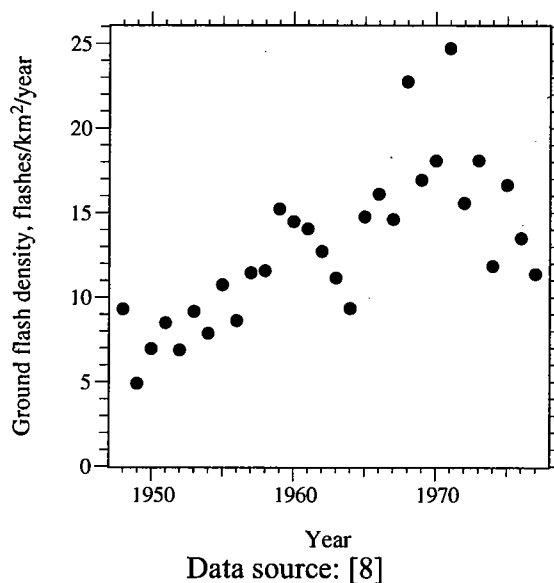
Lightning is highly variable. It takes several hundred lightning flash counts to obtain modest accuracy for an estimate of the average flash density. A smaller geographic area requires more measurement time to arrive at a decent estimate. Similarly, a low-lightning area requires more measurement time to accurately estimate the lightning. Standard deviations for yearly measurements of lightning activity range from 20 to 50% of the mean [7]. Figure 2-4 shows the variability of ground flash density in a high-lightning area. Lightning and storms have high variability, but it's not completely random. Lightning and weather patterns may have cycles that last many years.

**Figure 2-4**  
**Estimated Annual Ground Flash Density for Tampa, Florida Based on Thunderstorm-Hour Measurements**

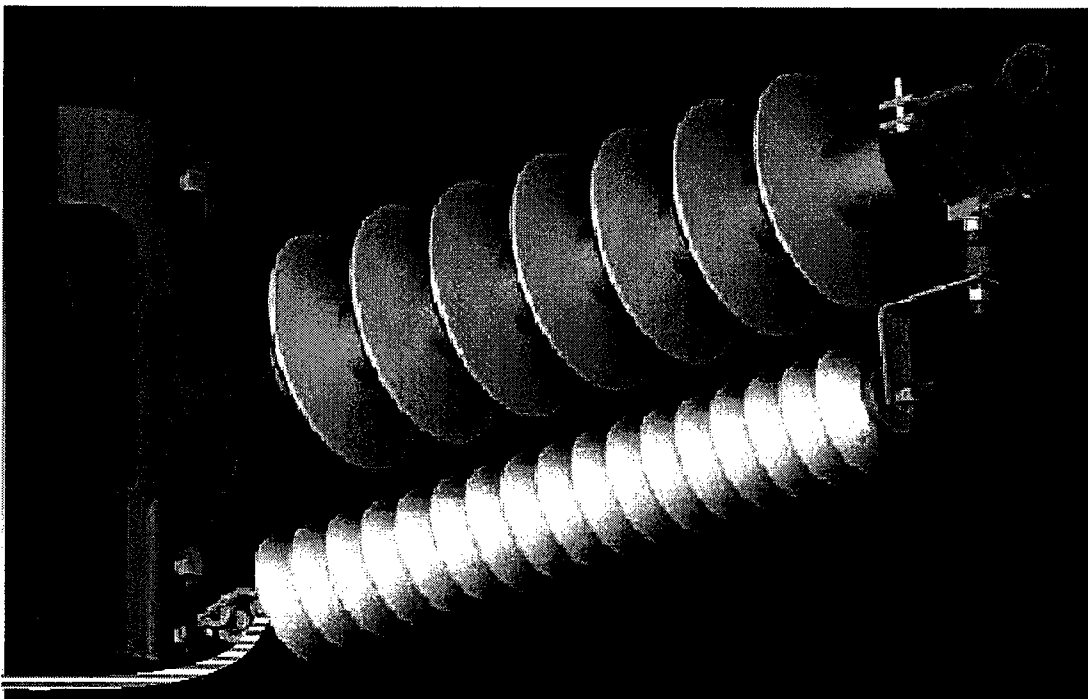
The main voltage rating system for Transmission Line Surge Arresters (TLSA, see Figure 2-5) is Maximum Continuous Operating Voltage (MCOV). As the name implies, the MCOV is the maximum line-to-ground, power-frequency voltage (RMS) that can be continuously applied across the arrester. Voltages above the MCOV will cause the arrester to change impedance and absorb excessive energy from the system. Depending on the overvoltage and length of time the voltage is applied, arrester life might be shortened, or the arrester might be completely destroyed. Arrester manufacturers specify both the MCOV and the length of time voltages in excess of the MCOV can be applied without damaging the arrester. Typical TLSA can withstand 150% of the MCOV for 5 seconds and 110% of the MCOV for 2000 hours with no loss of arrester life.

**Figure 2-5**  
**Transmission Line Surge Arrester in parallel with an Insulator**

To prevent insulation flashover, Transmission Line Surge Arresters (TLSAs) are designed to limit voltages between phase conductors and the tower structure. TLSAs will prevent lightning-related flashovers in both high footing resistance areas (backflash prevention) and poorly shielded designs (shielding failure prevention), provided they are selected and located properly. Reducing the ground impedance on a transmission line that is experiencing many shielding failures will not help improve the lightning performance of the line. Shielding failure flashovers can be prevented only by improving shielding or by installing TLSAs. On transmission lines up to 230 kV, TLSAs have been applied in the United States for many years with excellent results.

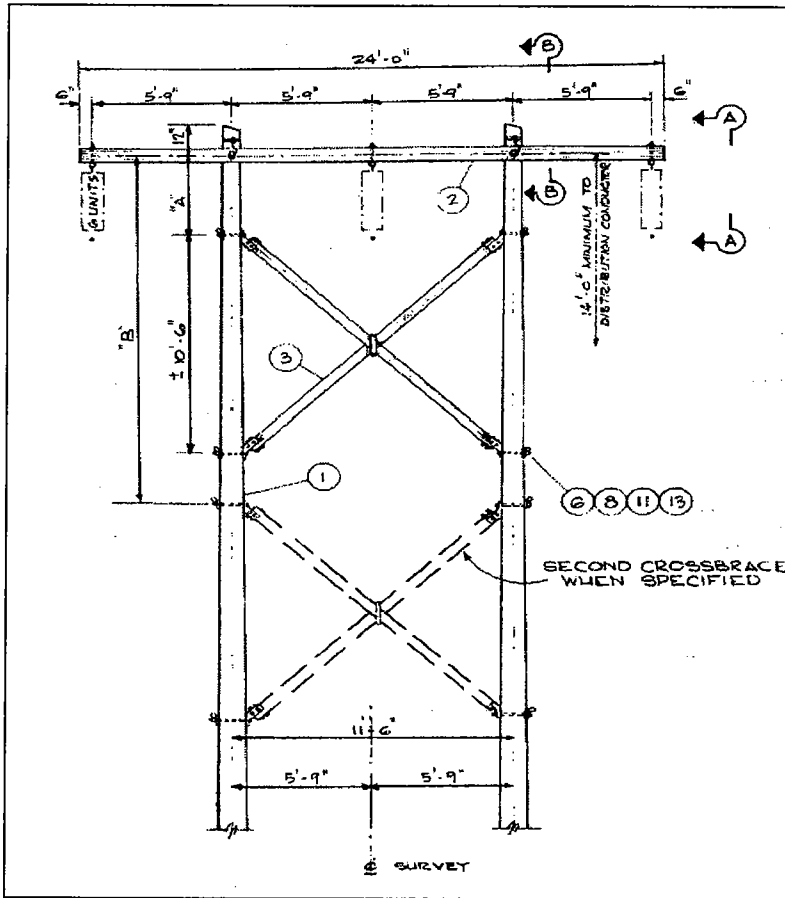
Figure 3-1: "HSL" Pole Structure

Starting Sub	Ending Sub	Typical Towers
Cascade Kraft	Walla-Walla	HSL
Walla-Walla	Cascade-Touchet	HSL
Cascade Kraft	Touchet	THP- Tower 1-94 HSL- Tower 95-163
Touchet	Walla- Walla	THP
Cascade Kraft	Pasco	A – Tower 1-192 THPA – Tower 193-365

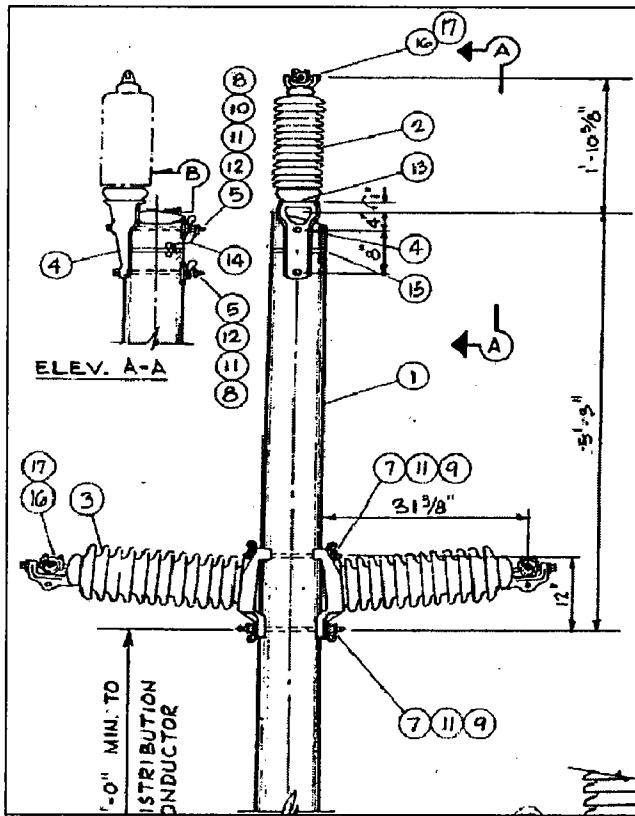
Figure 3-2: "THPA" Pole Structure

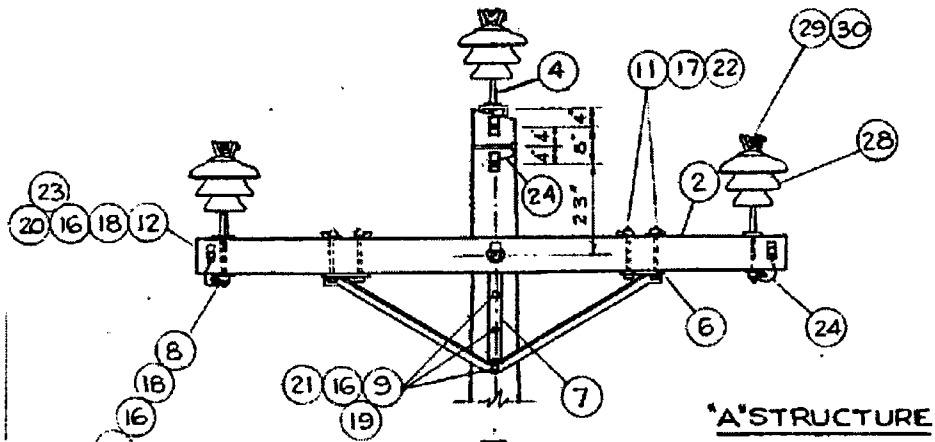
Figure 3-3: "A" Pole Structure

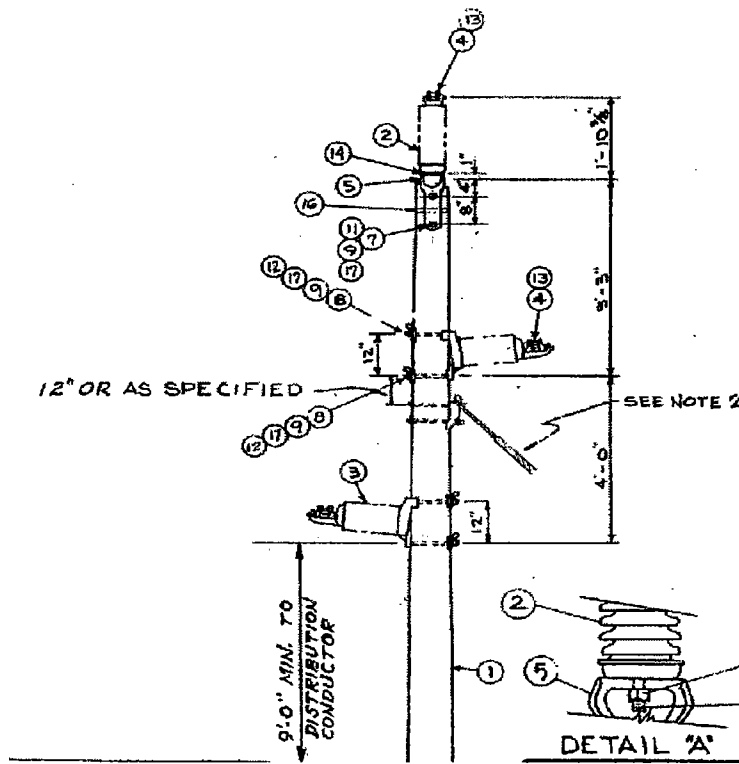
Figure 3-4: "THP" Pole Structure

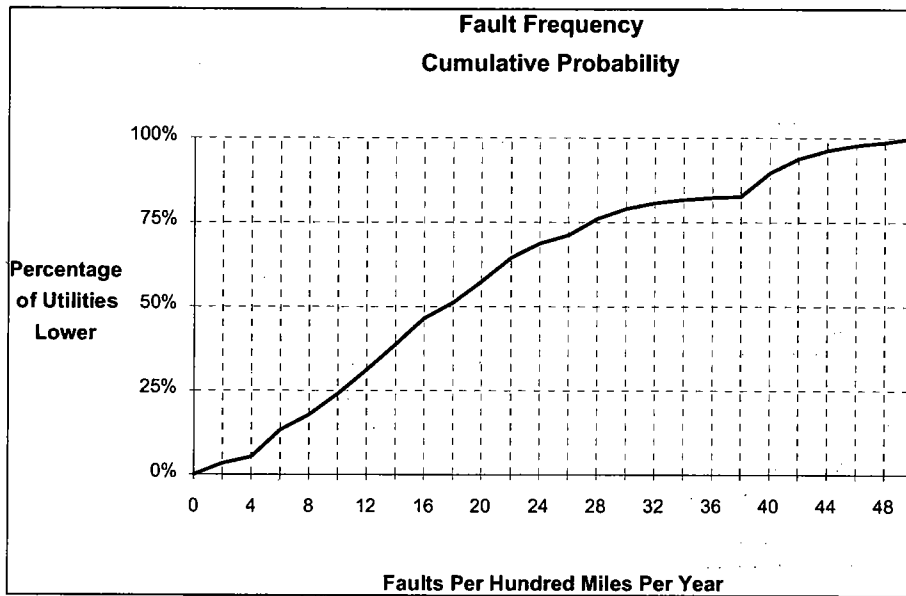
The configuration of the system is such that almost all of the flashovers are the shielding failure kind arising out of the direct strikes on the phase wires. The number of resultant lightning faults (3.85 per 100 mile) in the 69kV system that are likely to result in a year is still low compared to typical 69 kV line fault rates as documented in a 1992 transmission survey that was carried out by EPRI in 1992 (Figure 4-1). 16 utilities in U.S. responded in this survey that covers nearly 55,000 transmission line miles. The median fault rate for 46-69 kV lines was about 18 faults/100 miles/year.

**Figure 4-1**  
46-69kV Fault Performance Survey Results

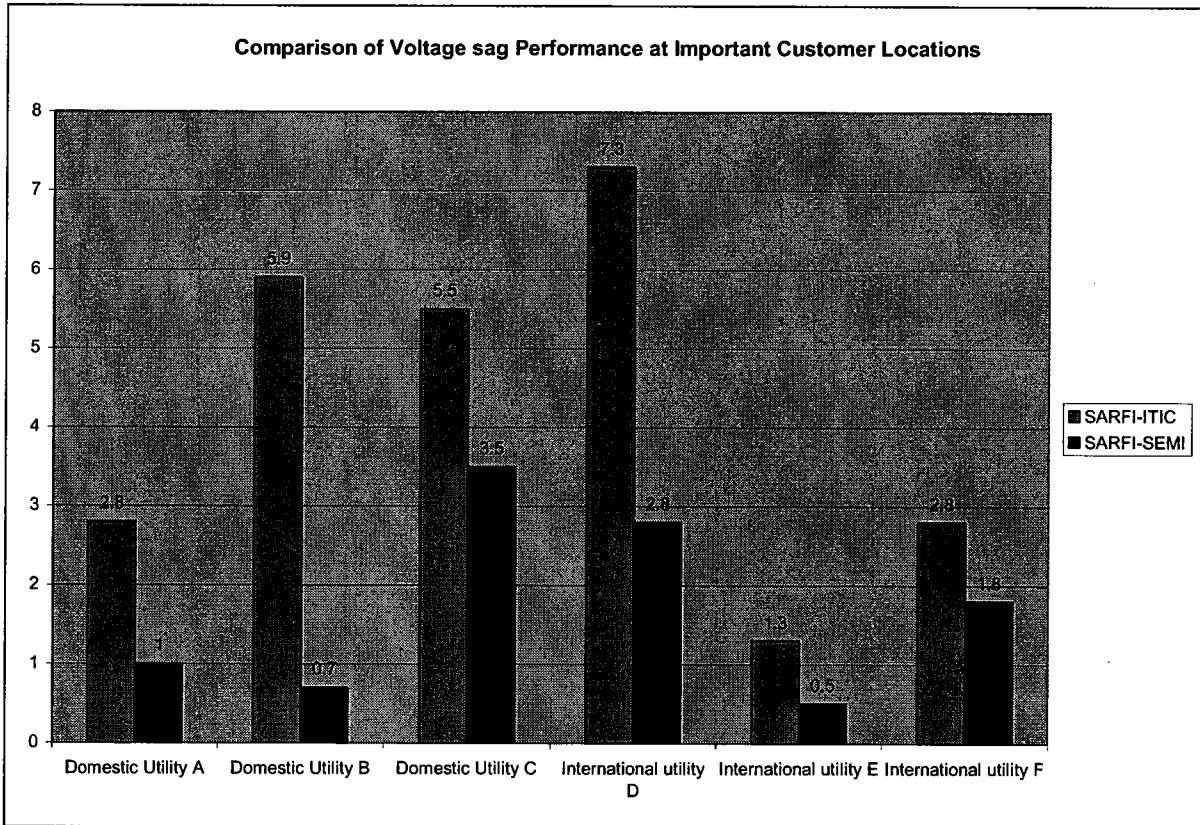
It is also helpful to understand typical voltage sag performance levels for critical customers typically supplied from transmission and subtransmission systems. Figure 4-2 provides results of a survey that was performed of utilities that have supplies to critical customers like semiconductor industry facilities.. It is evident that SARFI-ITIC levels in the range of 2-7 events per year can be achieved at these customer supply points.

**Figure 4-2**  
**Comparison of SARFI Performance for Critical Customer Supply Systems around the World**

It is apparent from the worldwide survey results about the fault performance and voltage sag performance of the critical customer supply systems that the fault performance associated with lightning events for lines directly supplying Cascade Kraft should not result in an excessive number of events at the plant. This needs to be considered in combination with all other possible causes of faults on these lines.

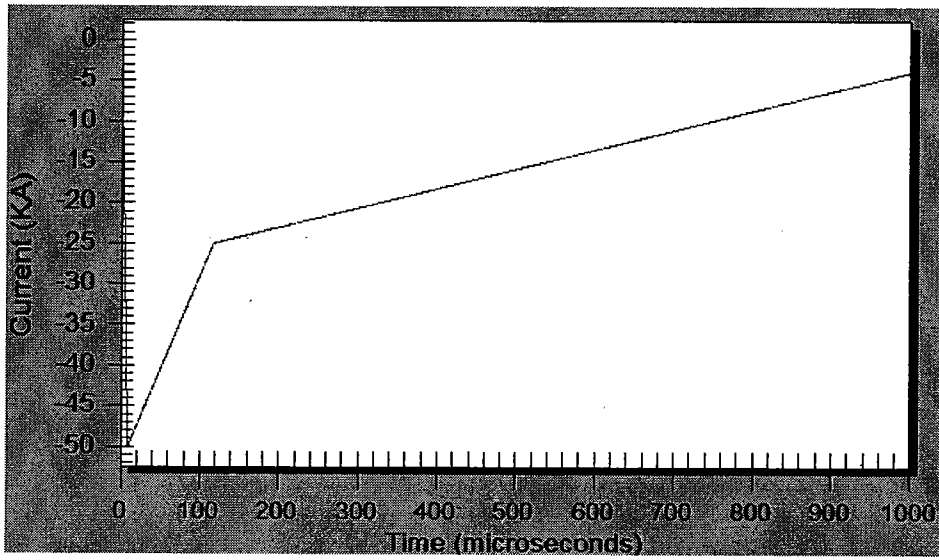
In order to understand the failure rate of the arresters for the solutions discussed in preceding section, the impact of one stroke on a tower having HSL configuration is explained here. It is assumed that lightning stroke hits the phase conductor at Tower 10. The lightning stroke waveform that has been used for the analysis is shown in Figure 4-3 and the parameter values are given in Table 4-9. The failure probabilities of the arresters associated with this lightning stroke are given in Table 4-10.

Figure 4-3  
Stroke Current Waveform
