Quality Fence Builders installation of security fence over primary conductor at 6520 S. 228th St. Kent

Search and Status

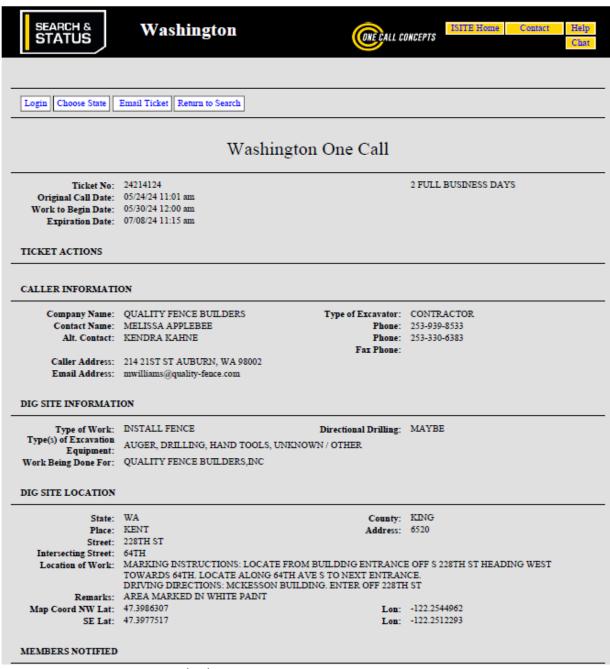
- Locates were called in 5/24/24 11:01 am
- Work begin date 5/30/24
- Locates paint was put down 6/10, 11 days past the work to begin date.
- White Paint marks cannot be confirmed or denied due to the late nature of the ticket and proceeding weather and landscaping activities.
- ELM documented phone calls to the primary phone number (below).
- The fence company states they have no record of receiving voice mail messages from the tech.

- There is no evidence that the secondary phone number was used by ELM to reach the company.
- PSE has no information that the building owner or fence company reached out to inquire about power structures and easements on the property despite multiple above ground switch gear and concrete vault lids visible.
