M&L Construction vs Avista  
Case 24-077  
4606 N Hartley Spokane Wa

### Avista Supporting Documentation Narrative

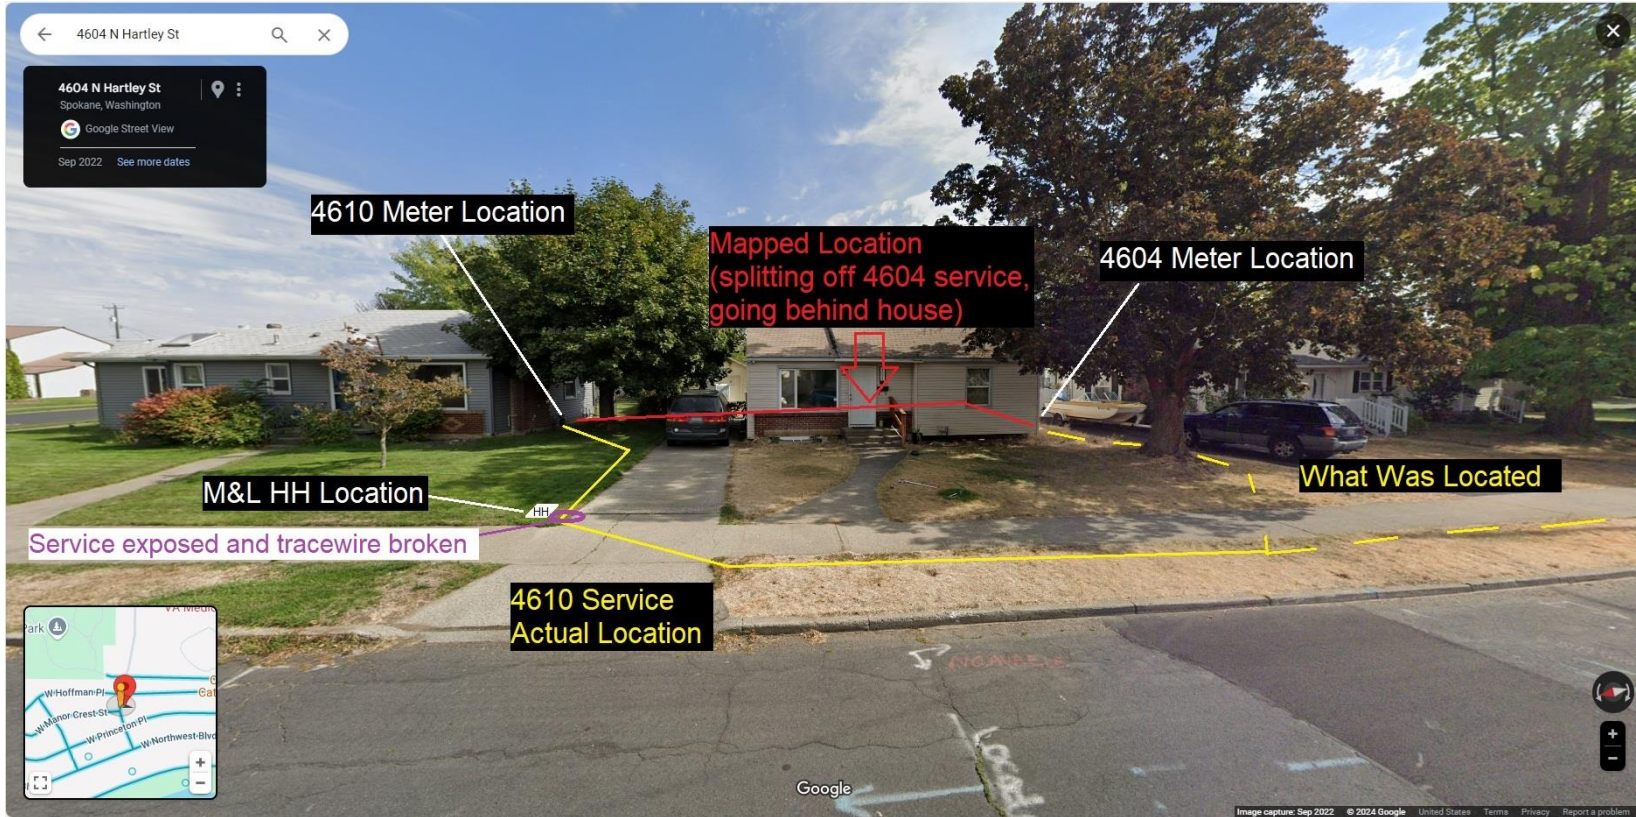
The gas line M&L Construction discovered was incorrectly mapped in Avista's GIS system. Our investigation identified the line as the gas service for 4610 N Hartley. Initial mapping during the locate and excavation suggested that this service was a split (twin) with 4604, extending around the back of 4604's house and away from the excavation area. ELM hooked-up to the 4604 gas meter with the understanding that the 4610 service would be accounted for through that hook-up location. Through further locating efforts and verification with original installation records after M&L's discovery, we accurately determined the service's correct location and updated the mapping to reflect this accurately. Avista has now adjusted its locating procedures and expectations to include verifying split services. This change will help ensure mapping accuracy and prevent potential errors that could lead to unlocated facilities.

### Sketch/Explanation of Incident

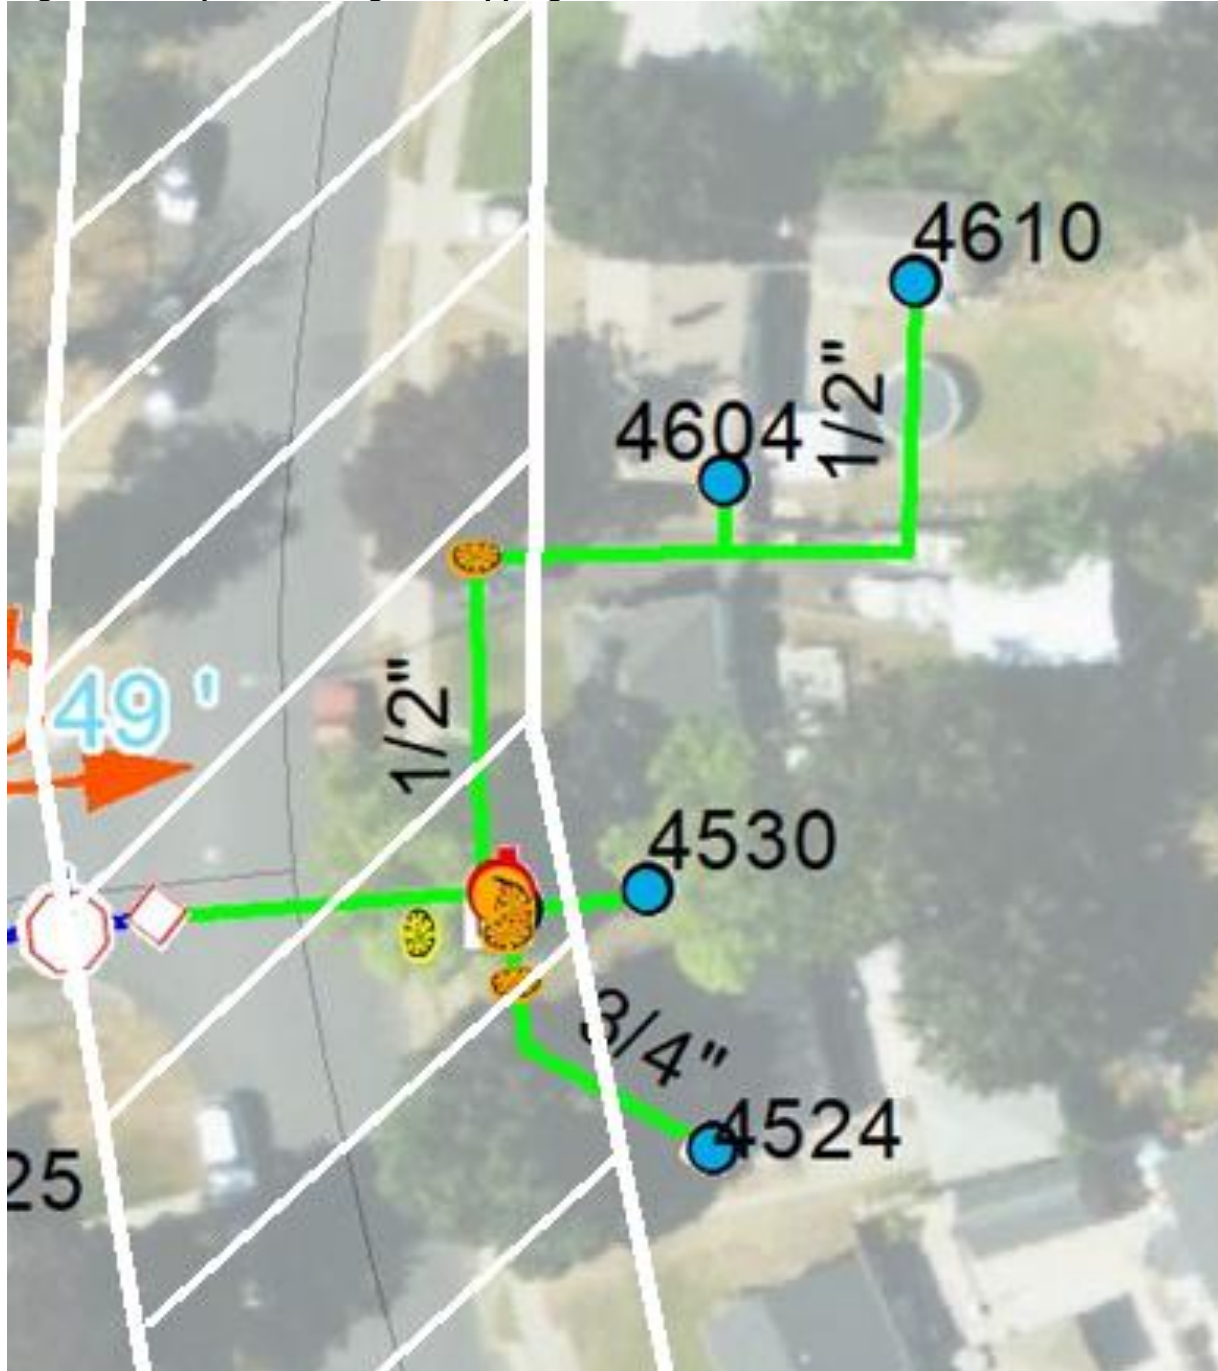
### Dig Area Compared to Original Mapping
