HEATHER L. ROSENTRATER

REPRESENTING AVISTA CORPORATION

# Avista Utilities Distribution Infrastructure Plan 2020

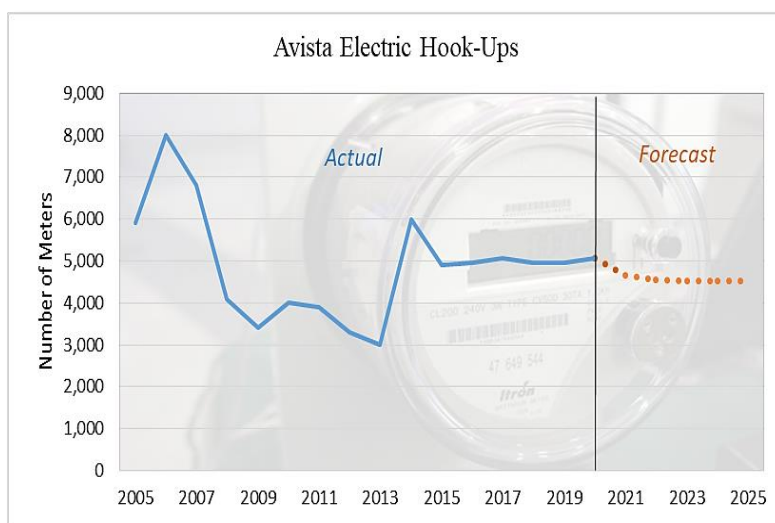
Figure 1. Electric Customer Growth

Avista has experienced relatively flat customer growth over the past few years, about 1% per year, as shown in Figure 1. Between 2005 and 2019, the Company has responded to an average of over 4,600 requests for a new residential electric service connection each year. For the current five-year planning period, Avista expects customer growth to continue at about 1% per year based on regional economic and population forecasts. On the commercial side, the Company connected an average of over 1,000 new commercial customers per year between 2005 and 2019, peaking in 2007 with nearly 1600 new commercial customers. Today we are expecting growth rates more in the range of 700 new commercial connects per year.

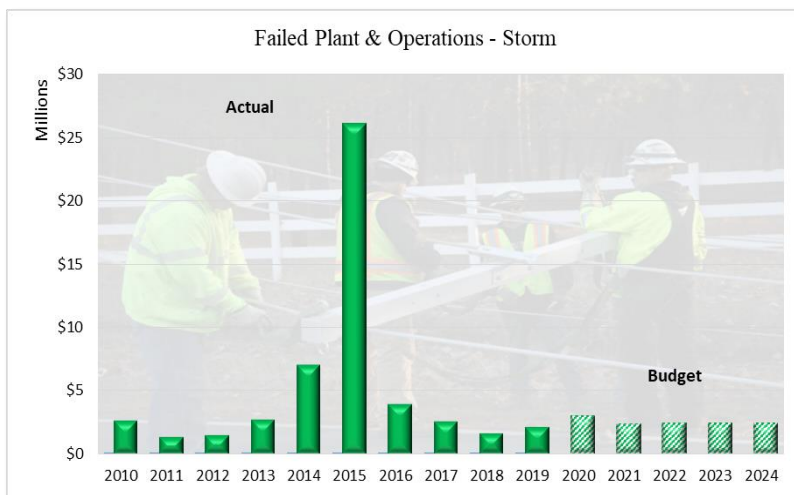
Figure 9. Capital Actual & Budget Expenditures: Storms

During this budget cycle the Company expects to spend about \$2.7 million on distribution storm repairs but, as can be imagined, this amount could vary substantially. As shown in Figure 9, one major event can have drastic impacts on Avista’s capital budget. For example, in 2015 a historic 100 year wind storm event rolled through the area. Hurricane force winds caused the greatest level of

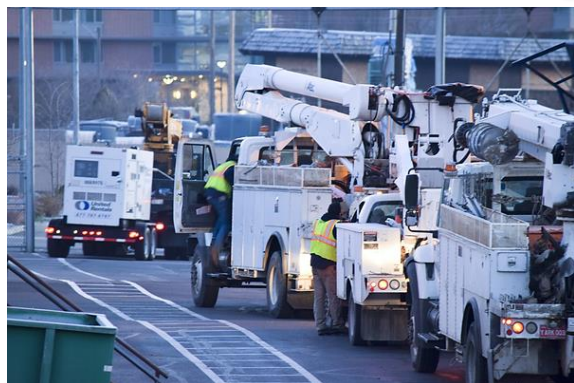
damage to Avista’s system ever experienced. At the peak of this storm, more than 180,000 Avista customers were without power, some for up to two weeks. It took nearly a year for the Company to complete permanent repairs on its infrastructure. This event cost nearly \$23 million in damage to equipment and facilities. Though this situation is not typical, such unexpected expenditures are always possible.

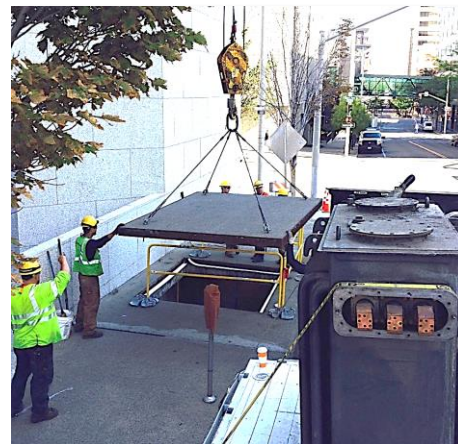
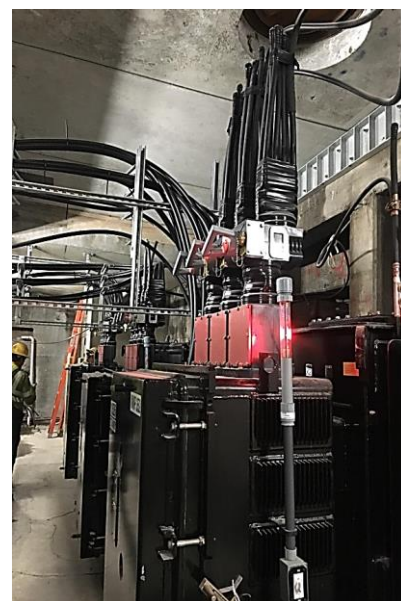
*Above & Below: Downtown Network Vaults*

The majority of the Network’s structural assets (such as manholes, vaults, and ducts) have exceeded their expected life and must be programmatically replaced in order to continue service. When this equipment fails, it can have a significant impact on downtown businesses as well as pose safety hazards for the public. The Company is in a state of constantly replacing old structural and electrical equipment while at the same time addressing requests from the city, county, and customers for service changes in addition to mitigating construction impacts on Company facilities and operations. These projects fall under the Asset Condition investment driver for the Downtown Network.

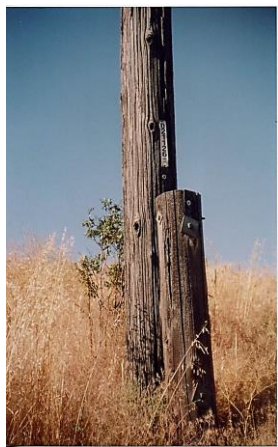
*Stubbed Pole*

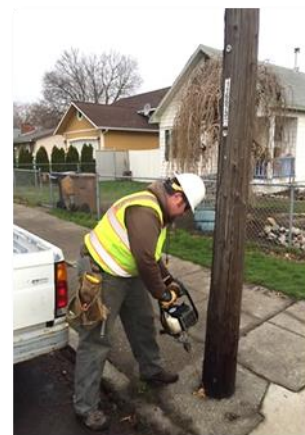
*Avista Wood Pole Inspection*

Avista’s distribution wood poles have an average lifespan of approximately 70 years as they are managed in the system today.<sup>9</sup> A key part of maintaining the wood pole population is Avista’s robust inspection program. The condition of each pole is assessed during this inspection to determine whether any issues

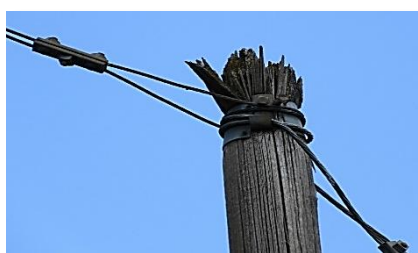
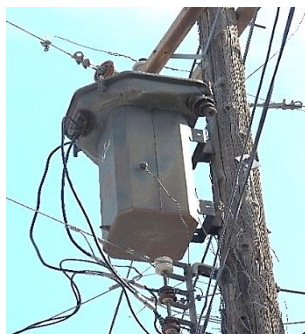
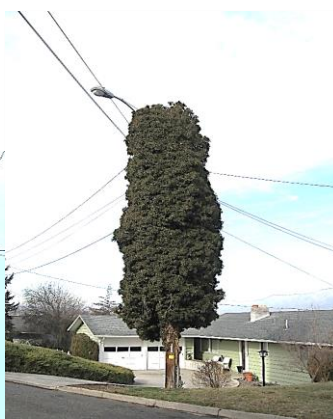
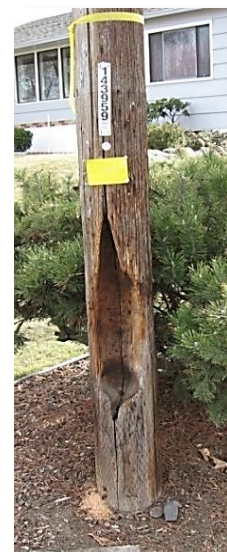
need to be addressed, rather than relying only upon only age information to categorize the health of the pole. The inspection process identifies damage from insects, animals, lightning, fire, decay, mechanical damage, equipment failure (such as a leaking transformer), unauthorized attachments, and other issues such as a broken guy wire, grounding, or soil concerns. Decay is the most common reason for pole failure and is detectable with proper inspection. Inspectors also assess components including transformers, ground, and guy wires. The capital investments made under this program cover the needed repair and replacement of poles and attached equipment that is identified during the inspections.

Types of Pole Inspection Issues Identified in Inspections

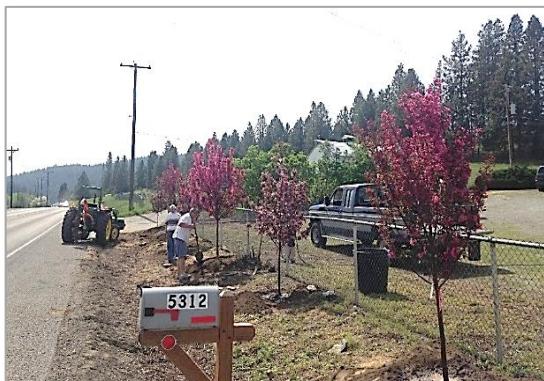
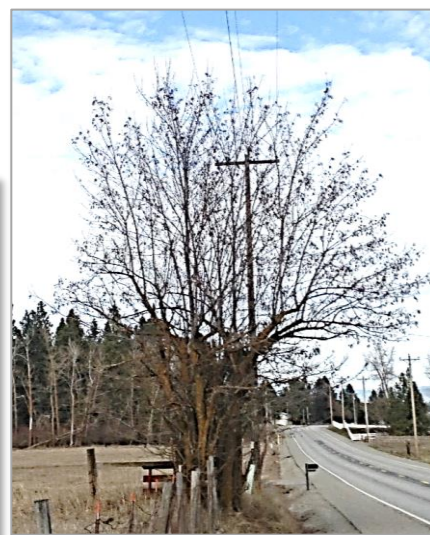
Above: Before Vegetation Management Work Begins  
Left: After Work is Complete

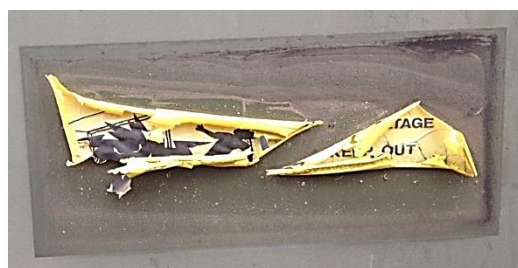
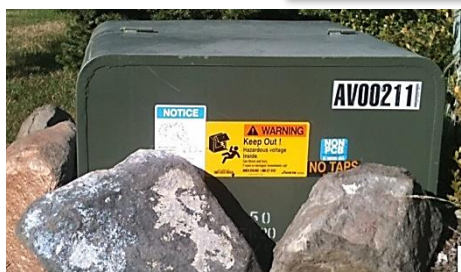
The second focus of this program is the physical security and integrity of the cabinets and associated mountings. Clearance violations such as the boulders shown in the photo on the left limit accessibility, especially in an emergency

*This program addresses required labeling such as the transformer decal above and access issues such as the boulders blocking access to the transformer on the left.*

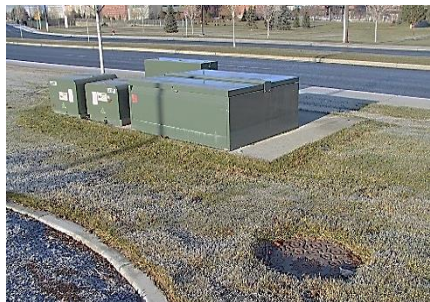
*Padmount Transformers*
