Re: September 2023 Monthly Progress Report
Administrative Settlement Agreement and Order on Consent for Removal Action
EPA Region 10 Docket No. CERCLA 10-2009-0255
Gasco Sediments Site Within the Portland Harbor Superfund Site

Attachment A Monthly Visual Monitoring Report for Pilot Cap Vicinity

Visual Observations Log Form

Project: NW Natural – Gasco

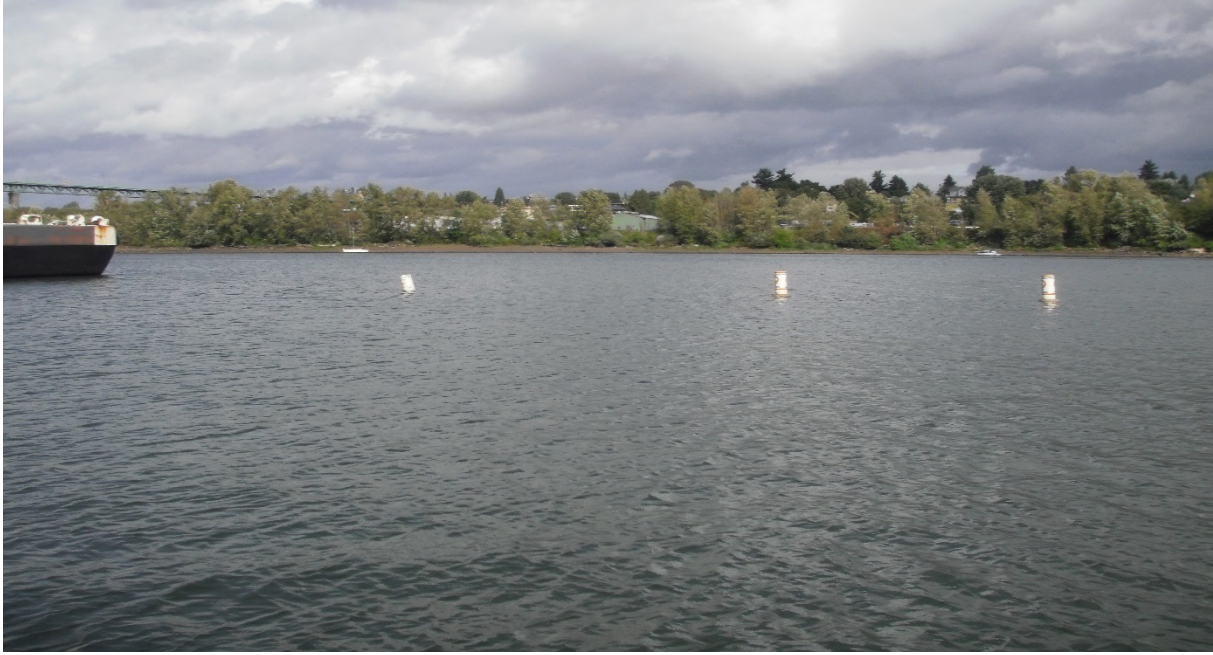
During the observation, a barge was moored at the Centerline Logistics (Centerline) ship dock. The Centerline containment boom is being managed along the dock face during the ongoing Gasco In Situ Stabilization and Solidification (ISS) Field Pilot Study. The sheen control boom at the Gasco/Siltronic property line has been temporarily reconfigured and replaced to support the ISS Field Pilot Study. The three buoys identifying the cap area to mariners were in place as installed. The positions of the warning buoys are shown in Photo 1.

Photo 1
Three Mariner Warning Buoys at Pilot Cap Area (9/26/2023)

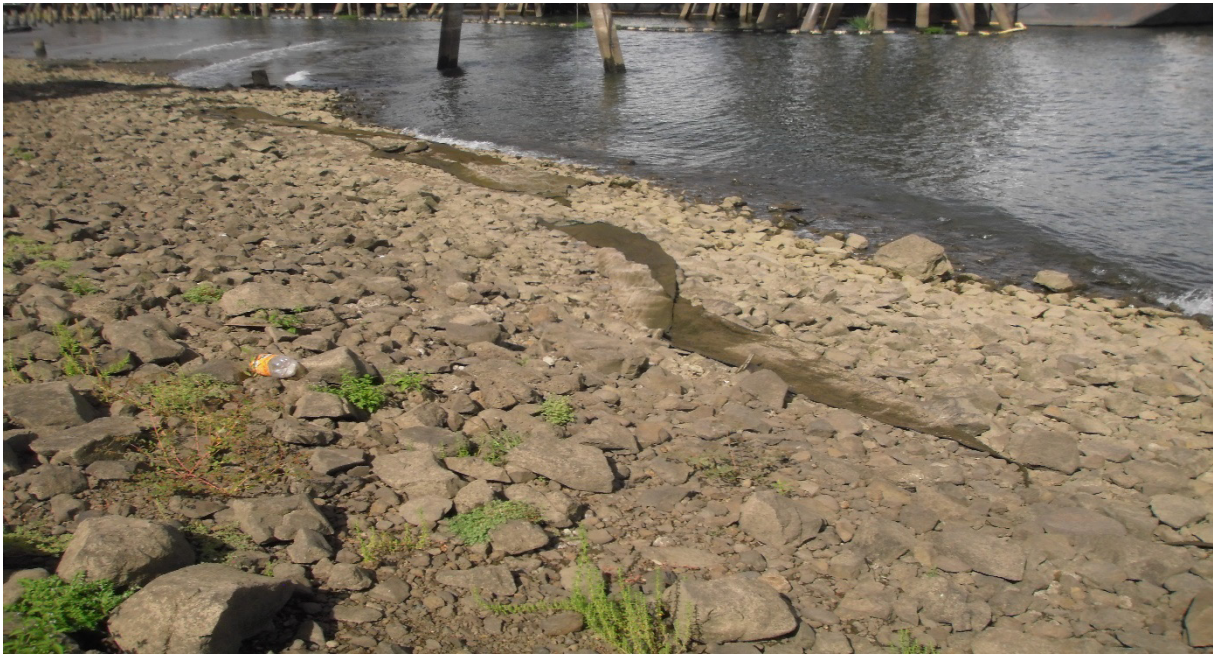
All exposed organoclay mat material segments were visible and out of the water (Photo 2). The visible, exposed segments of organoclay mat were in visually good condition.

Photo 2
Organoclay Mat Material at the Downriver Extent of the Pilot Cap Area (9/26/2023)

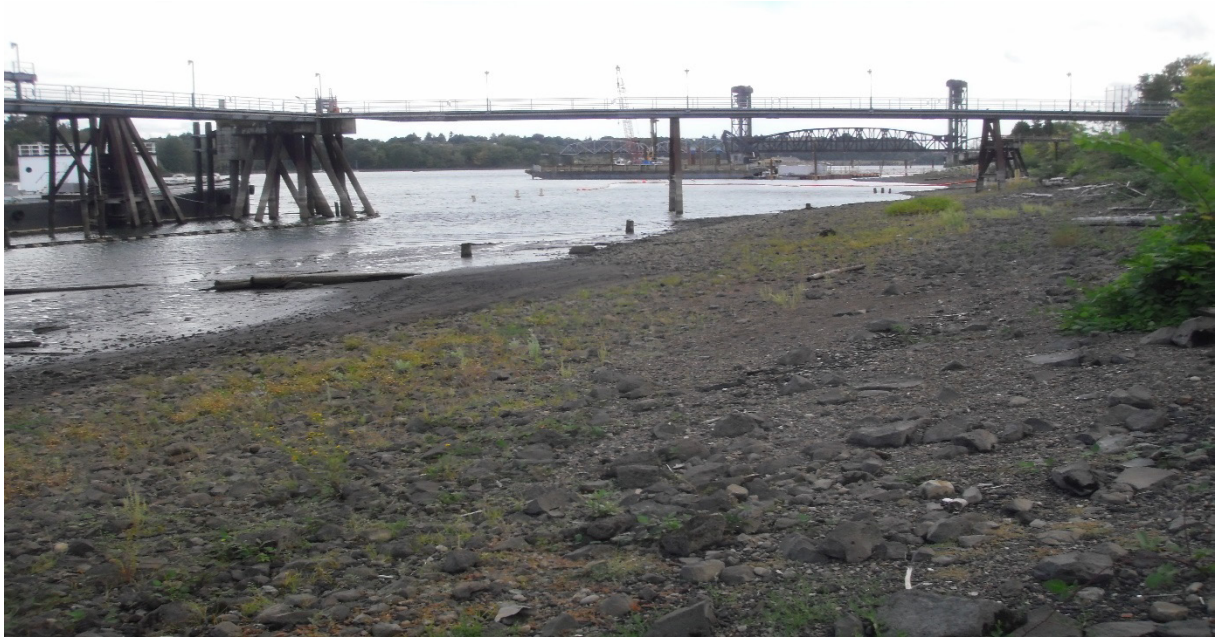
Photo 3 shows the water surface and shoreline immediately downriver of the sediment cap. No sheen was observed within the cap area.

Photo 3
Conditions Immediately Downriver of Cap Area Looking Upriver (from PZ-5 Location)
(9/26/2023)
