Compilation of Pedestrian Safety Devices In Use at Grade Crossings

Federal Railroad Administration

Prepared by the Office of Safety, Federal Railroad Administration

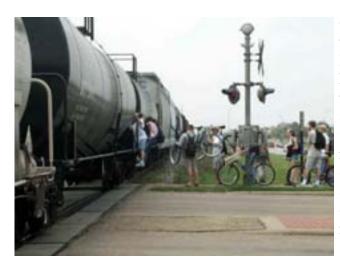
Obviously, the best safety devices in the world cannot overcome poor judgement. Examples such as illustrated here indicate the high value of law enforcement when coupled with safety outreach and education programs aimed at high-risk groups. At the same time, it is important for localities to work with railroads and transit operators to reduce excessive blocking of high-use crossings that are on known pedestrian routes, such as in college or university settings, or on access routes to sports facilities or fairgrounds.

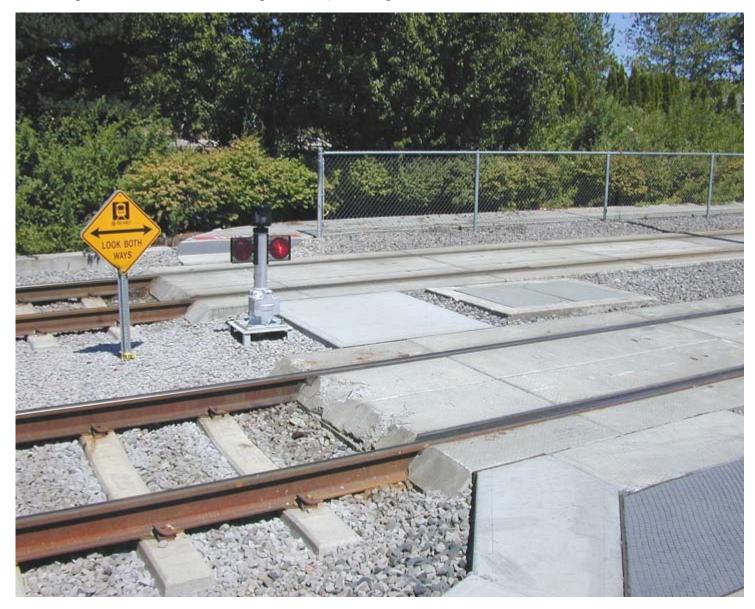
The intended pathway for pedestrians in this situation is clearly defined. A design drawing for this device, developed by Tri-Met, the light rail system in Portland, Oregon, is included on the next page.

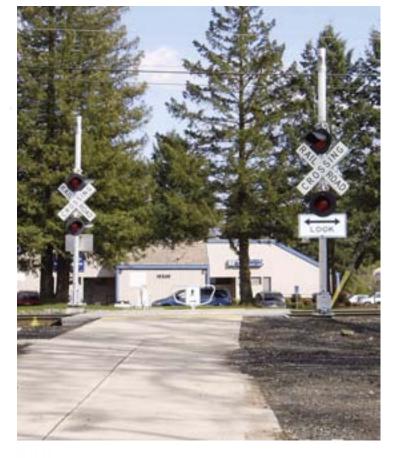
OAR 741-110-0030(3)(c) OAR 741-110-0040(4) FIGURE 9

Design Criteria

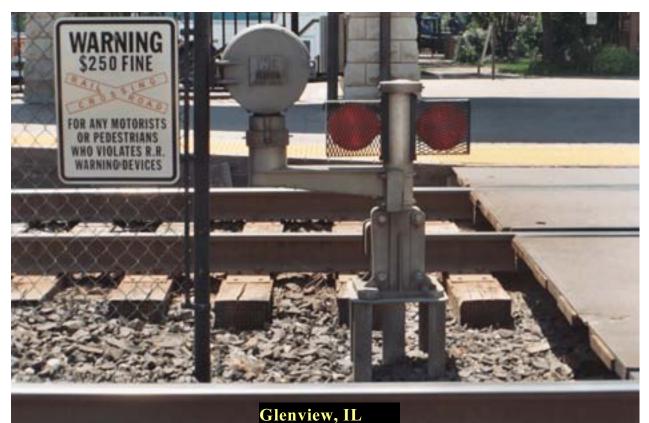
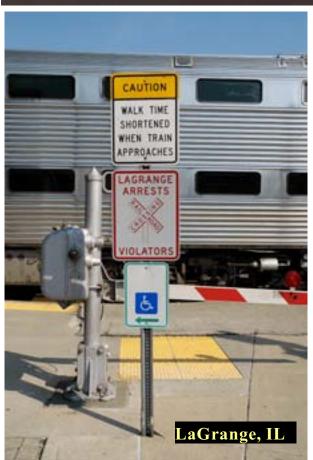
ABOVE: Glenview, IL, on Metra's Milwaukee District North Line, has established a \$250 fine for any pedestrian who violates railroad warning devices. Warning devices include both a bell and flashing light signals.

> LEFT: This signing is in place at LaGrange Road Metra station. The numerous pedestrian crossings in this area make tougher sanctions necessary to prevent tragedies.

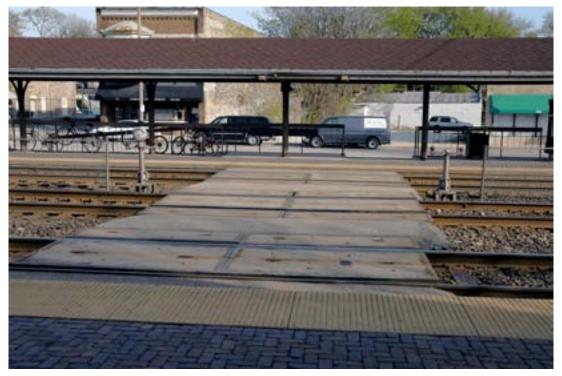
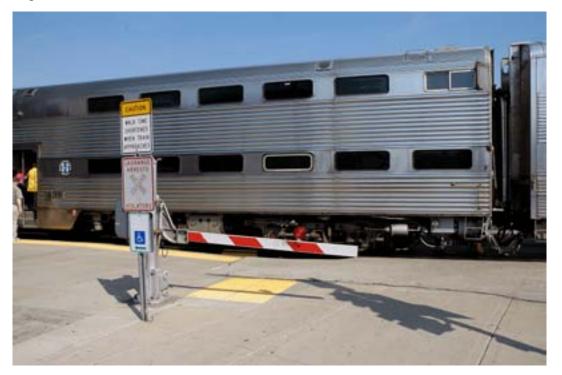
Stone Avenue Metra station (ABOVE) in LaGrange, IL features these pedestrian warning devices between inbound and outbound platforms. Short gate arms (BELOW) are used at the LaGrange Road station.

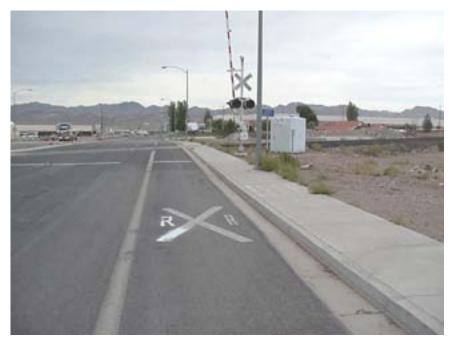
LEFT: In Henderson. Nevada, along Horizon Drive, both the bike lane and the sidewalk are included in the same crossing. With the warning device assembly located behind the sidewalk, a single gate arm serves pedestrians, bicyclists and motor vehicle traffic. The crossing surface is continuous across the tracks to the other side, delineating the safe crossing path for pedestrians.

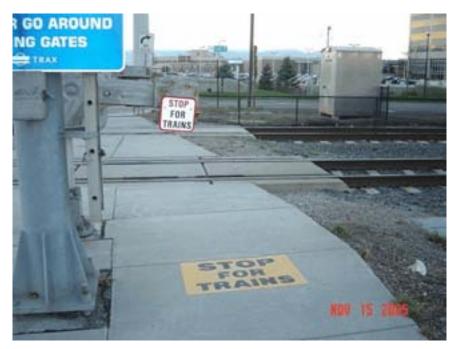
RIGHT: In Utah, Salt Lake City's UTA TRAX light rail system is evaluating the effectiveness of specialized warning signs for pedestrians. Below is a safety treatment that they installed at one crossing, which is close to a middle school and other sources of pedestrian traffic. Light rail trains run at 55mph over this crossing, so this was felt to be a good test site for these devices intended to provide additional safety awareness to pedestrians. Notice the small sign placed on the crossing gate counterweight.

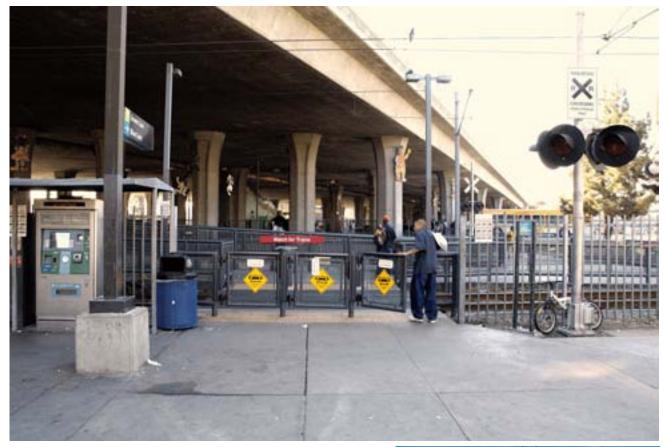
The use of channelizing devices can help encourage some of the desired behavior in pedestrians when they attempt to cross the tracks. In the case shown above, the use of "swing gates" at this light rail transit station serves to focus the eyes of the pedestrian in the direction from which a train on the near track would be entering the station. This has reduced incidents related to passenger inattention to trains in the station area.

In order to operate the gate, and enter the station, the user must turn in the direction of oncoming train traffic, and then stop to open the gate. This can reduce sudden, inattentive "dart outs" into the path of an oncoming LRT train. In addition, signing is used on each gate : PULL TO OPEN, LOOK BOTH WAYS, along with a large Watch For Trains sign posted in clear view.

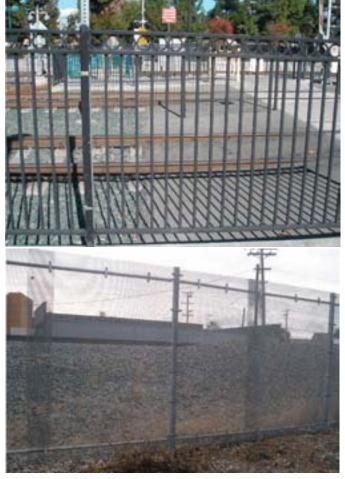
RIGHT: The "zigzag" or "Z-Gate" crossing is a good example of channelization that also can improve pedestrians' observation of any approaching trains as they traverse the crossing approaches. Pedestrians are forced to look in the direction of oncoming trains as they make the turns approaching the crossing. While this type of crossing does increase the distance that pedestrians have to travel, sturdy fencing provides good compliance.

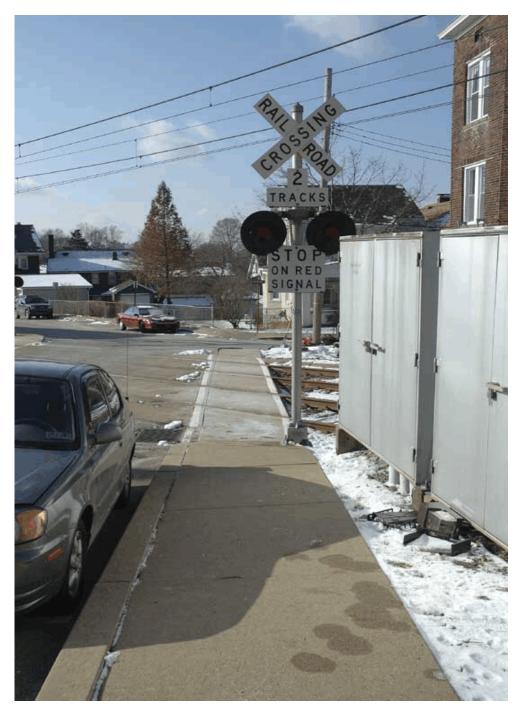
Light rail systems that are the remnants of streetcar networks constructed in the early 20th century often feature a higher frequency of pedestrian and street crossings. Many of these systems retain crossings with restricted sight distances due to the development that has taken place around the transit line. In this photo, there are railroad wayside signal cabinets adjacent to the sidewalk approaching the light rail station, as well as the controllers for the grade crossing system. For pedestrians walking downhill toward the station, sight distances to the right are extremely limited. This makes the pedestrians very dependent upon the crossing warning devices for notice of an approaching train.

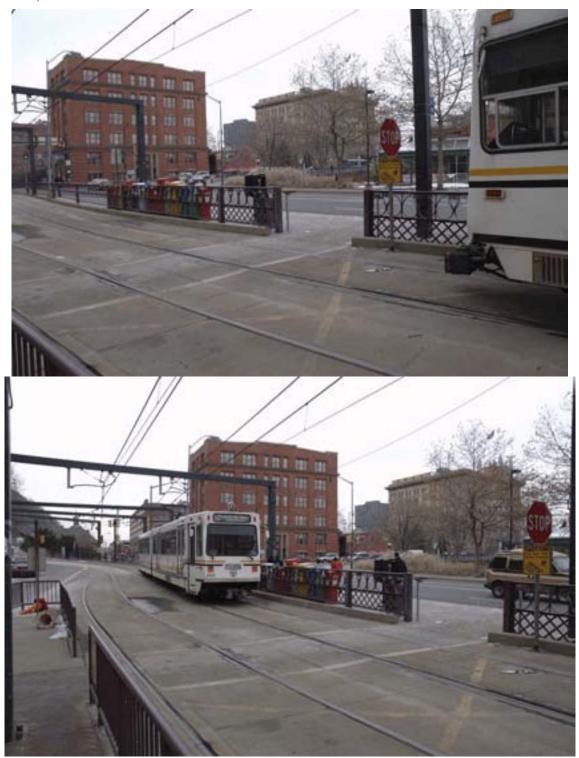
In rare circumstances within a station, a transit system may elect to have a safety stop for all outbound vehicles. This stop is used to allow passengers to cross over to the inbound platform, which only has access from this side.
