**EXH. JPH-8
DOCKETS UE-240004/UG-240005
2024 PSE GENERAL RATE CASE
WITNESS: JAMES P. HOGAN**

**SEVENTH EXHIBIT (NONCONFIDENTIAL) TO THE
PREFILED DIRECT TESTIMONY OF**

**Seepage Reduction Alternatives
Lower Baker Dam
Concrete, Washington**

21-1-22284-005

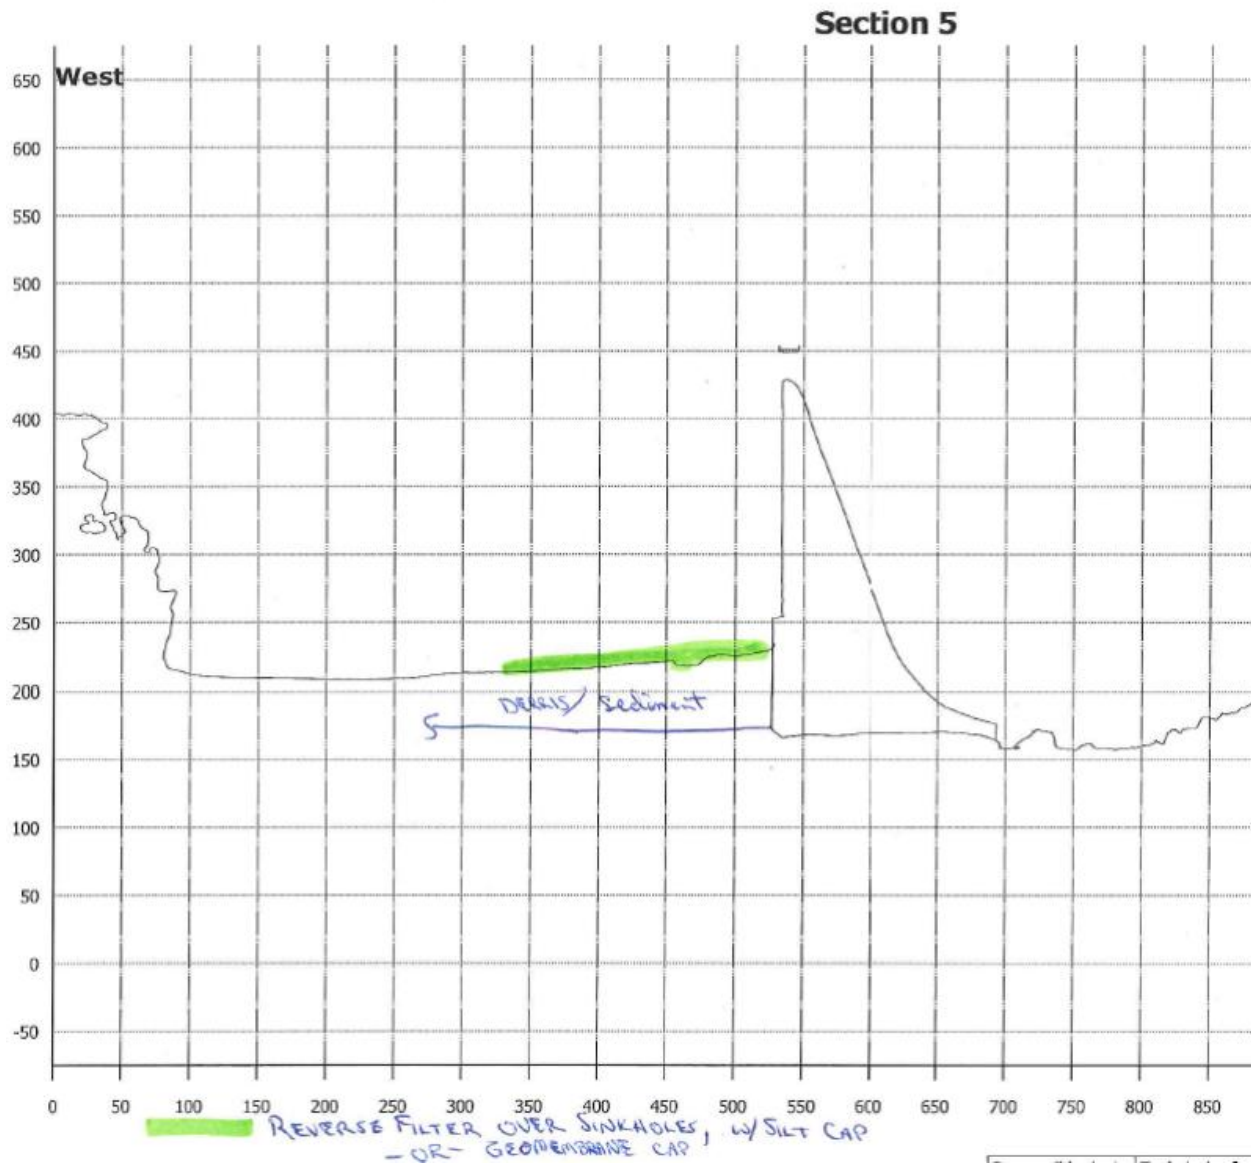
Exhibit Alt 1A-4: Blanket over forebay depressions, section perpendicular to dam

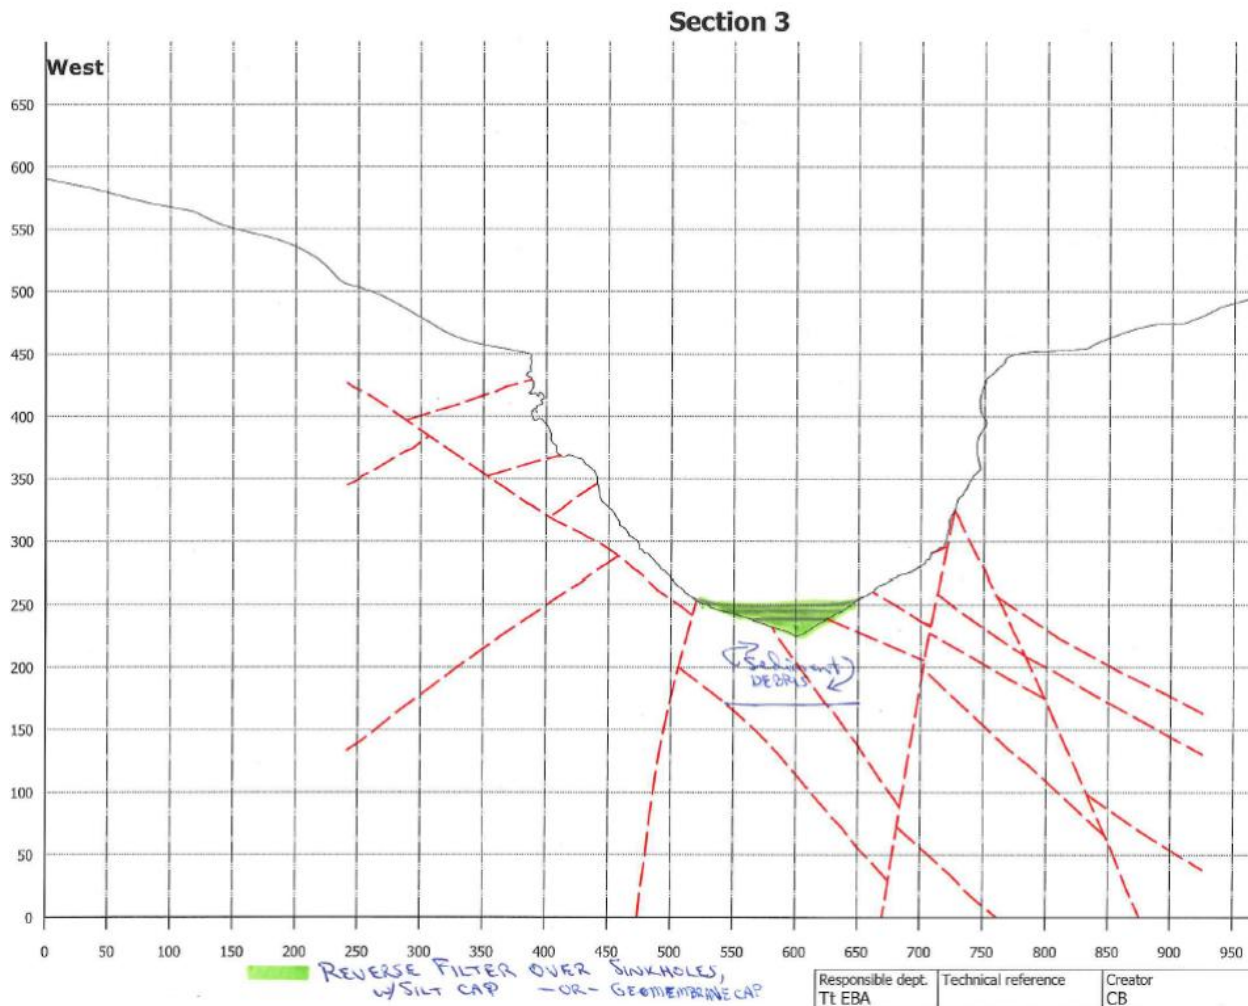
Exhibit Alt 1A-5: Blanket over forebay depressions, cross section

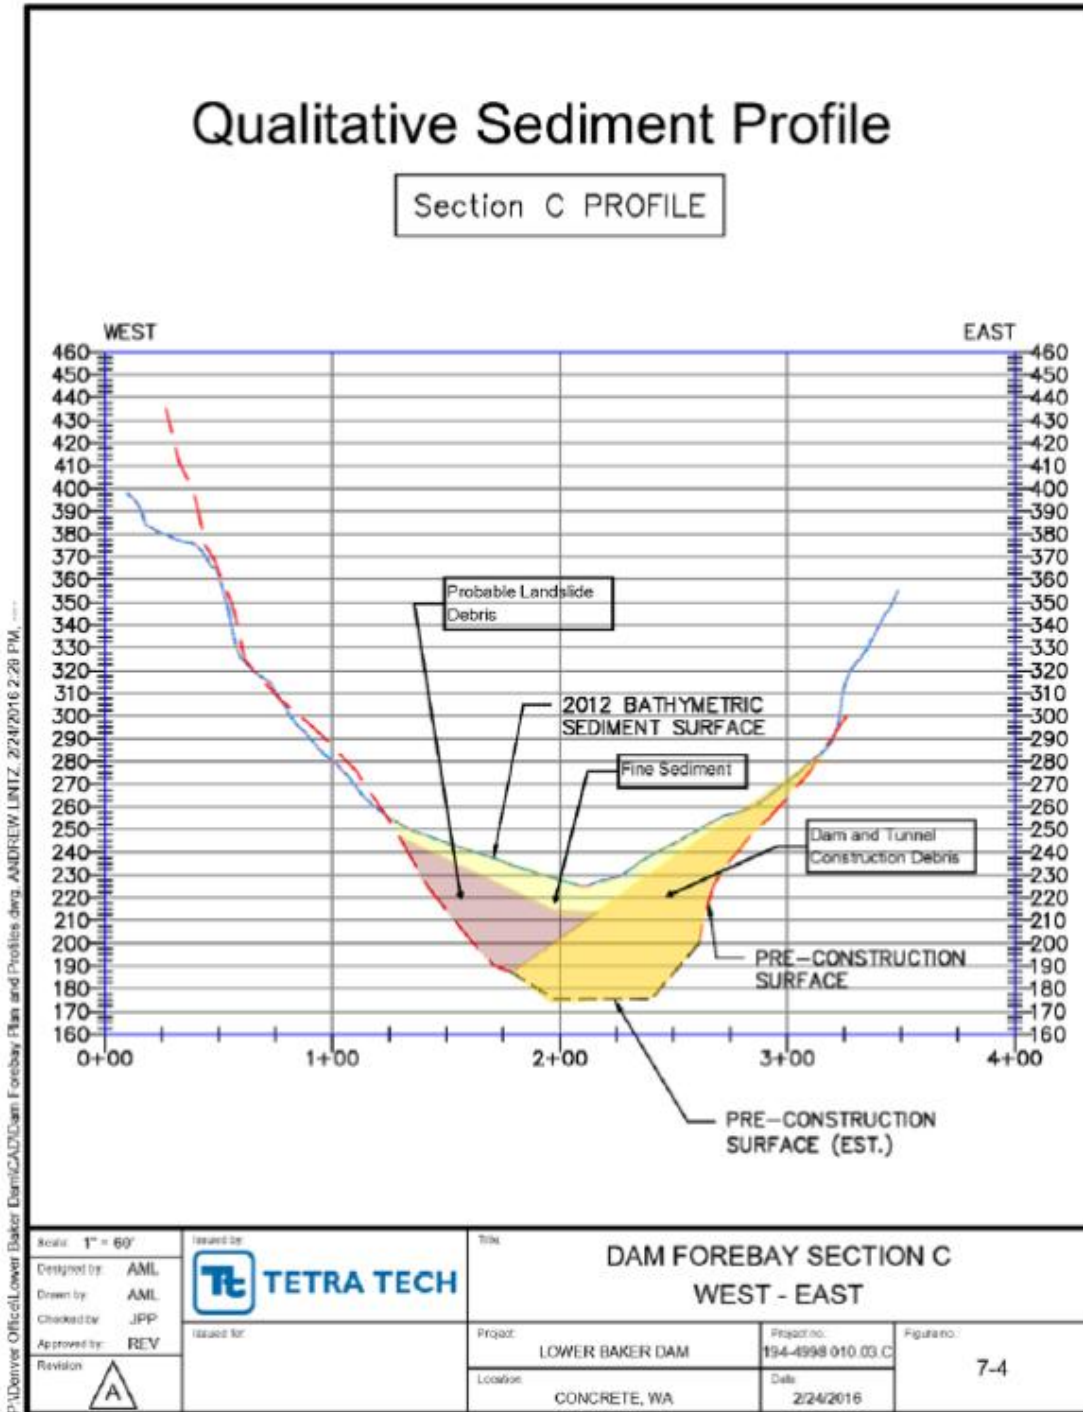
Figure 7-4: Dam Forebay Section C

Exhibit Alt 4-1: Debris and sediment upstream of LBD, cross section (Tetra Tech, 2016)

Alternative 4 consists of grouting voids in debris and sediment that overlie the bedrock and cover the reservoir bottom upstream of the dam (Exhibit Alt 4-1), thus creating a grout blanket above the bedrock (Exhibits Alt 4-2 through Alt 4-4). Alternative 4 includes targeted filling and grouting of bedrock faults, joints, and fractures that have been identified as conduits for high seepage below the dam, such as those shown in Exhibit Alt 4-4. The objective of Alternative 4 is to reduce seepage through bedrock joints and fractures in the dam foundation and abutments so as to increase potential for successful completion of cutoff wall or grout curtain construction. Alternative 4 grouting would be performed in a few-foot-thick zone immediately above the bedrock to cap and plug fractures in the bedrock through which water flows from the reservoir into the bedrock. Alternative 4 would include targeted drilling into known faults, joints, and fractures to grout those features. Where very high flow occurs, this alternative includes drilling 4- to 8-inch-diameter holes and tremie-ing gravel and sand into the bedrock openings to reduce flow velocities prior to injecting grout.

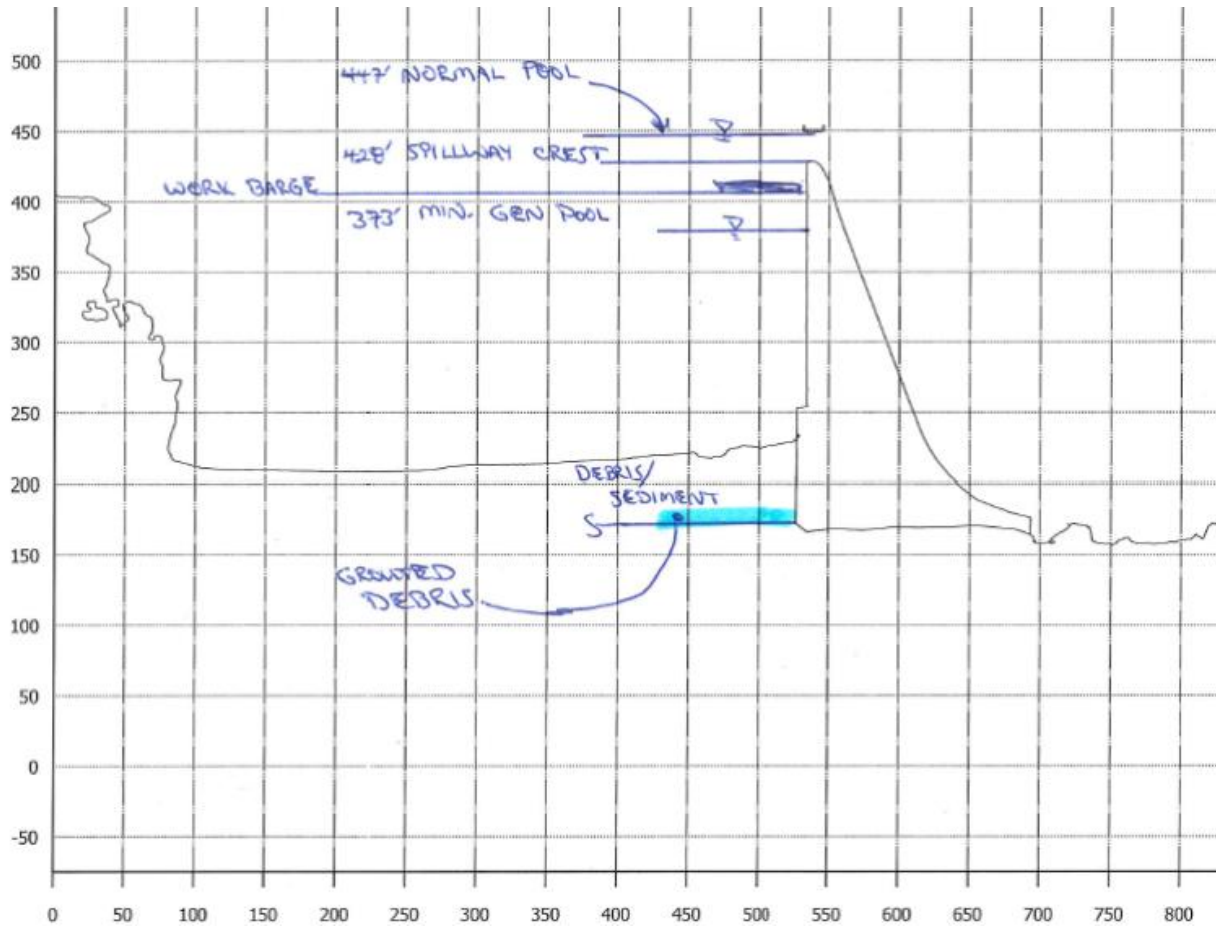
Exhibit Alt 4-3: Grout blanket in debris upstream of LBD, section perpendicular to dam

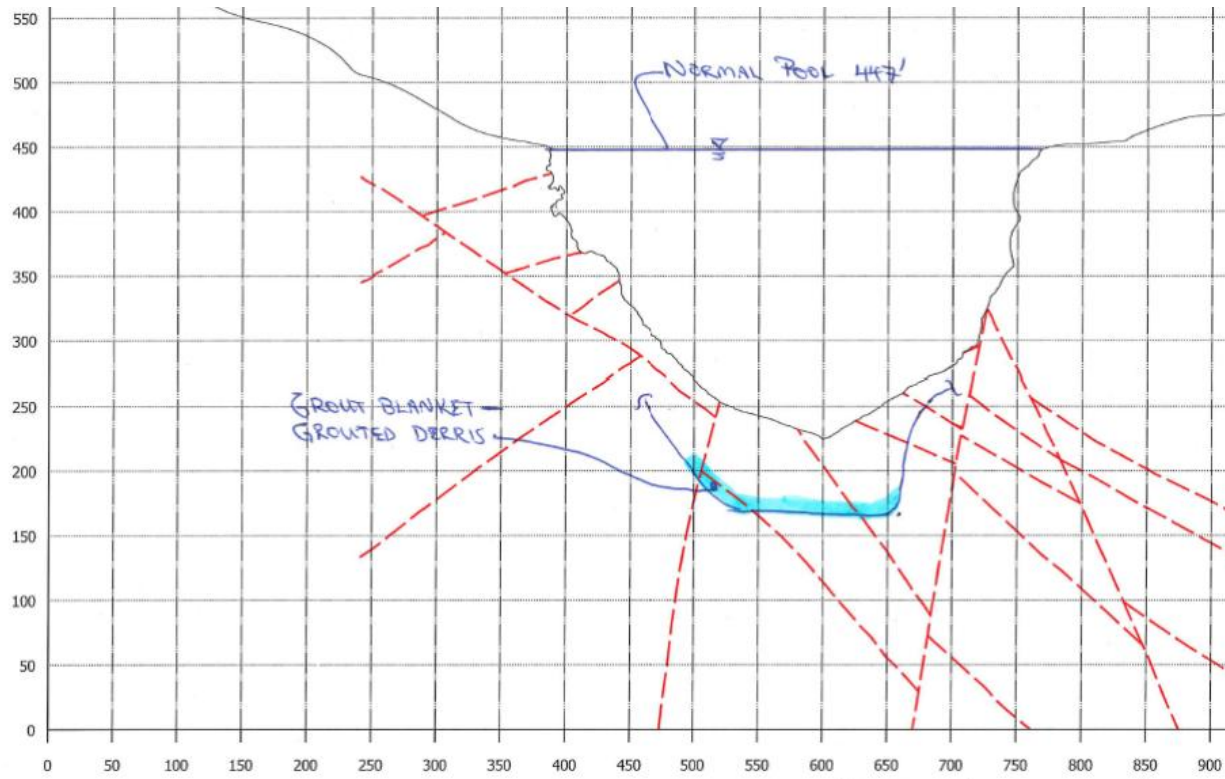
Exhibit Alt 4-4: Grout blanket in debris upstream of LBD, cross section

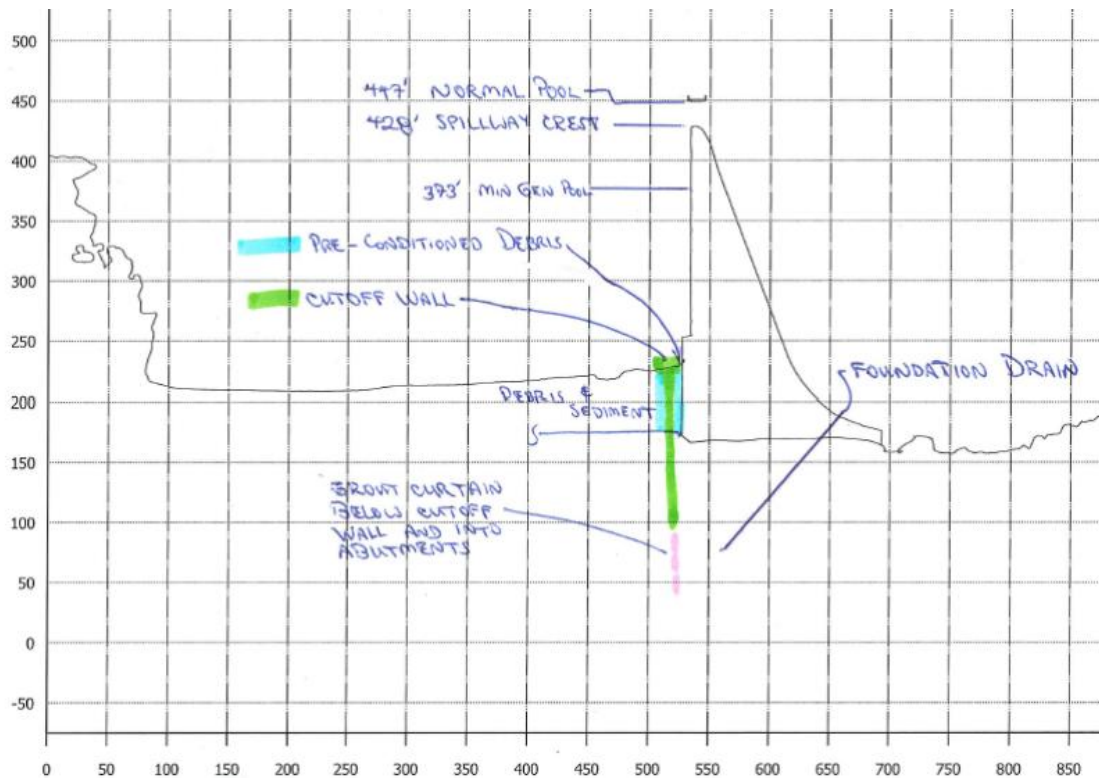
Exhibit Alt 2D-2: Cutoff wall and grout curtain upstream of dam, section perpendicular to dam

Alternative 2D would use a combination of a cutoff wall and grout curtain to reduce seepage through the dam foundations and abutments (Exhibits Alt 2D-1 through Alt 2D-3). The cutoff wall would be constructed just upstream of the upstream face of the dam, across areas of known large voids and documented high seepage flow. The cutoff wall would extend down through sediment and debris and into foundation bedrock to the depth at which the rock joints are known to permit high-volume and high-velocity seepage. The vertical and lateral cutoff wall limits would roughly correspond to areas of previous foundation and abutment grouting. After completing the cutoff wall, construct a grout curtain to reduce flow through foundation and abutment rock below the bottom of the cutoff wall and farther into the abutments where seepage could otherwise occur below or around the cutoff wall. The grout curtain extension below the cutoff wall would include grout lines along the cutoff wall alignment and upstream of the cutoff wall alignment.

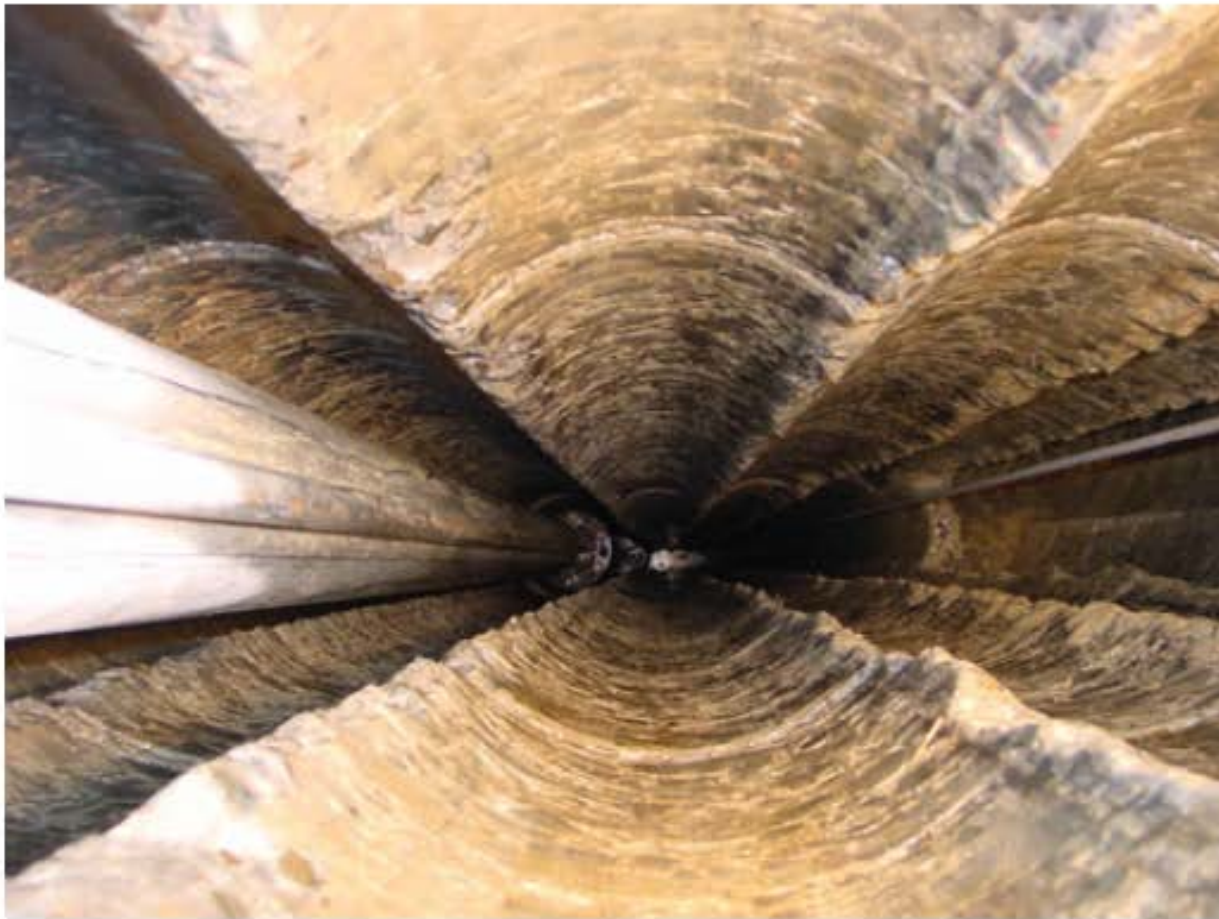
Exhibit Alt 2D-4: Downhole photograph of overlapping secant pile drill holes, Arapuni Dam (Amos and others, 2008)

Adjacent panels are constructed to overlap and thus result in a continuous wall, similar to overlapping adjacent piles in a secant pile wall. Hydromill-constructed cutoff walls can extend to hundreds of feet deep because of the vertical alignment accuracy to which the panels can be excavated.

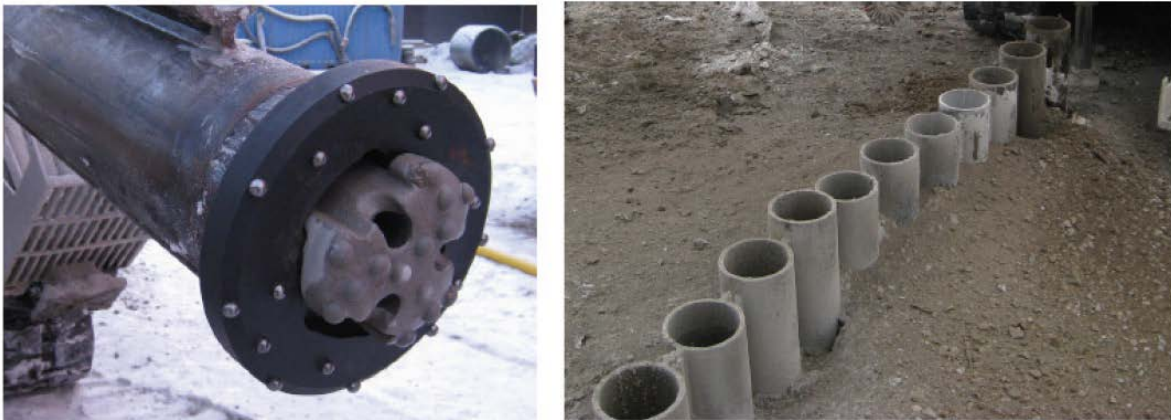
Exhibit Alt 2D-6: RD pile bit and downhole hammer (left) and view of top of piles after installation (right) (Uotinen and Jokiniemi, 2012)

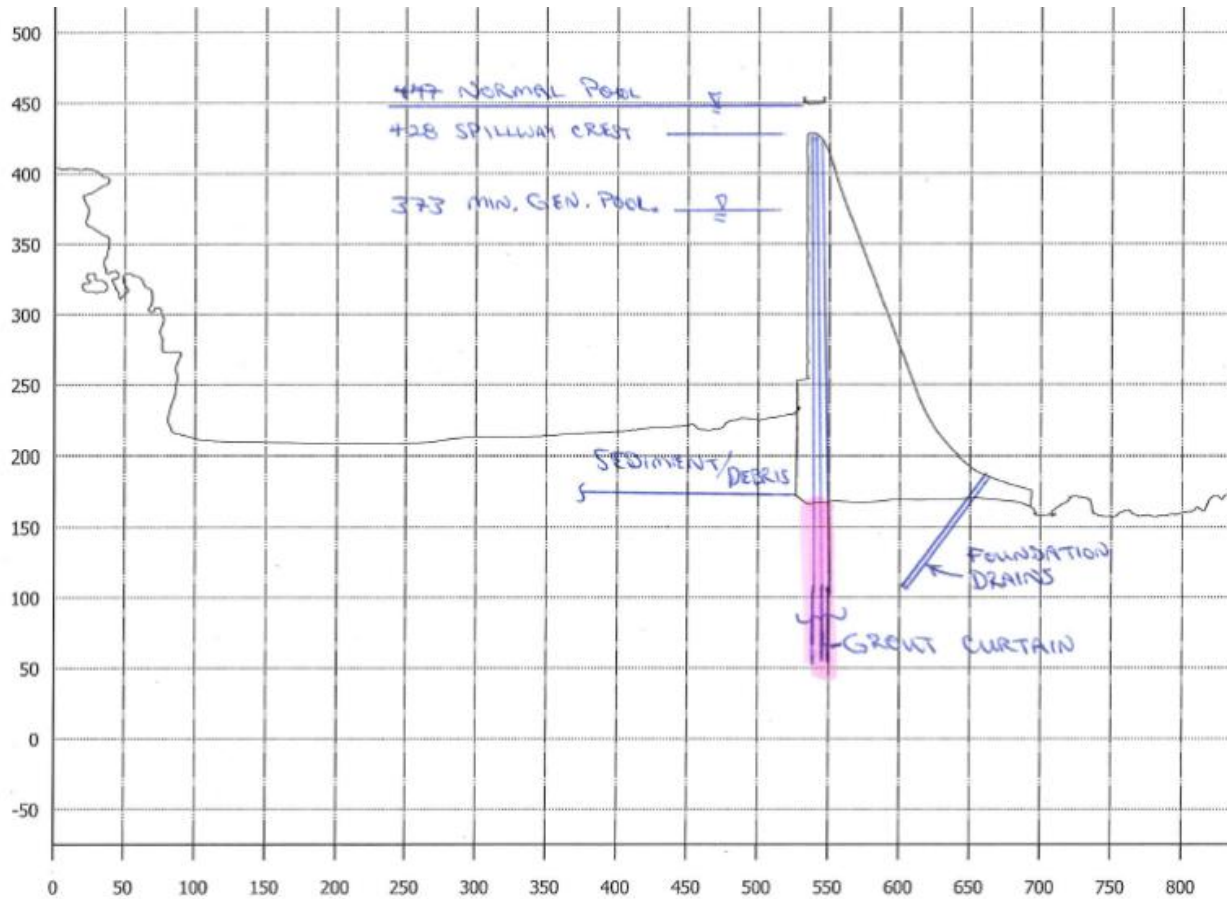
Exhibit Alt 3A-2: Grout curtain drilling through dam crest, section perpendicular to dam

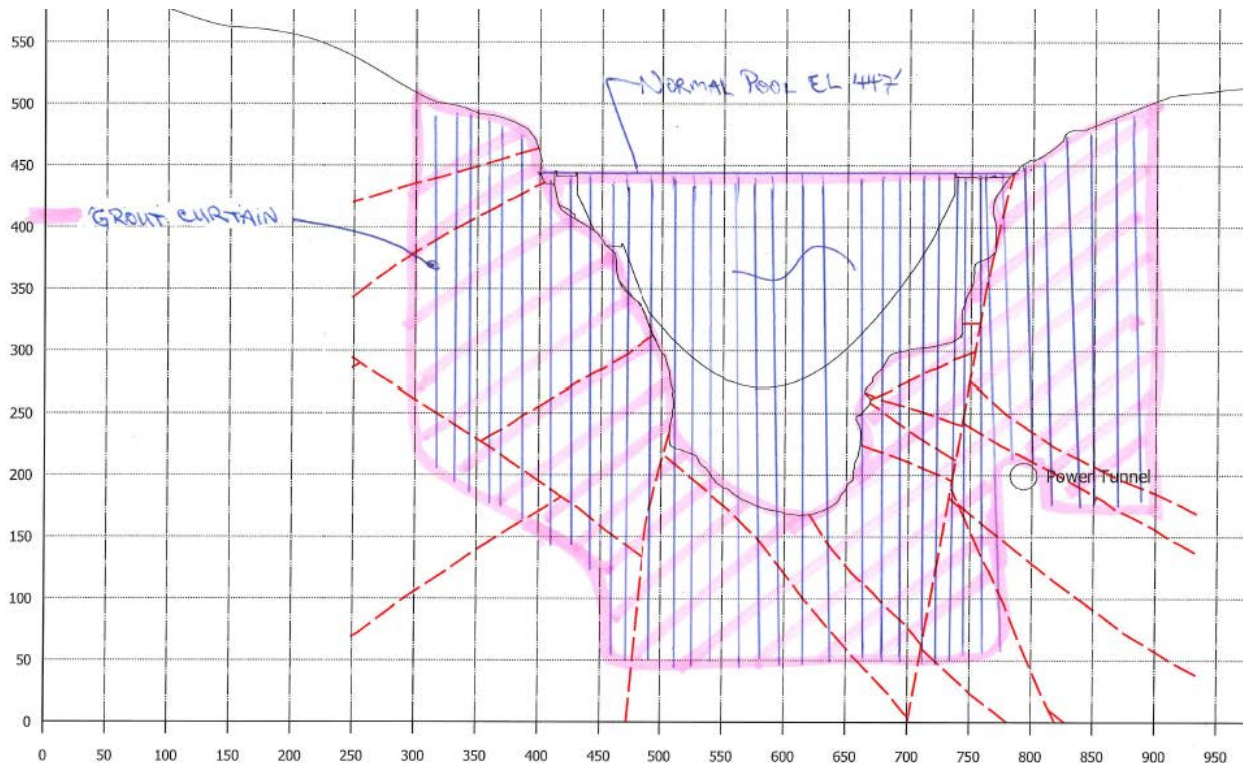
**Exhibit Alt 3A-3: Grout curtain drilling through dam crest, cross section
(grout holes shown vertical—grout holes may be inclined and grout holes in
adjacent grout curtain lines drilled at different orientations)**

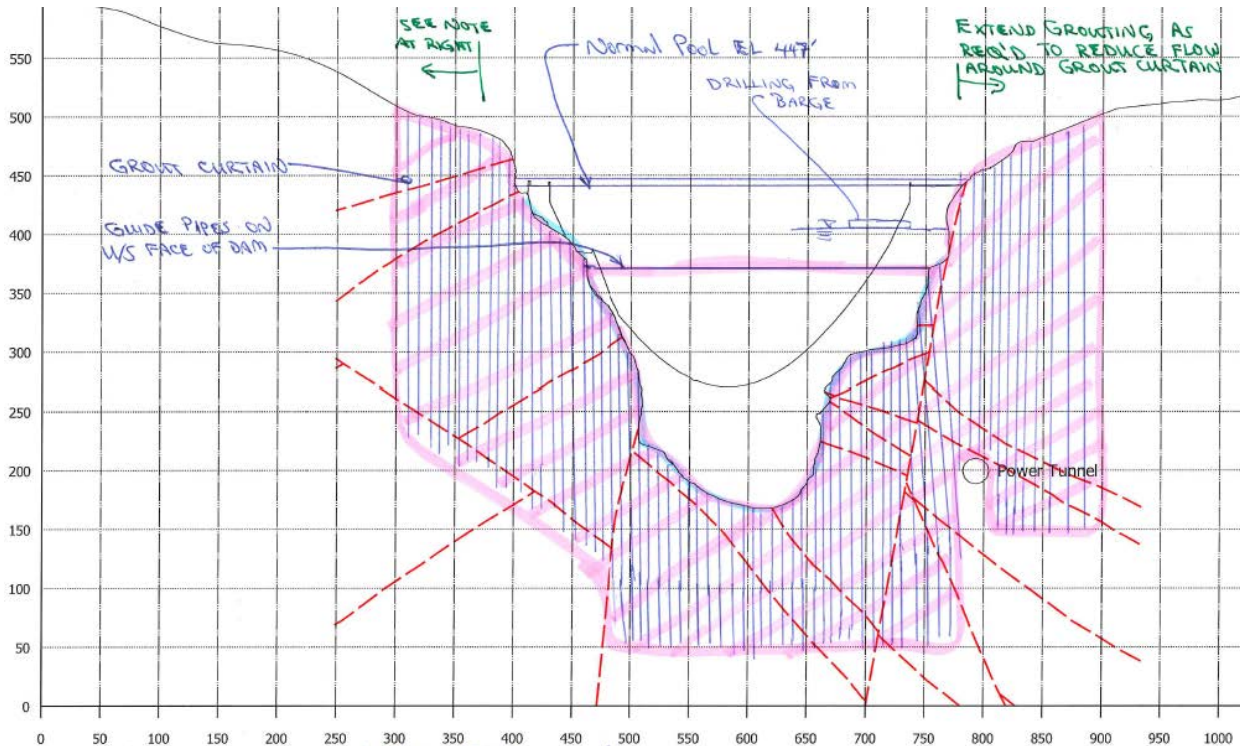
Exhibit Alt 3D-3: Grout curtain drilling from barge through upstream dam face, cross section (grout holes shown vertical—grout holes may be inclined and grout holes in adjacent grout curtain lines drilled at different orientations)

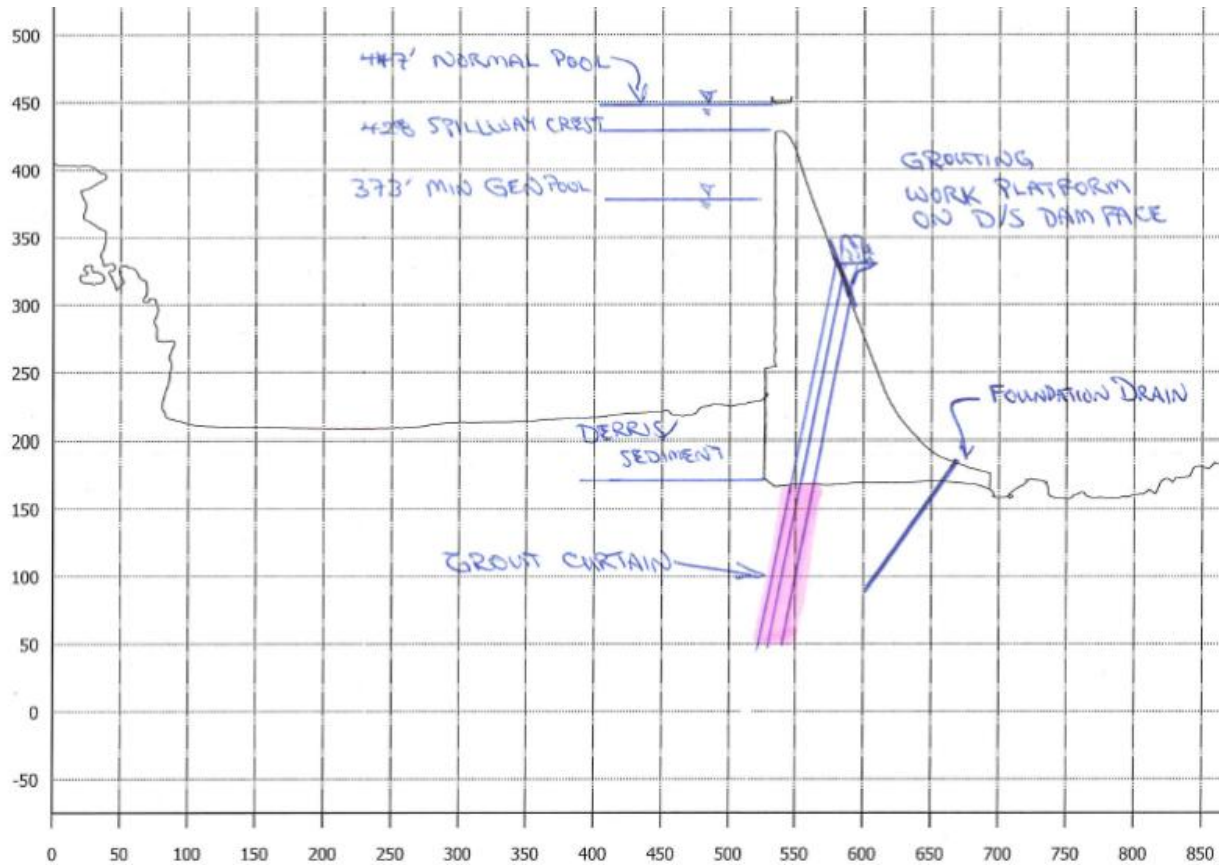
Exhibit 3E-2: Grout curtain drilling through dam from downstream dam face, section perpendicular to dam

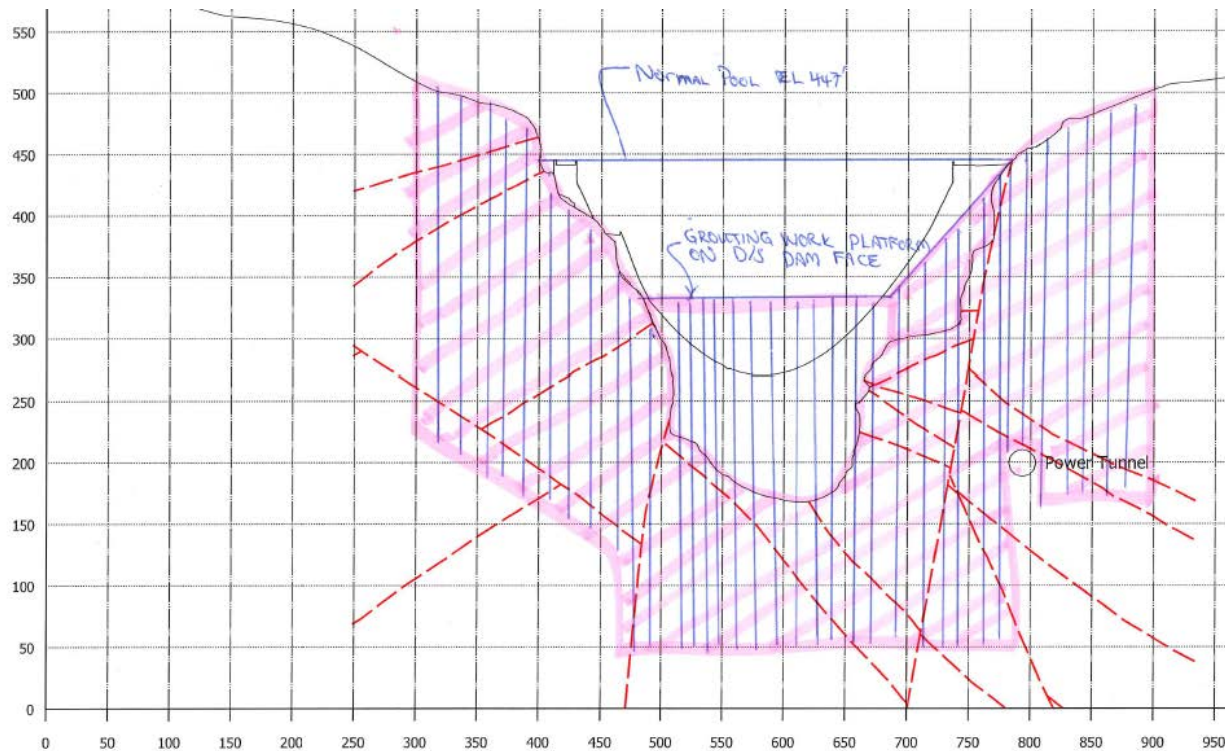
Exhibit 3E-3: Grout curtain drilling through dam from downstream dam face, cross section (grout holes shown vertical—grout holes may be inclined and grout holes in adjacent grout curtain lines drilled at different orientations)

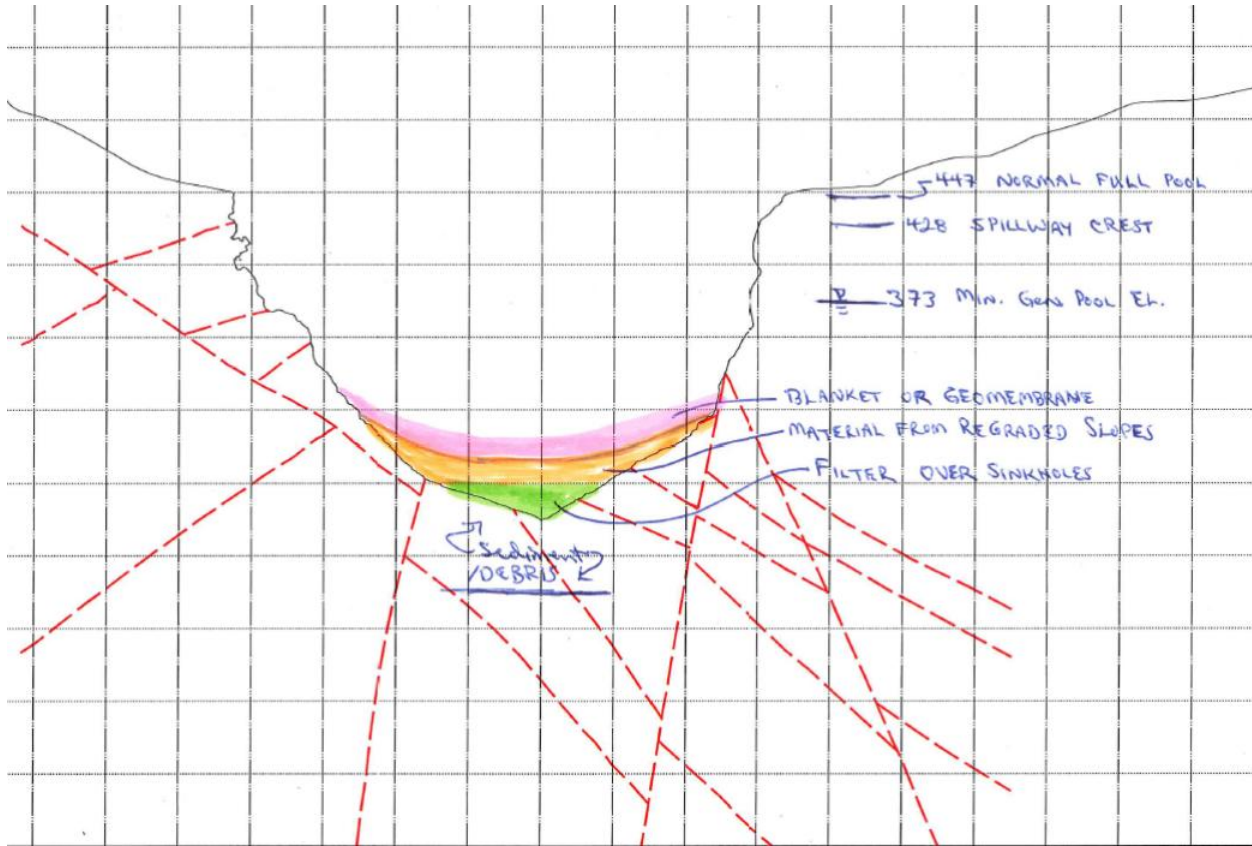
Exhibit A-Alt 1B-2: Filter over depressions and sinkholes, debris regrading, and blanket; cross section

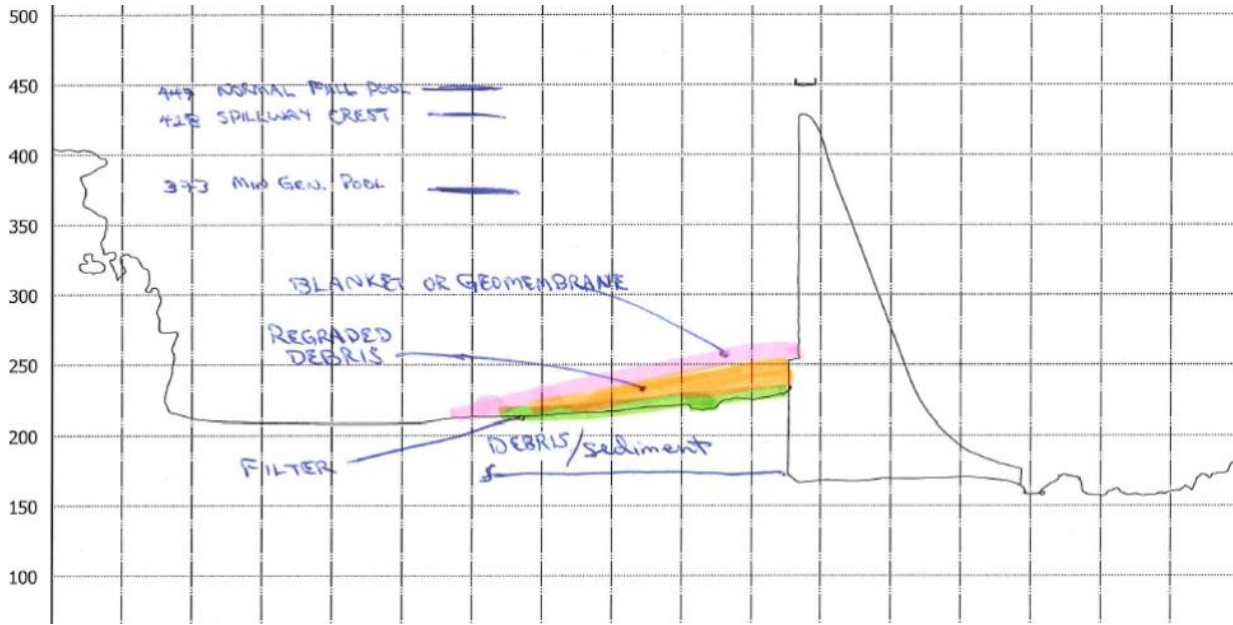
Exhibit A-Alt 1B-3: Filter over depressions and sinkholes, debris regrading, and blanket; section perpendicular to dam

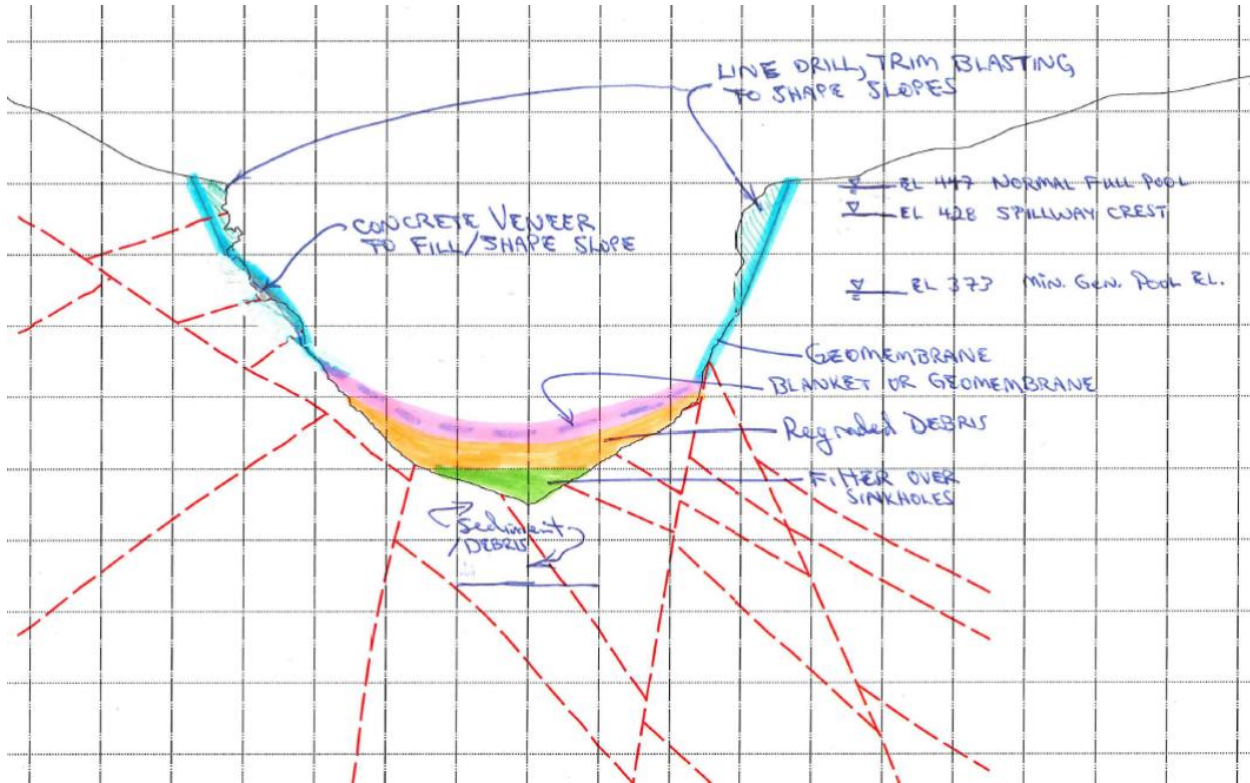
Exhibit A-Alt 1C-2: Filter over depressions and sinkholes, debris regrading, blanket, and geomembrane on slope; cross section

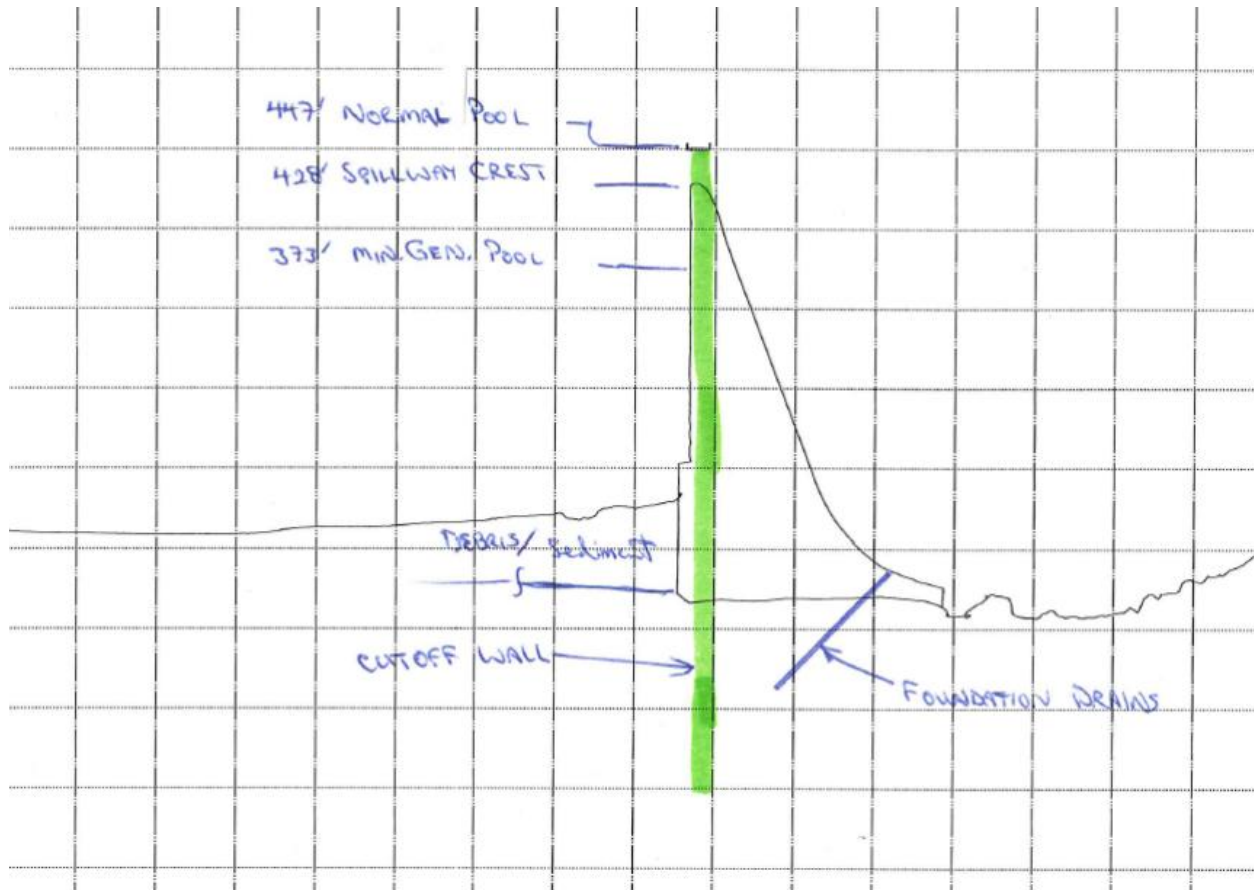
Exhibit A-Alt 2B-1: Cutoff wall through dam; section perpendicular to dam

- Potential for cutoff wall construction to modify the stress state in the dam or weaken the dam.
- Modifications to dam crest and existing gates would be required to create work platform from which cutoff wall construction equipment could operate.
- Difficult access. Work platforms on top of dam and equipment and materials transport systems would need to be constructed to deliver materials to cutoff wall work locations.
- Cutoff wall drilling depth is maximized, increasing the challenges of maintaining overlap of adjacent cutoff wall elements and challenges with equipment achieving the design depth. High precision drilling is required.
- Construction on steep slopes on either side of the dam to extend the cutoff wall into abutments.
- Ability to operate spillway gates and spillway may be reduced during construction period.
- High cost.

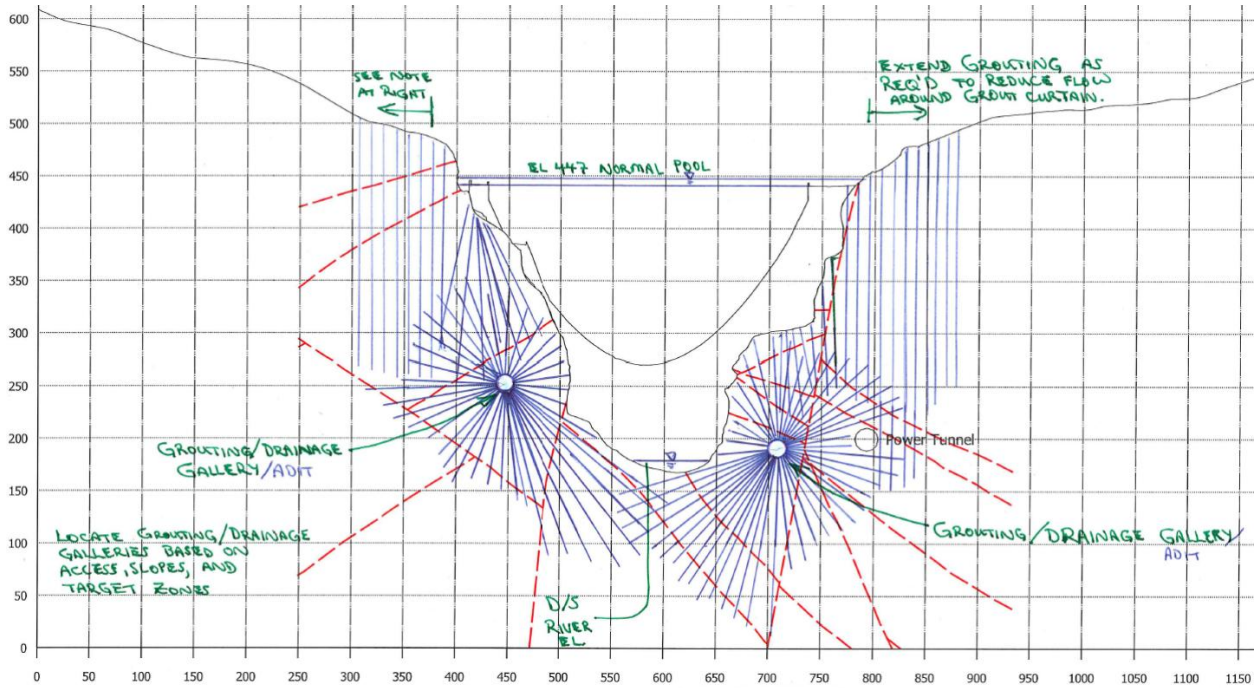
**Exhibit A-Alt 3B-1: Grout curtain – drilling from adits; cross section
(vertical and horizontal grout holes shown for convenience—grout hole orientations
would vary and would be different on adjacent grout lines)**

- Local grouting programs may be required to advance and work in adits.
- Access development to adit portal locations for personnel and material delivery and to remove spoils may be challenging.
- Work downstream of dam in river or on sides of river to deliver material to and from adits may be challenging and increase potential for excavated material-, cement-, and equipment-related contaminants to enter the water relative to a ground-surface-based grouting program conducted from higher on the dam and abutments.
- Difficulty controlling groundwater seepage into adits to be used for grouting.
- Excavating adits in existing dam foundation and abutments could change the stress state in the dam and foundation/abutment, potentially impacting the dam.

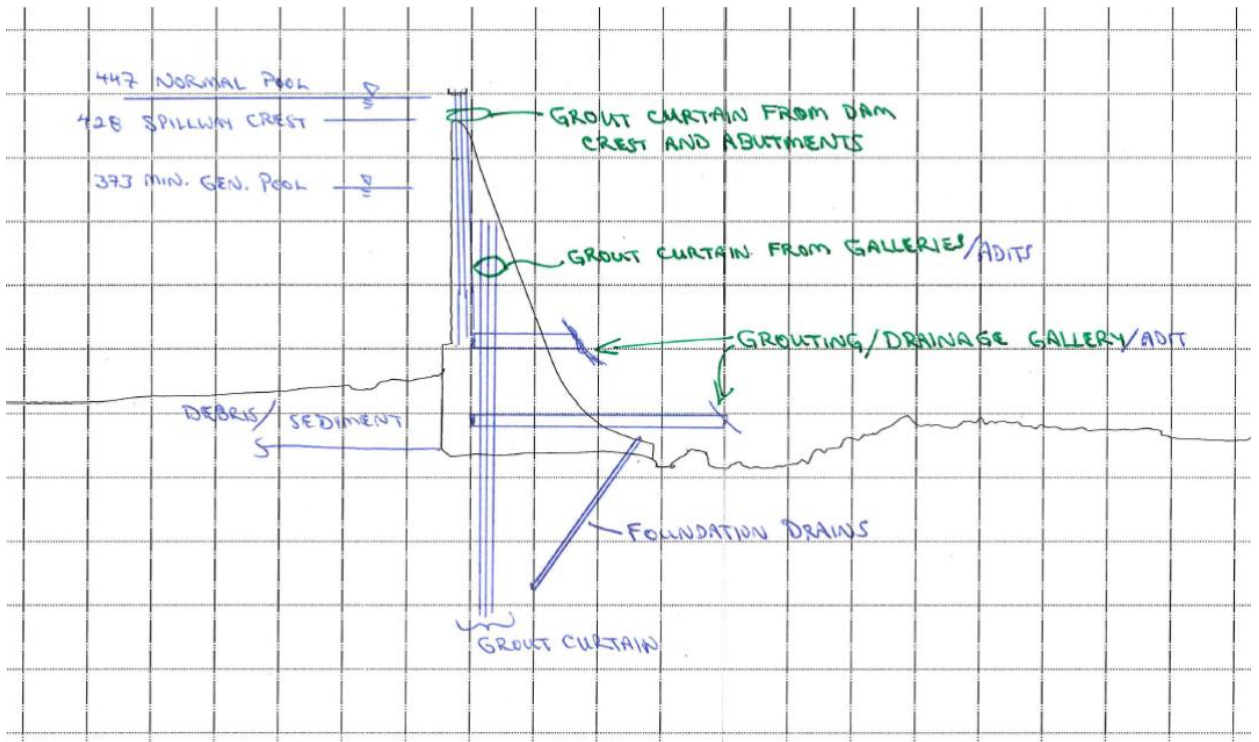
Exhibit A-Alt 3B-2: Grout curtain – drilling from adits; section perpendicular to dam

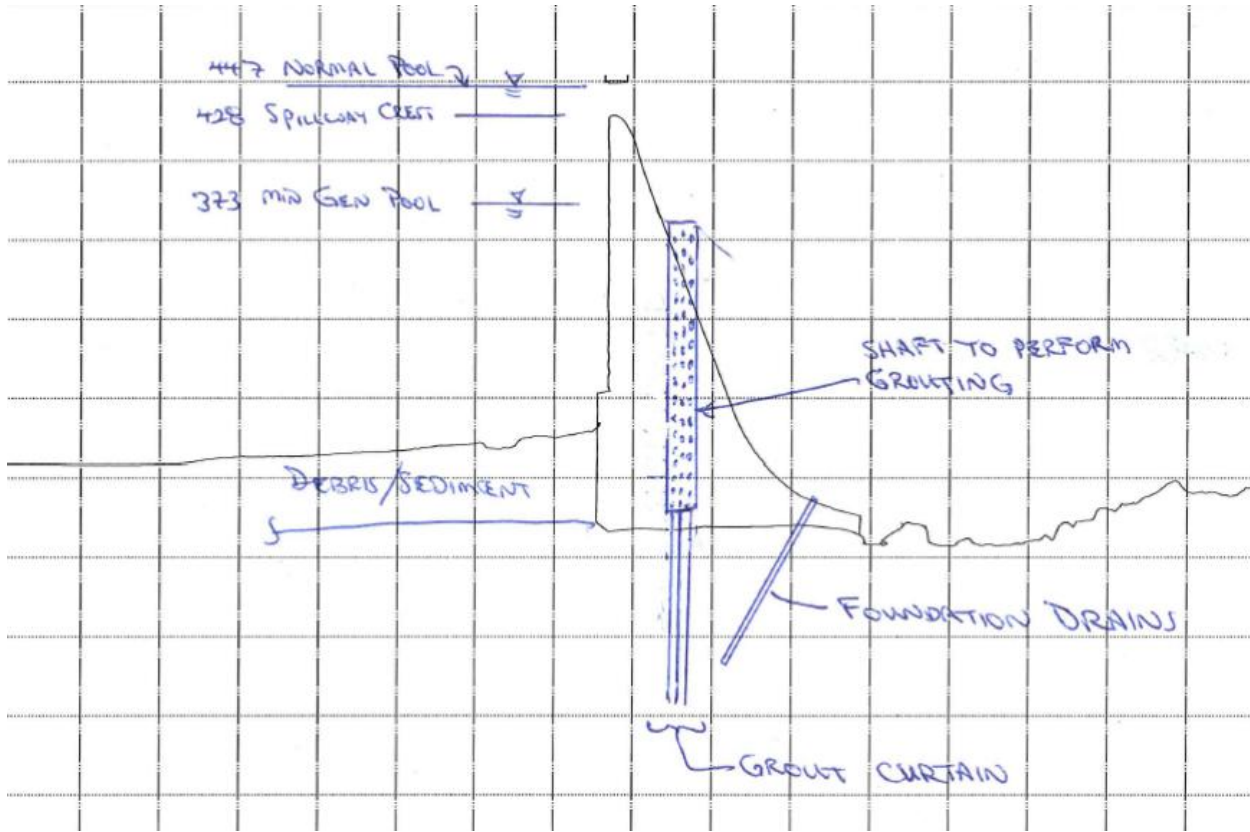
Exhibit A-Alt 3C-2: Grout curtain – drilling from shafts; section perpendicular to dam
