**SECOND EXHIBIT TO THE PREFILED DIRECT TESTIMONY OF
KEVIN C. GARRITY (NONCONFIDENTIAL)
ON BEHALF OF PUGET SOUND ENERGY, INC.**

FINAL REPORT

**LABORATORY-BASED EVALUATION OF FAILED SERVICE LINE
BELLEVUE, WASHINGTON**

PREPARED BY
CC TECHNOLOGIES LABORATORIES, INC.

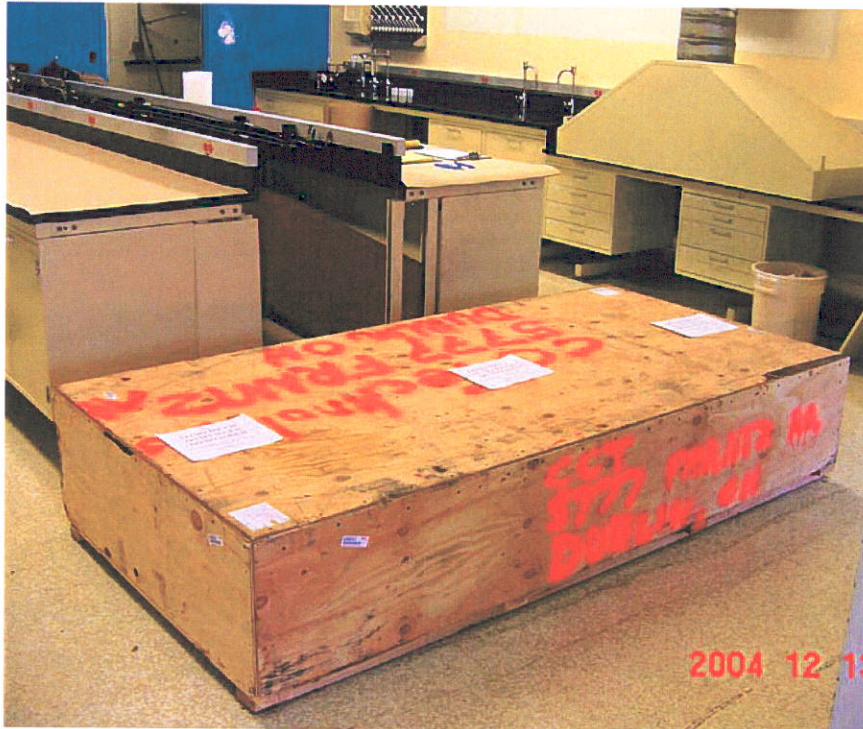
Figure 3. Shipping crate as-received at CC Technologies.

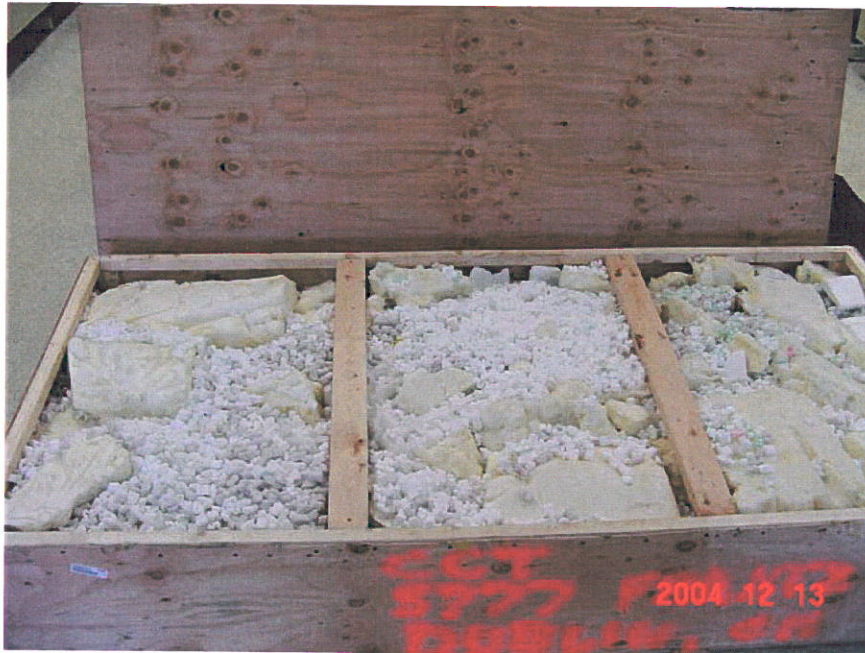
Figure 4. Crate after opening showing packaging of samples.

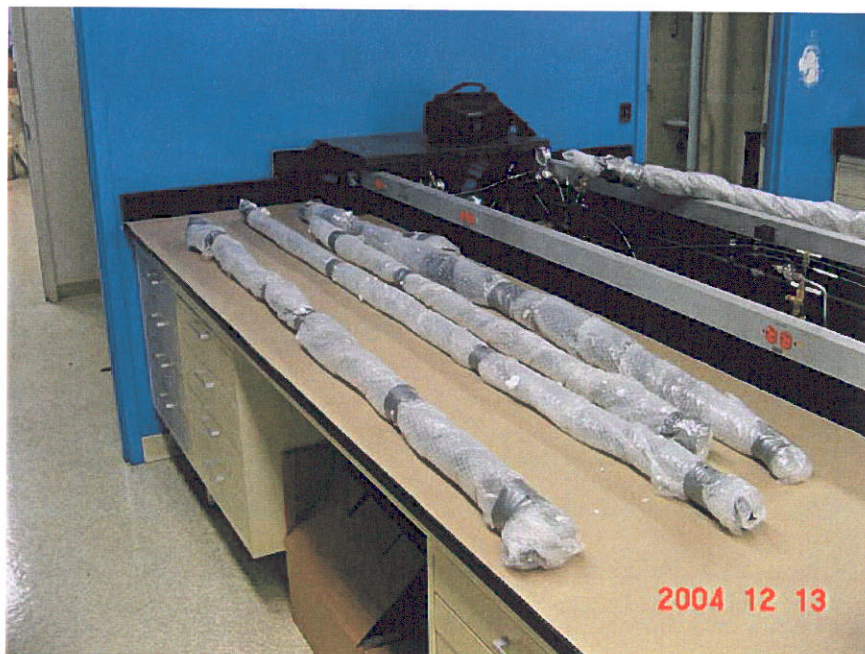
Figure 5. Individual pipe segments' packaging.

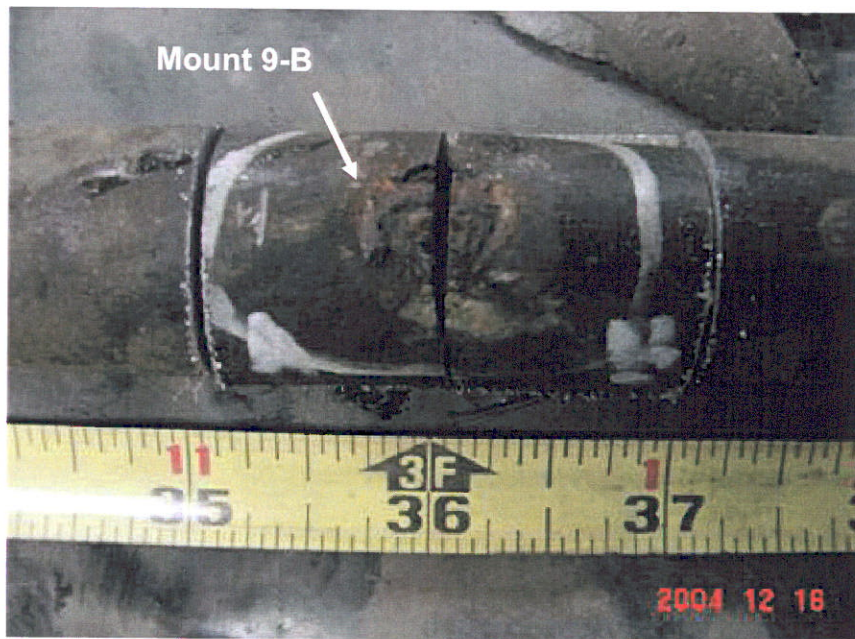
Figure 17. Segment 9 showing Mount 9-B (2nd piece from left).

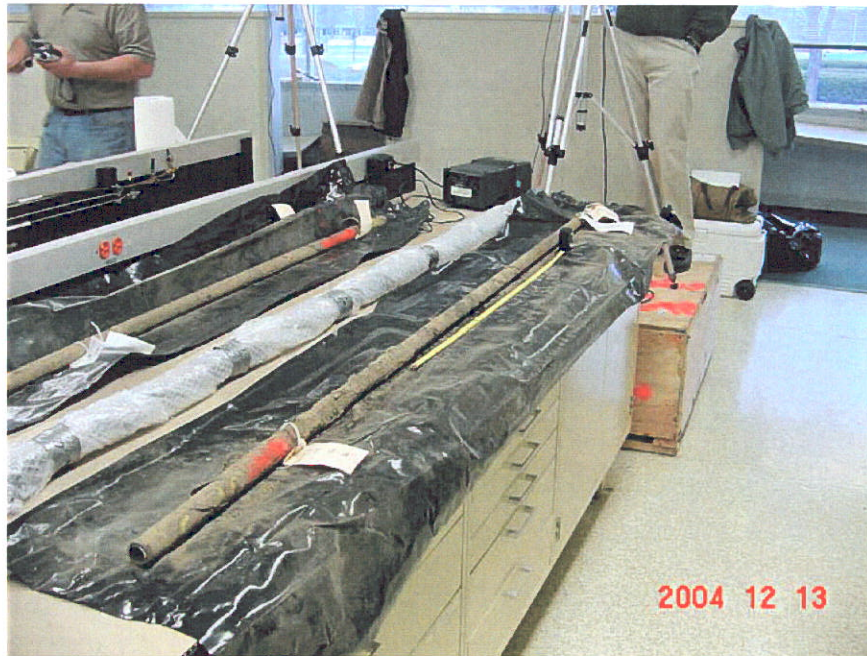
Figure 26. Photograph of Segment 8 after removal of protective wrapping for shipping.

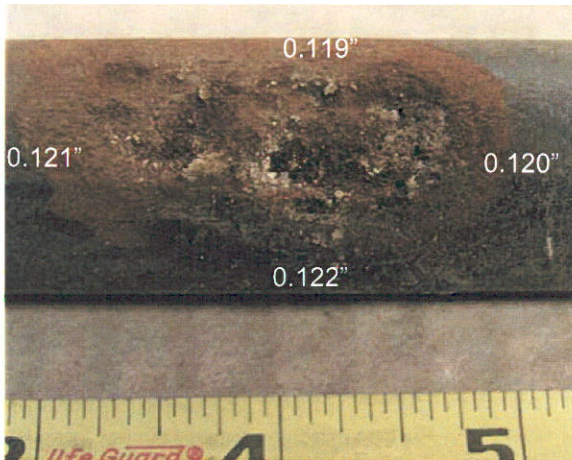
Figure 1. Circumferential profile of the anomaly at the 4-inch location of Segment 1.

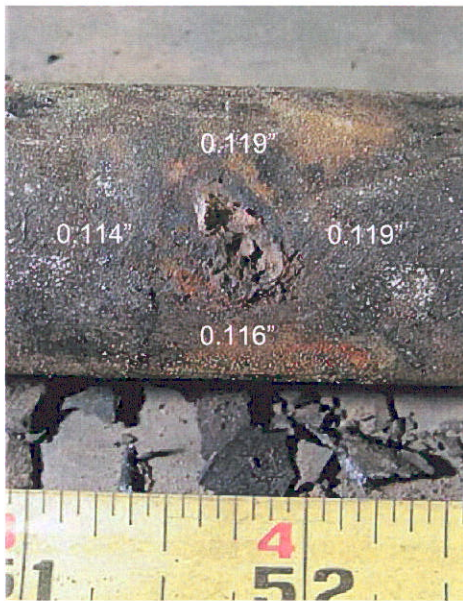
Figure 4. Circumferential profile of the anomaly at the 49.75-inch location of Segment 4.

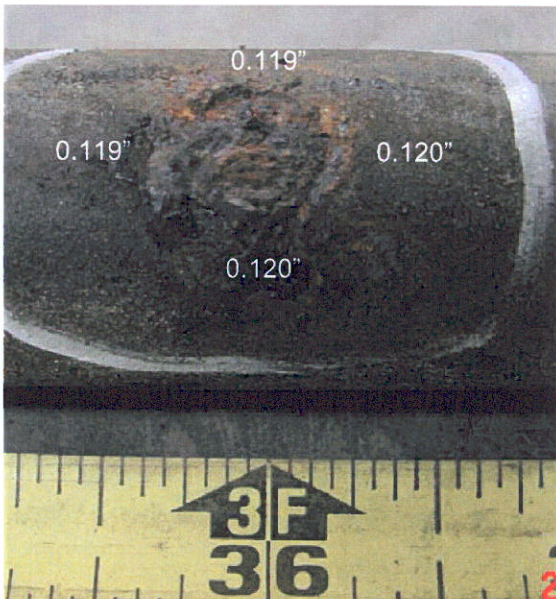
Figure 6. Circumferential profile of the anomaly at the 36-inch location of Segment 9.
